APPENDIX B – MMM GROUP LTD. CONCEPTUAL GATE CHAMBER DESIGN EXISTING CONDITION ASSESSMENTS REPORT

Re: RFP No. 818-2014 - Professional Consulting Services for Developing Conceptual Concepts for Gate Chamber Designs for Storm Relief Sewer Systems

CONCEPTUAL GATE CHAMBER DESIGN EXISTING CONDITION ASSESSMENTS

Prepared for:
The City of Winnipeg

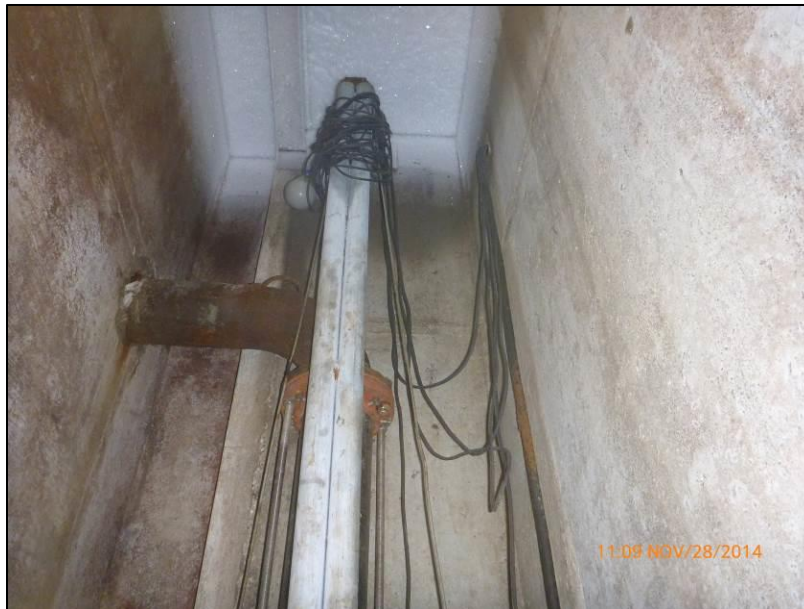
Photograph No. 3

Piping in upstream chamber to downstream chamber,
float switches not in use

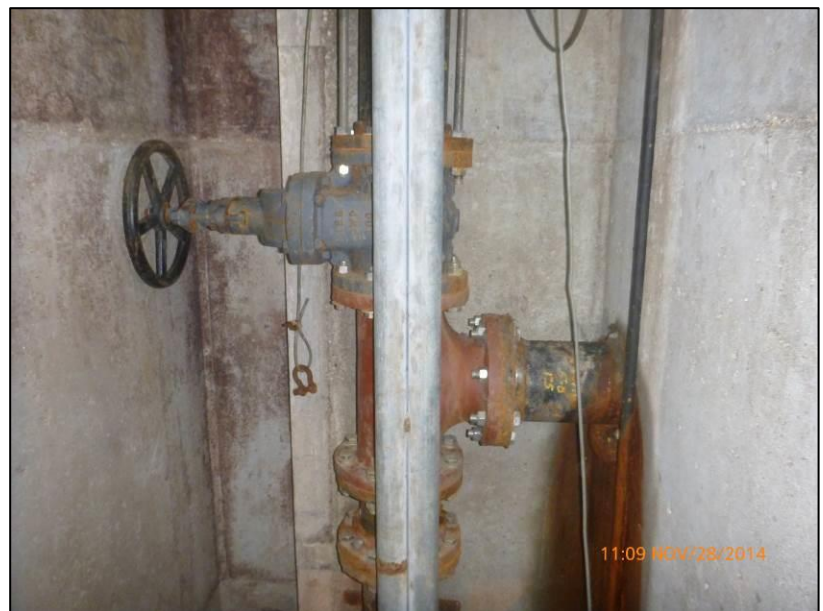
Photograph No. 4

Valve in upstream chamber and piping from submersible pump

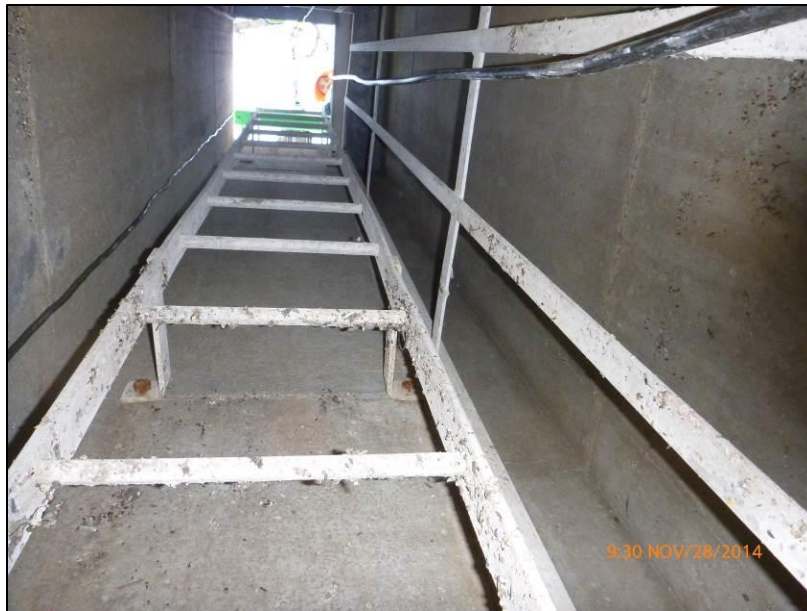
Photograph No. 3

Galvanized ladder and safety cage

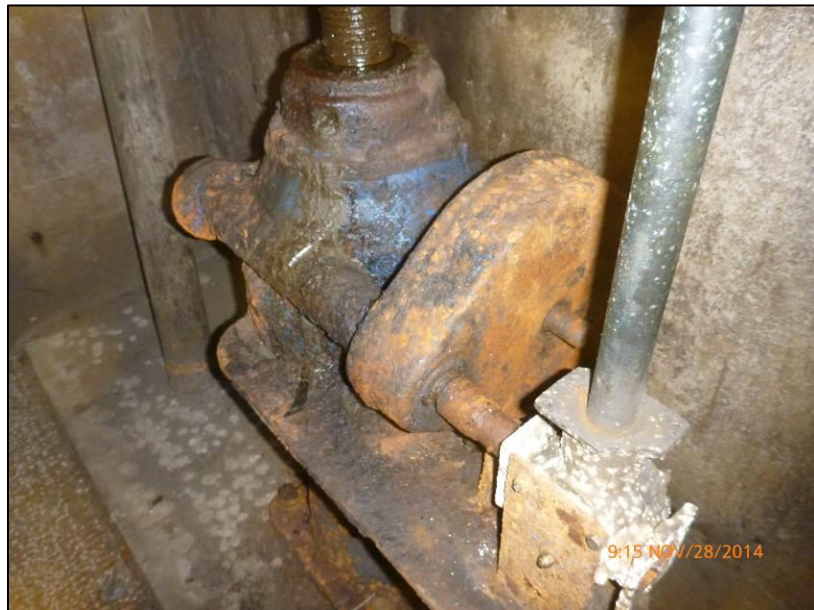
Photograph No. 4

Positive gate lift

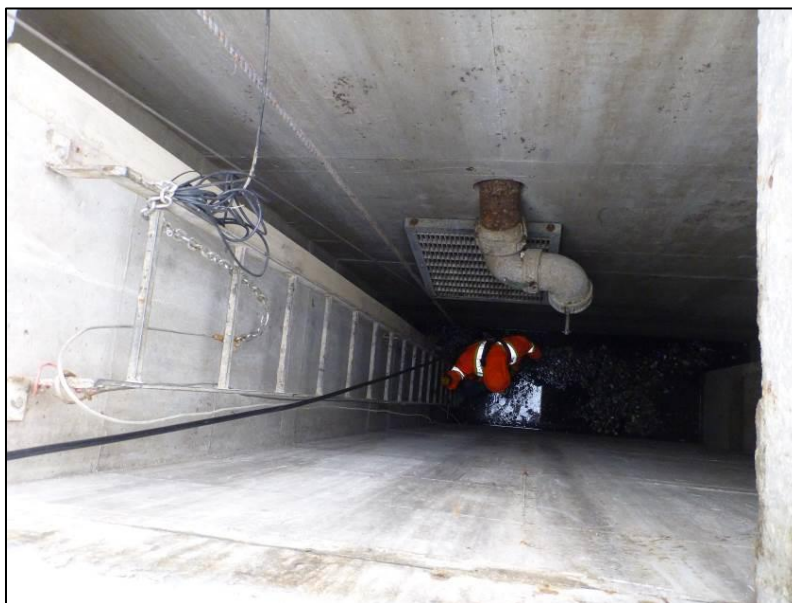
Photograph No. 4

Upstream chamber, ladder safety cage removed

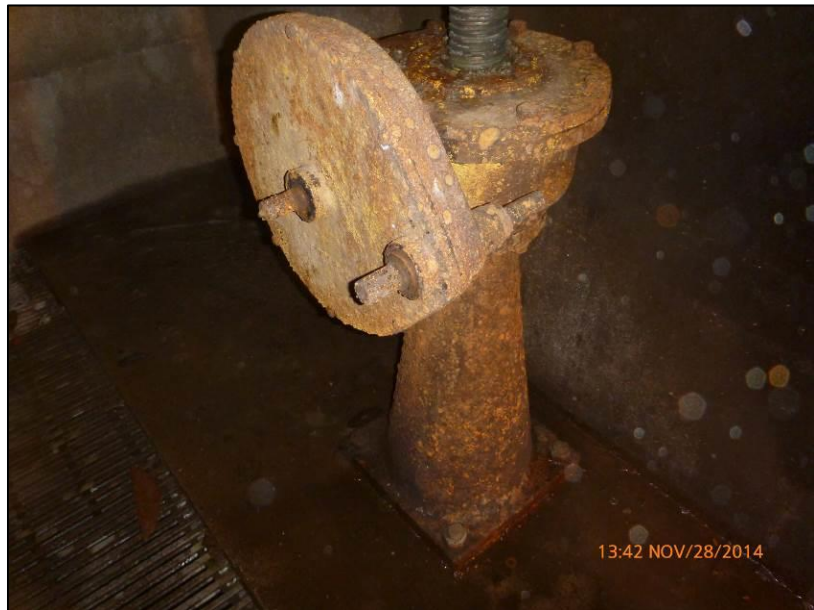
Photograph No. 6

Gate lift, operating shaft not present

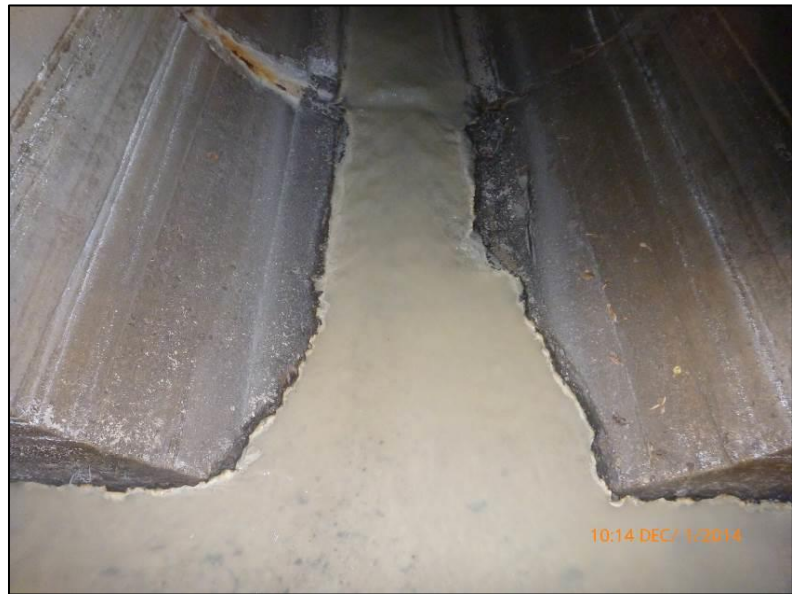
Photograph No. 4

Erosion at invert of LDS outlet
