## **APPENDIX B – MMM GROUP LTD. CONCEPTUAL GATE CHAMBER DESIGN EXISTING CONDITION ASSESSMENTS REPORT**

**Re: RFP No. 818-2014 - Professional Consulting Services for Developing Conceptual Concepts for Gate Chamber Designs for Storm Relief Sewer Systems**

# CONCEPTUAL GATE CHAMBER DESIGN EXISTING CONDITION ASSESSMENTS

Prepared for:  
**The City of Winnipeg**

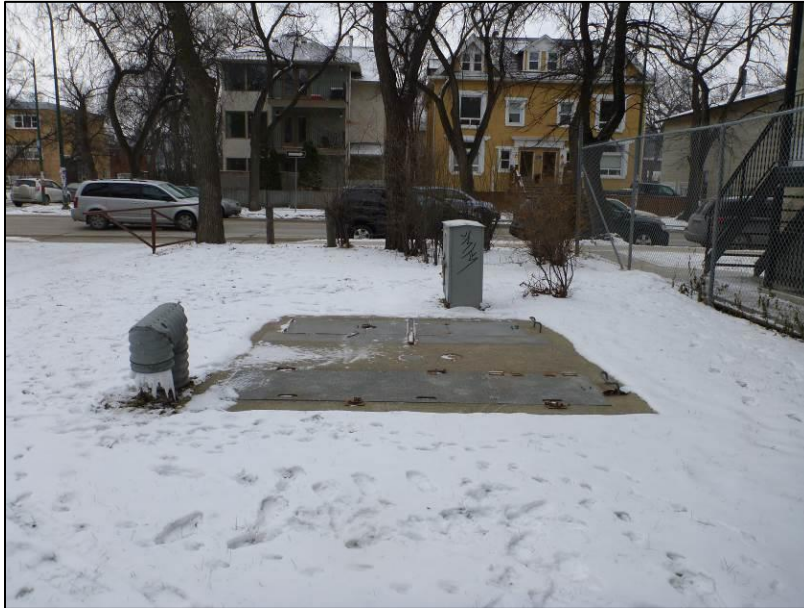
**Photograph No. 1**

Existing site looking south (towards upstream)

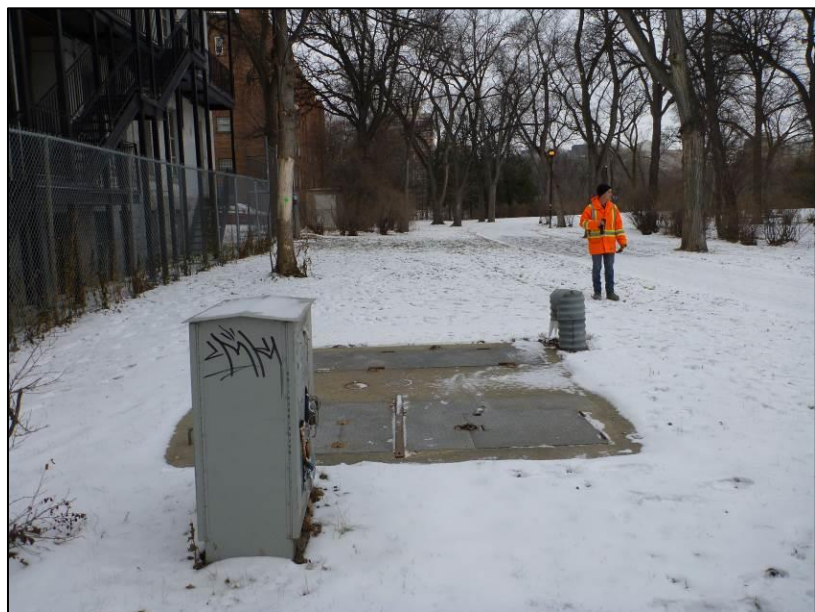
**Photograph No. 2**

Existing site looking north (towards outfall)

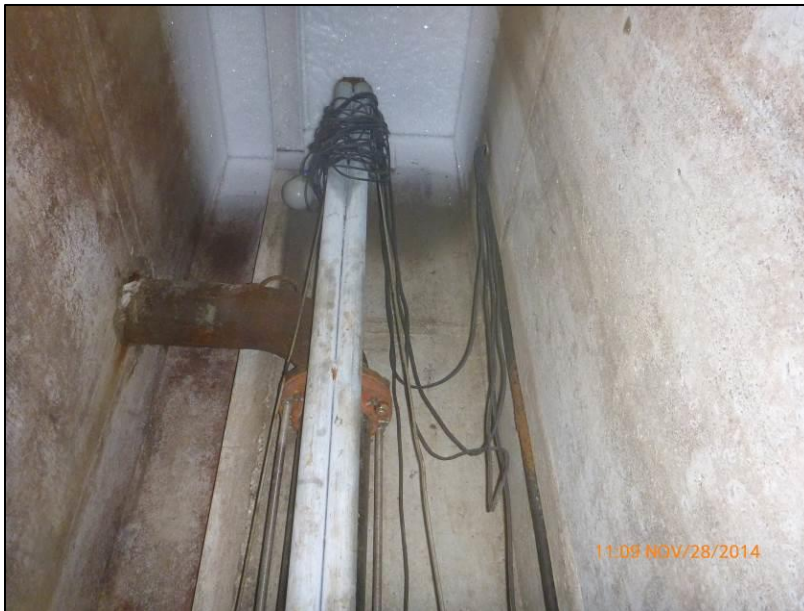
**Photograph No. 3**

Piping in upstream chamber to downstream chamber,  
float switches not in use

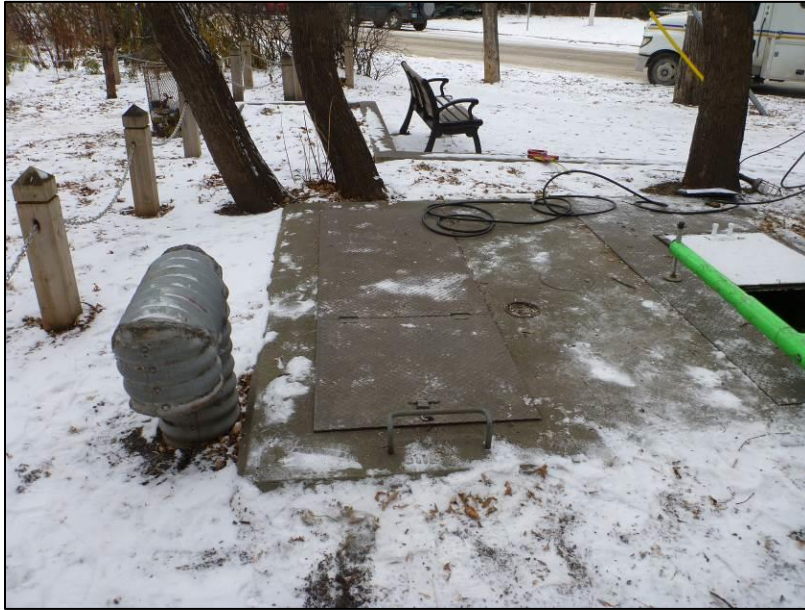
**Photograph No. 1**

Existing chamber roof looking west

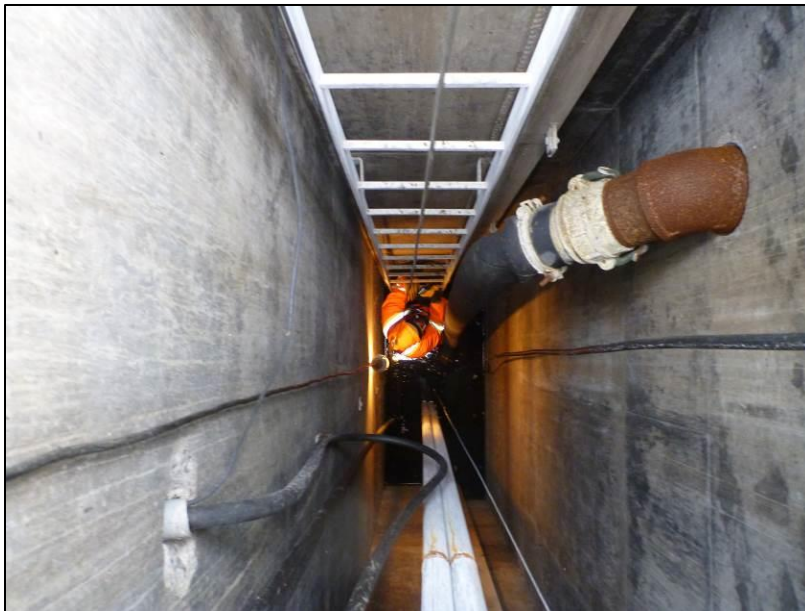
**Photograph No. 3**

Component	Condition	Notes
Structural Concrete	Good	Limited access. Minor damage around some openings.
Galvanized Steel Hatches and Frames	Good	
Galvanized Steel Ladders and Safety Cages	Good	Safety cage in upstream chamber has been removed.
Air Vent	Good	
Existing SRS	Unknown	SRS not accessible.

Piping in upstream chamber to downstream chamber, ladder safety cage removed

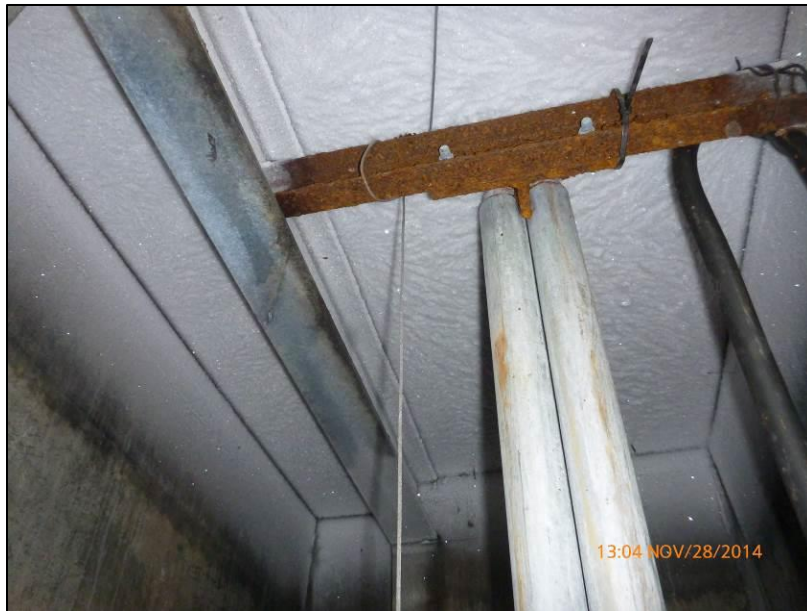
**Photograph No. 5**

C-shape channel support for submersible pump guide

Component	Condition	Notes
Submersible Pump	Existing - Unknown	Provide new simplex submersible pump c/w control panel, floats, and guide rail assembly. Pump to provide 1200GPM at design head conditions. Remove existing pump and controls. Estimated Cost \$46,500
Discharge Piping and Valve	N/A	Remove existing pump discharge piping, rails, appurtenances, and downstream flapper gate; replace with new. Provide valve operator extensions. Estimated Cost: \$20,000.
Electrical and Controls	N/A	Demolish existing control panel and provide new weatherproof, vandal-resistant outdoor enclosure c/w service entrance rated breaker, starter, controls and metering. Re-use existing feeder from to be demolished control panel to Manitoba Hydro. Manitoba Hydro to replace existing electrical service with new to suit new installation. Estimated Cost \$35,000.

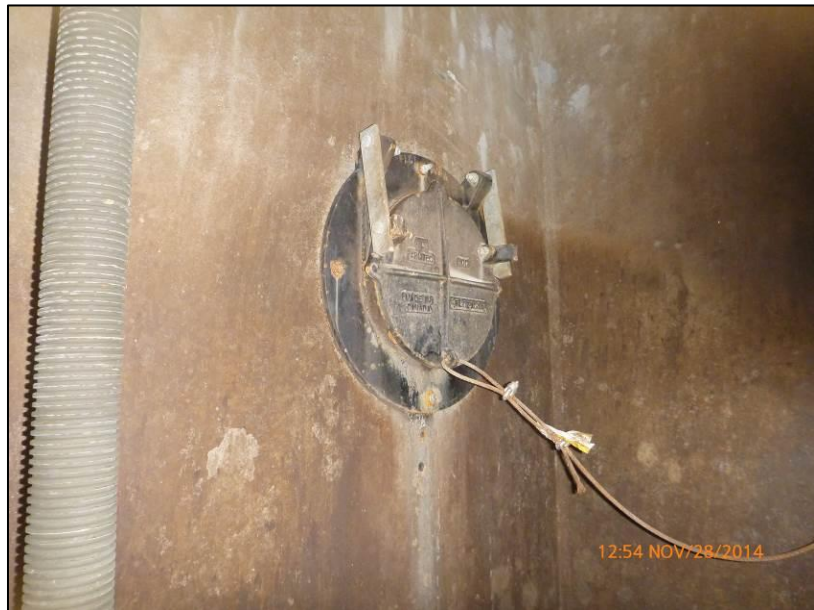
**Photograph No. 6**

Discharge flap in downstream chamber from submersible pump

Replacement of the discharge piping and components should also be performed. Valve extensions brought to grade elevation are recommended for any diversion valve. This will allow operation from outside of the chambers avoiding unnecessary entry into the chamber. During the detailed design process this should be reviewed to ensure the feasibility.

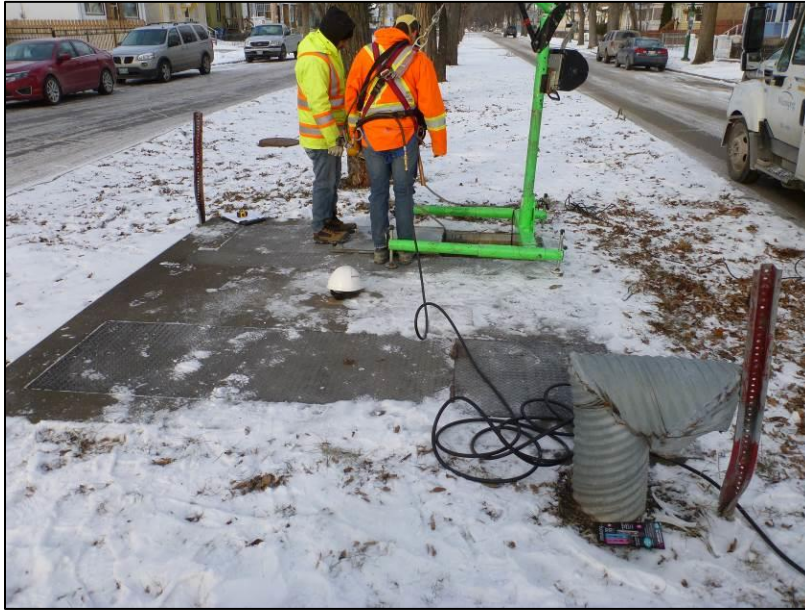
**Photograph No. 1**

Existing chamber looking west (towards upstream), combined sewer MH beyond chamber

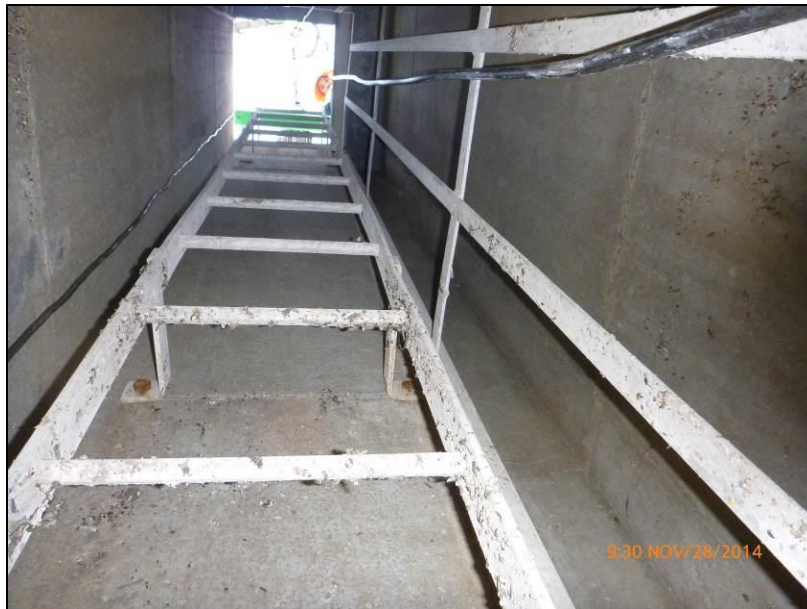
**Photograph No. 3**

Galvanized ladder and safety cage

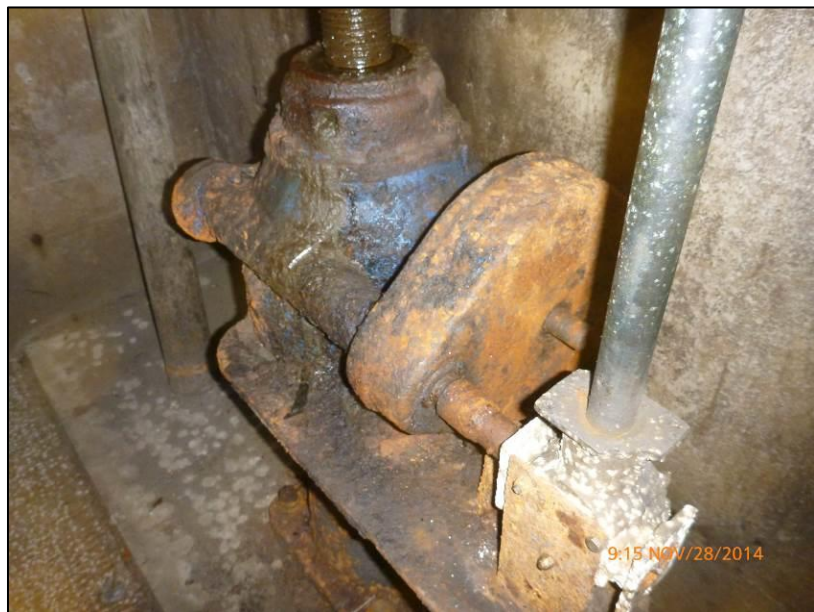
**Photograph No. 4**

Positive gate lift

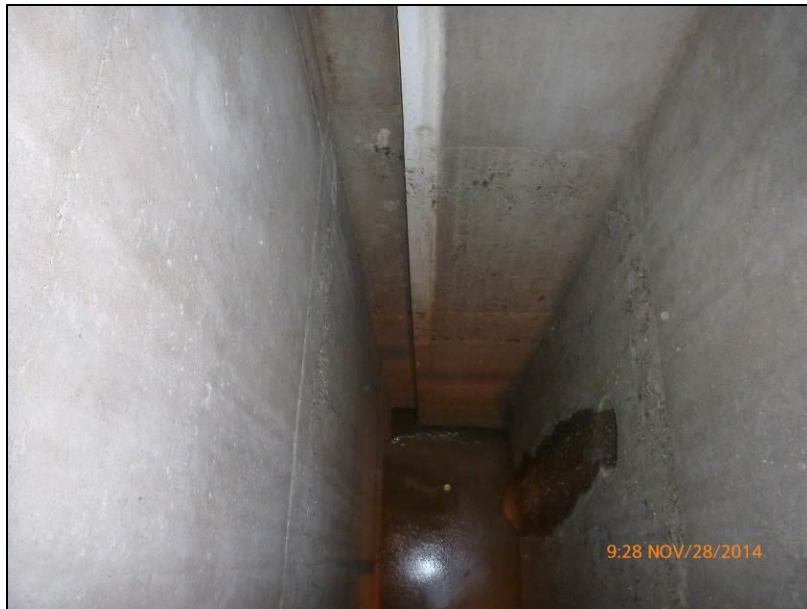
**Photograph No. 5**

Upstream chamber and combined sewer outfall

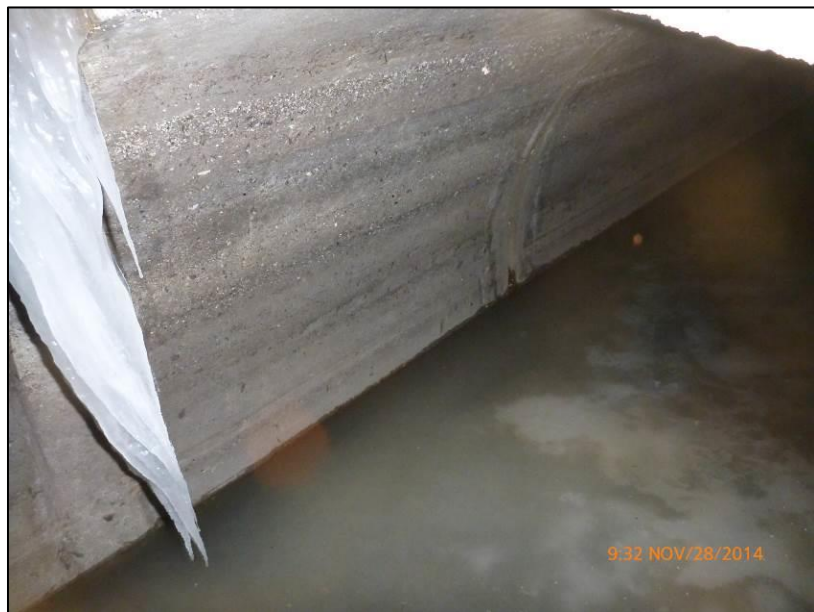
**Photograph No. 6**

Existing SRS looking upstream

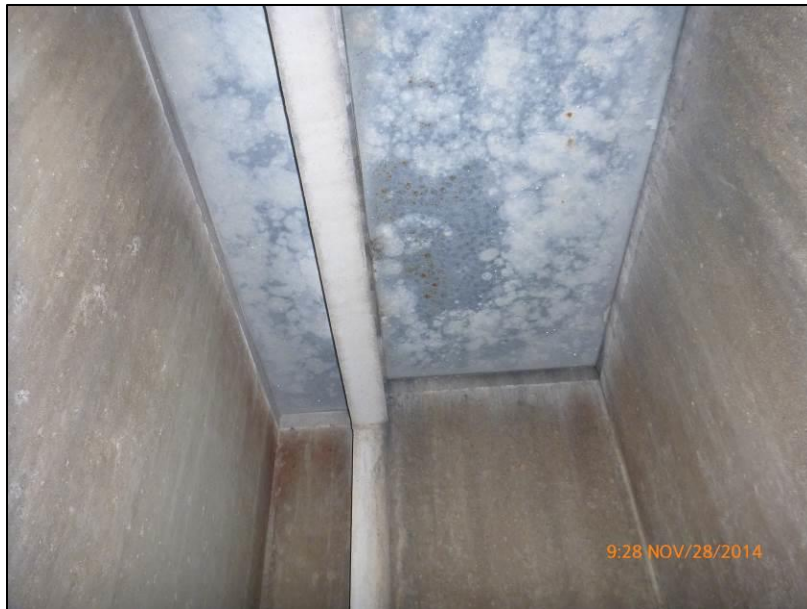
**Photograph No. 7**

Underside of galvanized hatch covers

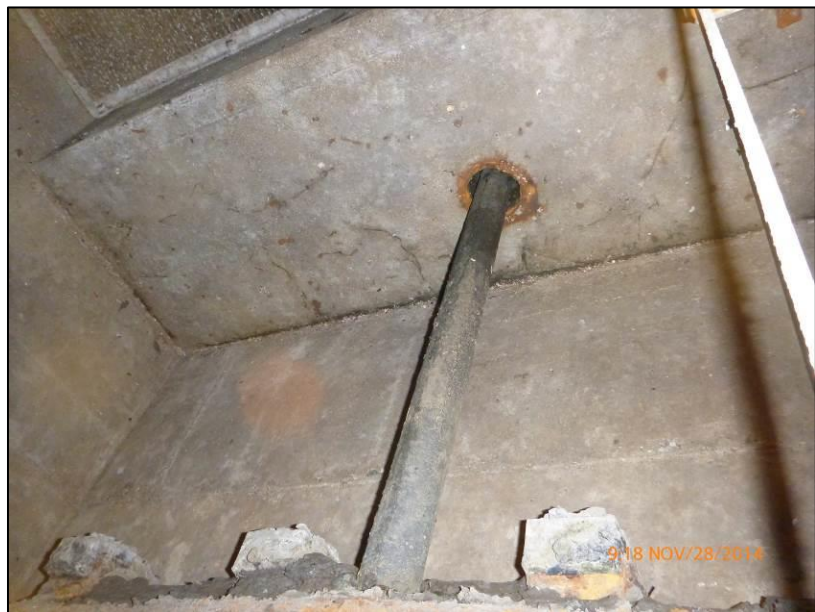
**Photograph No. 8**

Gate stem and sleeve in mid-level concrete floor

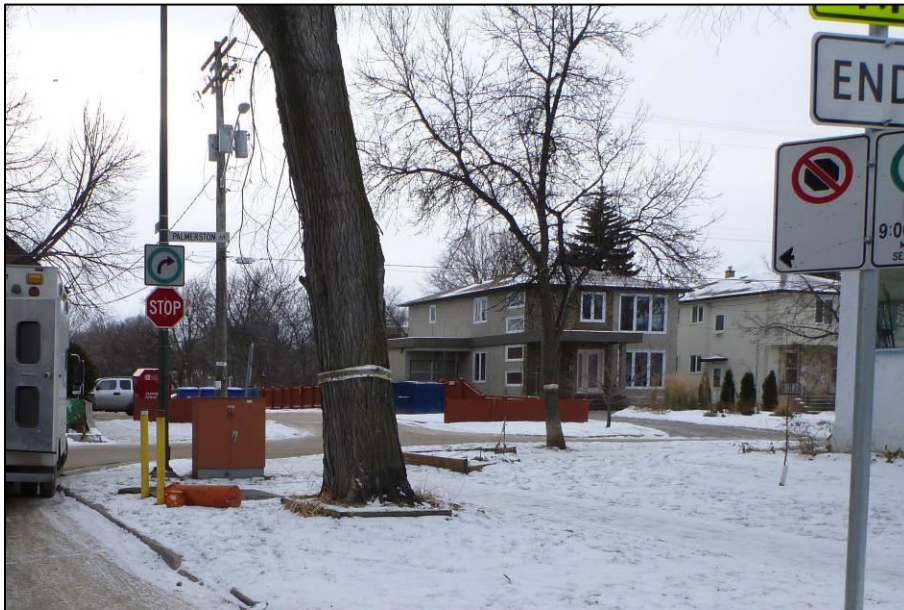
**Photograph No. 1**

Overall site looking south (towards outfall)

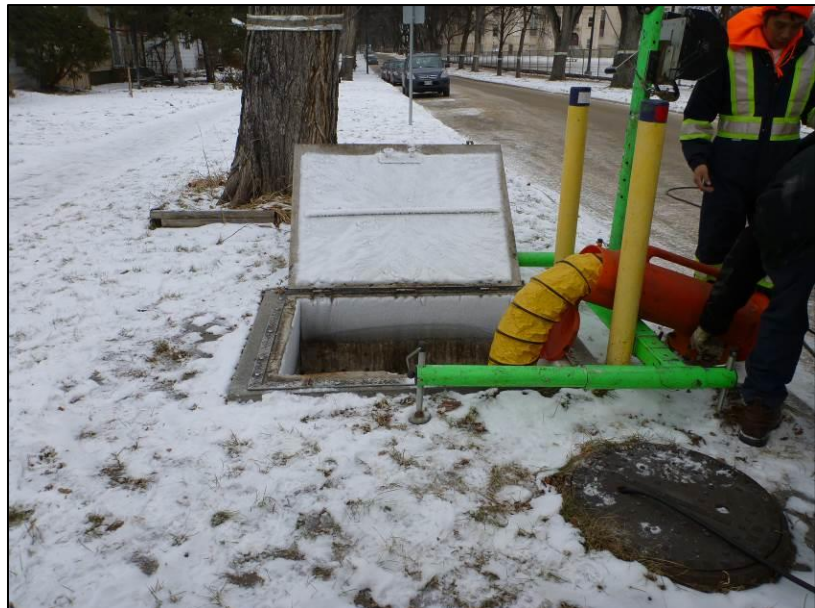
**Photograph No. 2**

Existing site looking north (towards upstream)

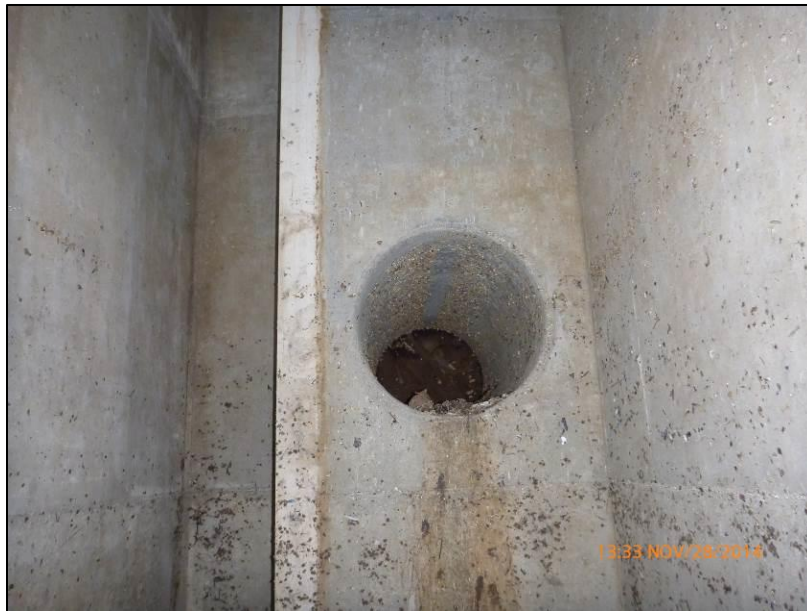
**Photograph No. 5**

450 mm combined sewer outfall

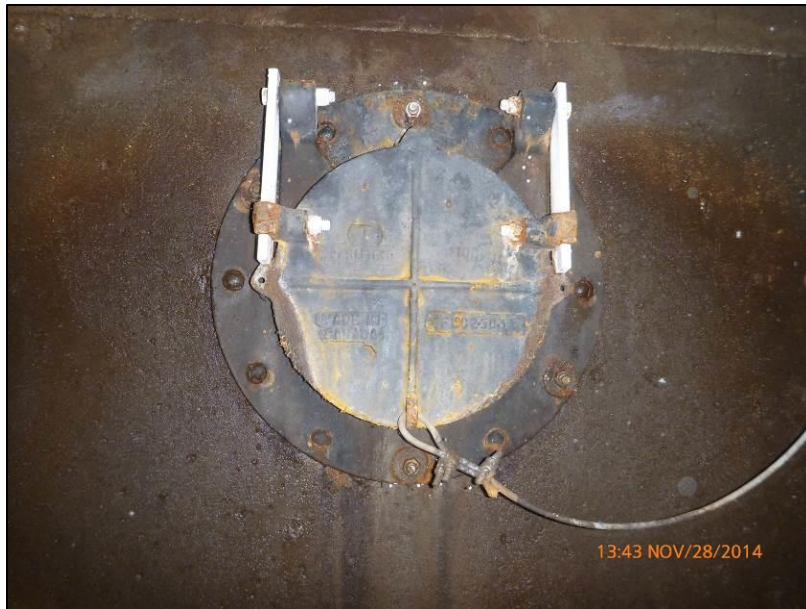
**Photograph No. 7**

Flap outlet for pumps from upstream chamber

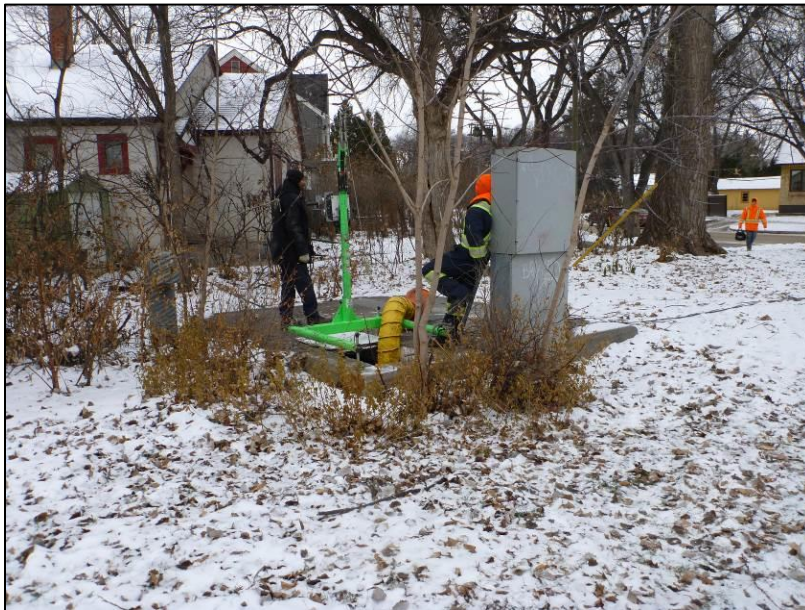
**Photograph No. 1**

Overall site looking northwest

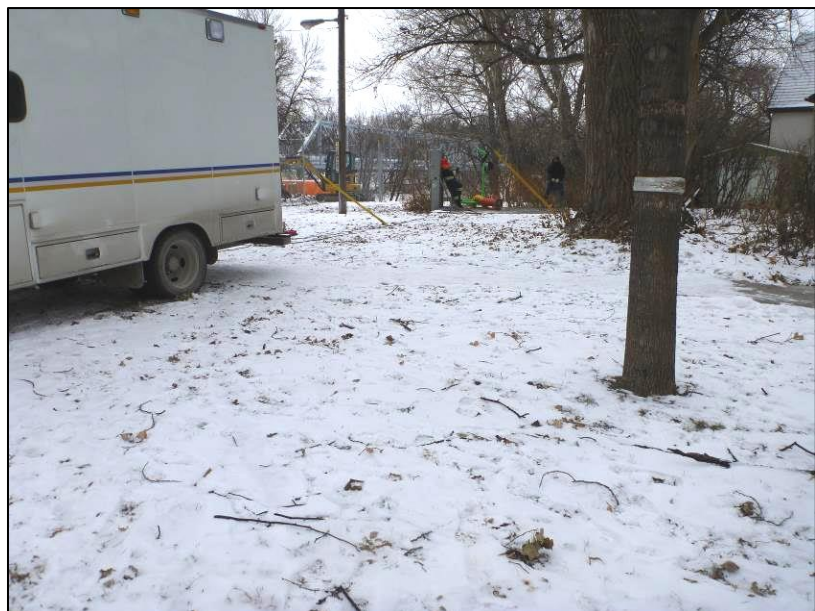
**Photograph No. 2**

Existing site looking south (towards outfall)

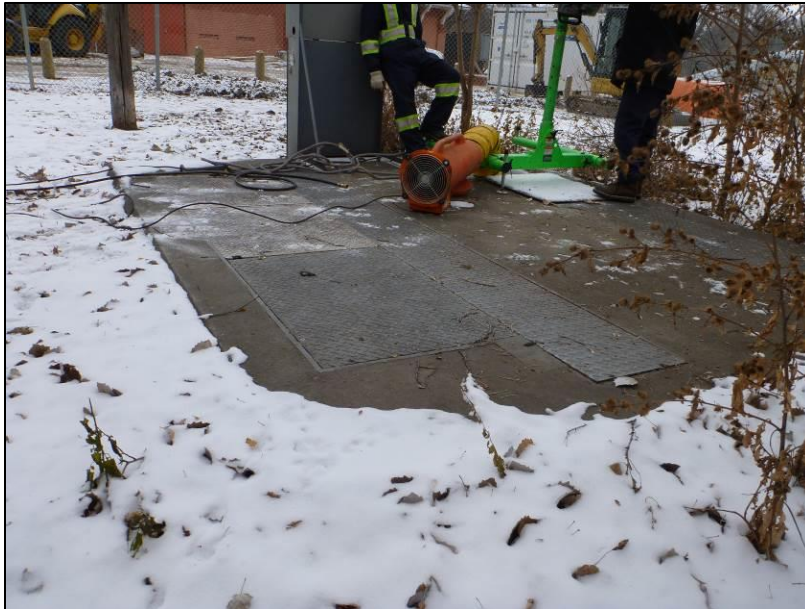
**Photograph No. 3**

Chamber roof looking east

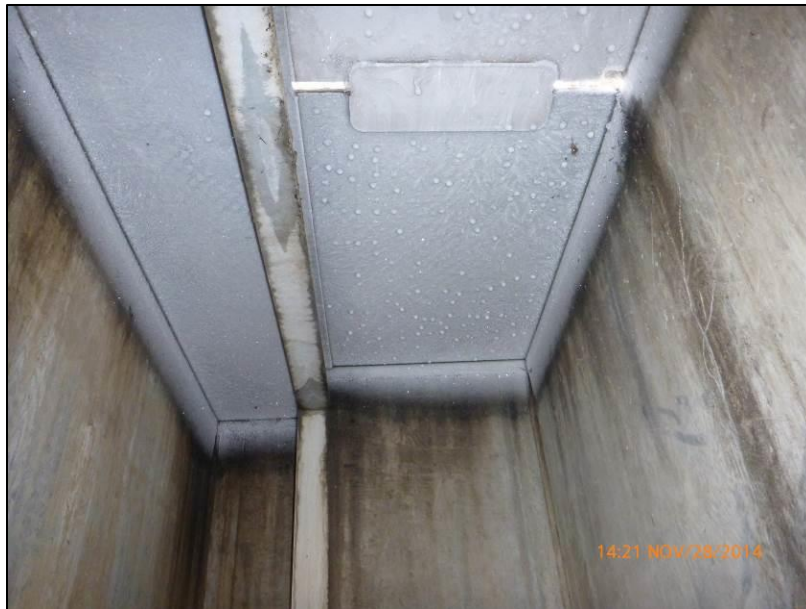
**Photograph No. 5**

Underside of upstream chamber galvanized hatch covers

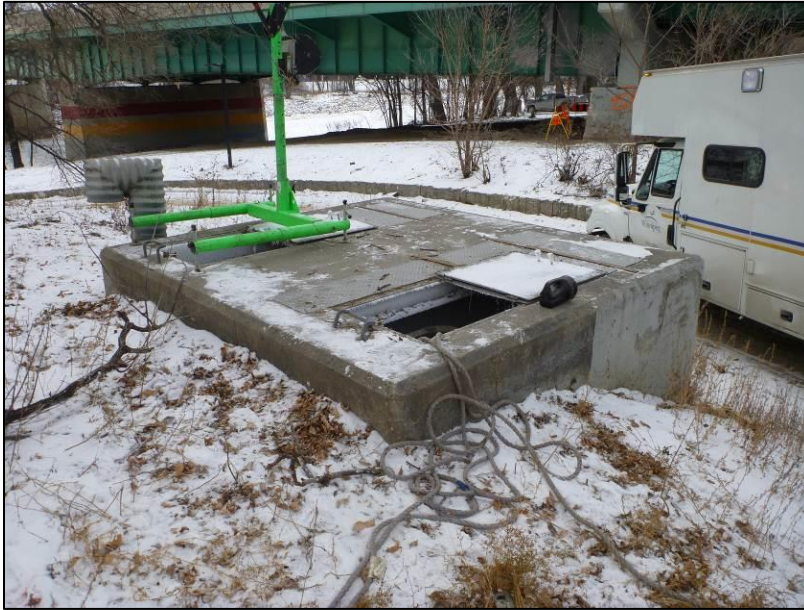
**Photograph No. 1**

Existing chamber looking southwest

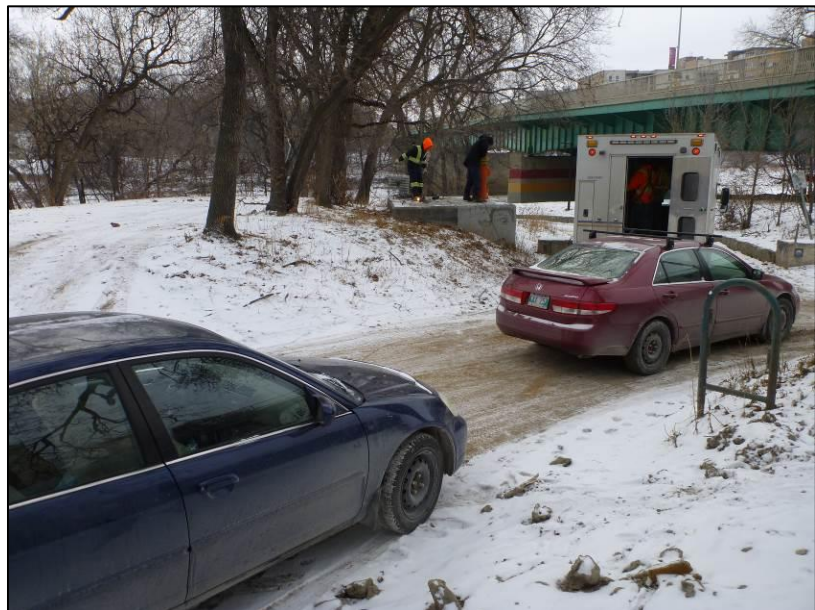
**Photograph No. 2**

Overall site looking south (towards outfall)

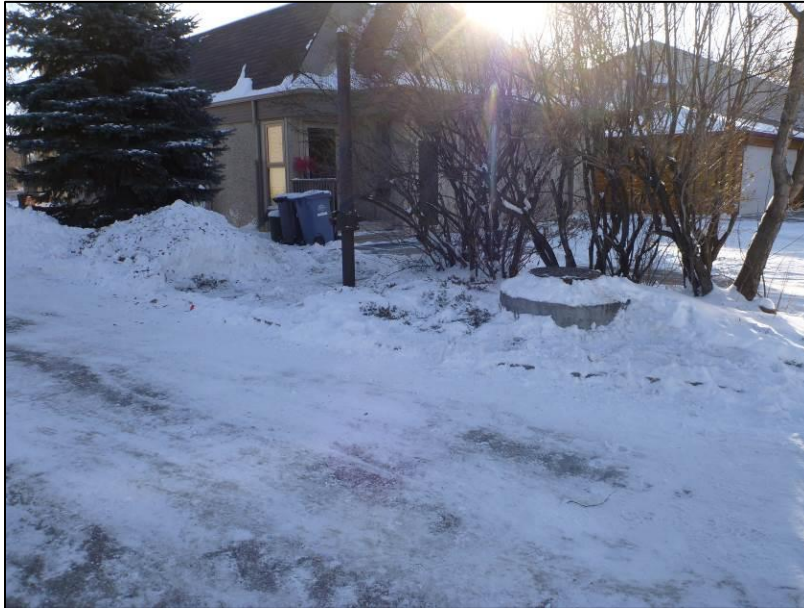
**Photograph No. 1**

Existing chamber looking southeast

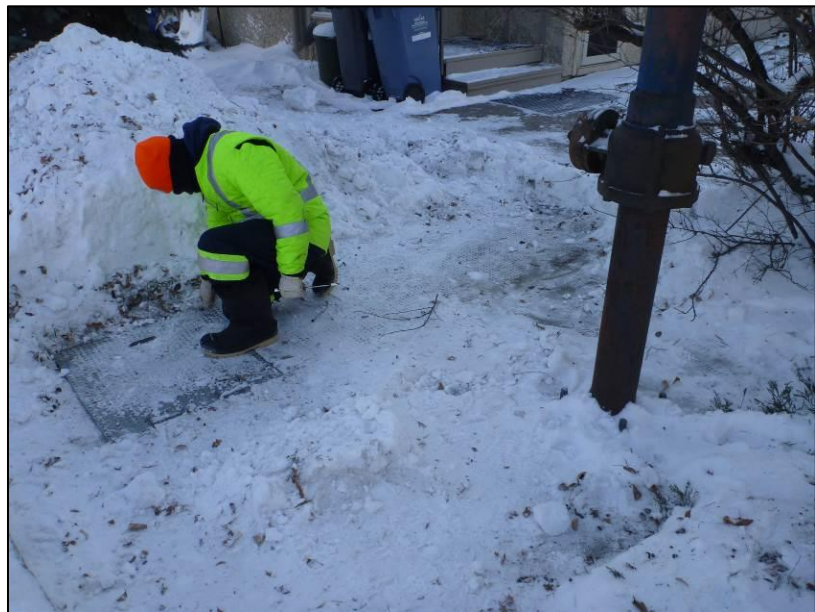
**Photograph No. 2**

Hatch and gate lift of existing chamber

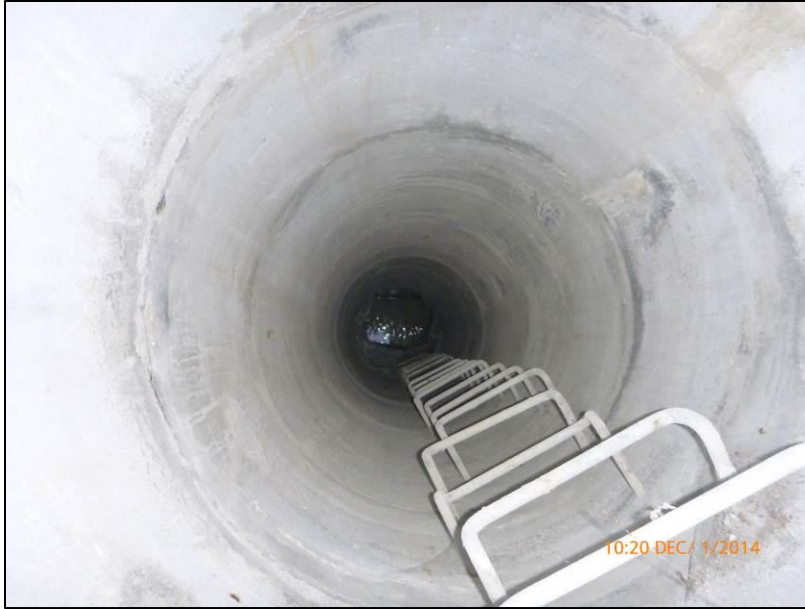
**Photograph No. 3**

Existing pump-out

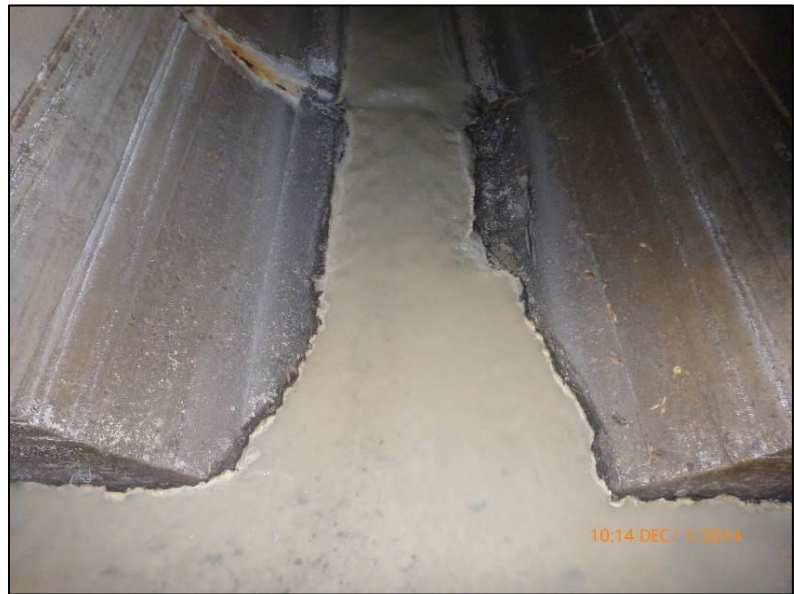
**Photograph No. 4**

Erosion at invert of LDS outlet

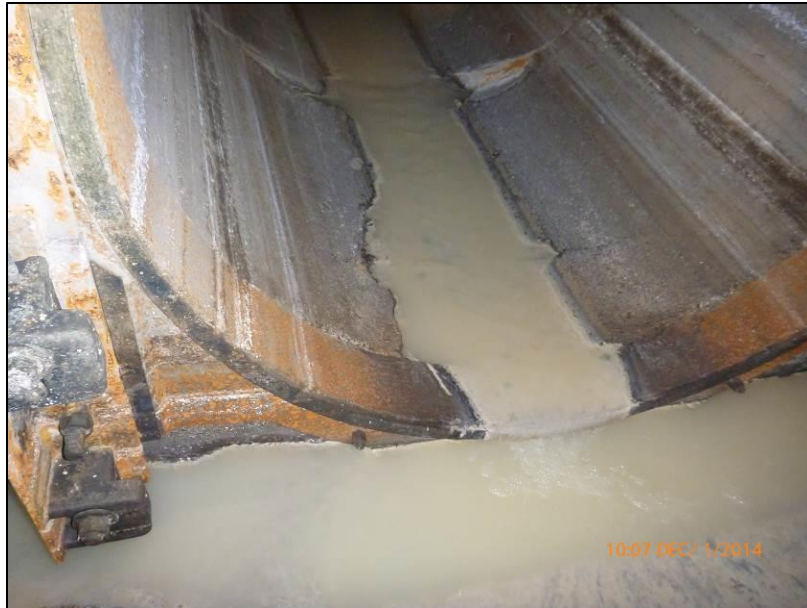
**Photograph No. 5**

Thimble for 1830 mm diameter sluice gate
