CONCEPTUAL GATE CHAMBER DESIGN EXISTING CONDITION ASSESSMENTS

Prepared for:
The City of Winnipeg

Submitted by:
MMM Group Limited

March 2015

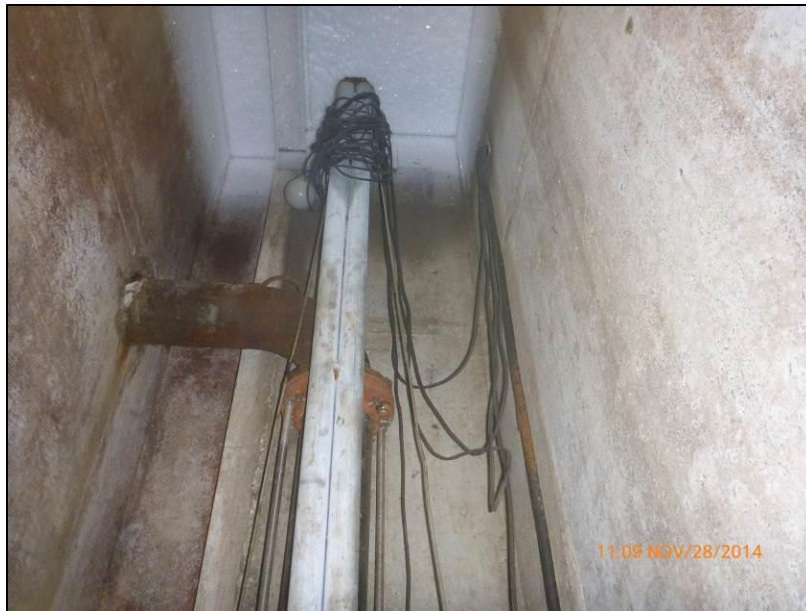
Photograph No. 3

Piping in upstream chamber to downstream chamber,
float switches not in use

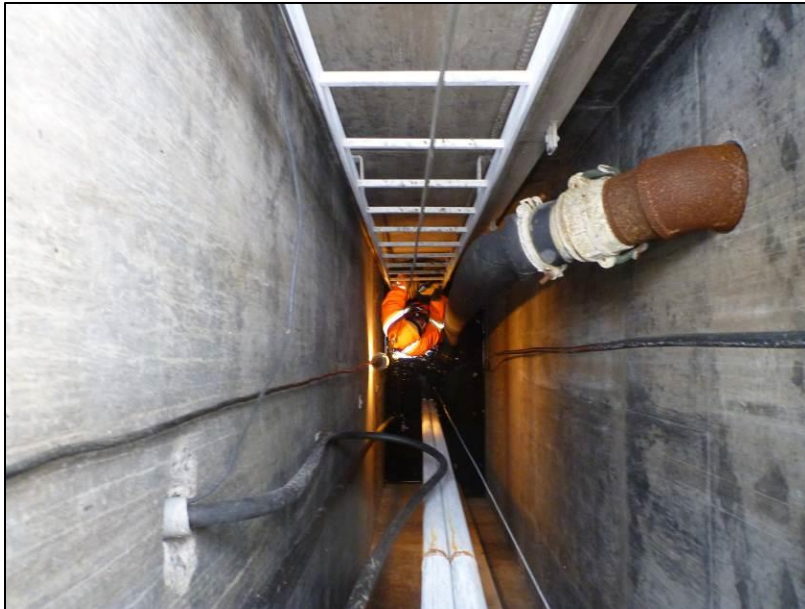
Photograph No. 3

Component	Condition	Notes
Structural Concrete	Good	Limited access. Minor damage around some openings.
Galvanized Steel Hatches and Frames	Good	
Galvanized Steel Ladders and Safety Cages	Good	Safety cage in upstream chamber has been removed.
Air Vent	Good	
Existing SRS	Unknown	SRS not accessible.

Piping in upstream chamber to downstream chamber, ladder safety cage removed

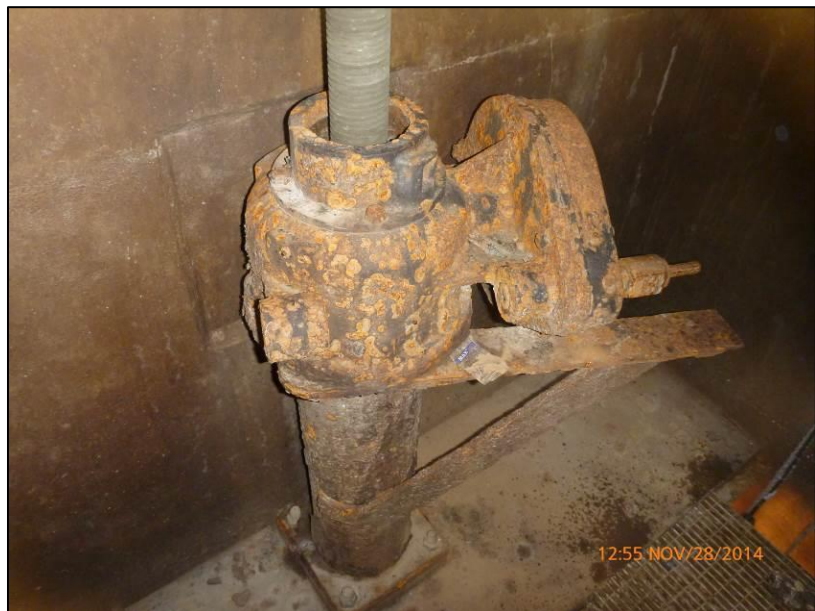
Photograph No. 4

Component	Condition	Notes
Gate	Fair	Rusted with scaling and some section loss, limited access during inspection.
Thimble	Unknown	Not accessible during inspection.
Gate Guides	Fair	Rusted with scaling and some section loss, limited access during inspection.
Gate Stem	Good	
Stem Guide	Fair	Rusted with scaling and some section loss.
Gate Lift	Good	Rusted with scaling, does not appear to inhibit function of lift. Operating shaft not present during inspection.

Positive gate lift, operating shaft not present

Due to the age of the existing steel positive gate it is recommended to replace the gate, frame, stem and other appurtenances. A new surface-mounted gate operator would be installed.

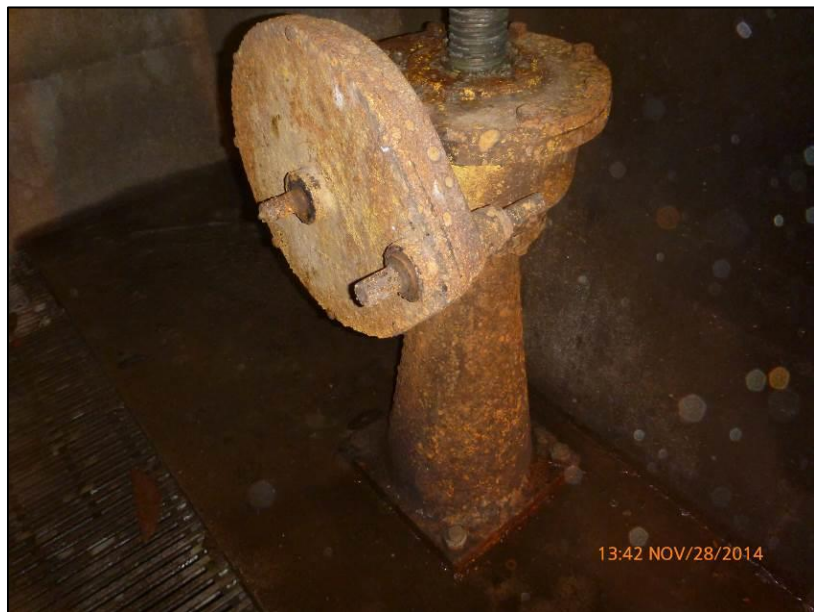
Photograph No. 6

Gate lift, operating shaft not present

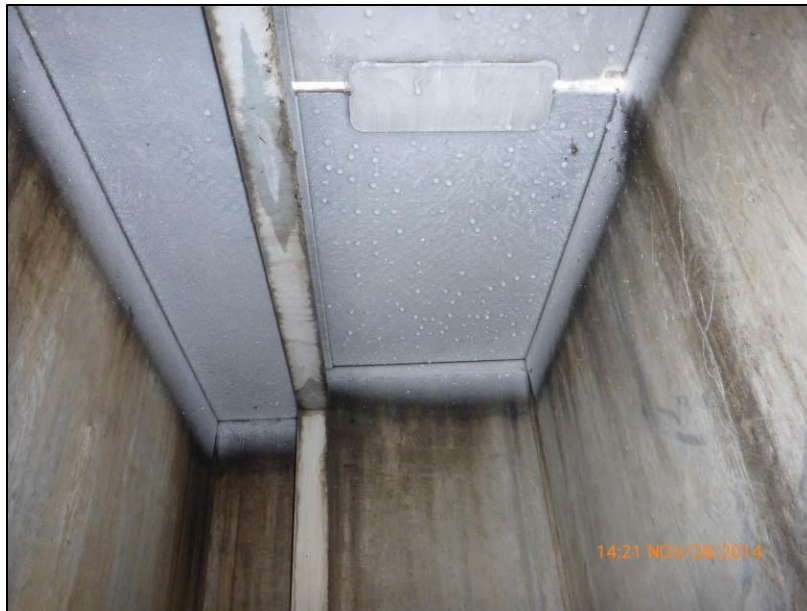
Photograph No. 5

Underside of upstream chamber galvanized hatch covers
