Carlton Street Skywalks
Structural and Cladding Investigation
City of Winnipeg Project No. 2013-139

Submitted to: City of Winnipeg
Planning Property and Development Department

Date: April 5, 2016

CKP File No. 2015-1231

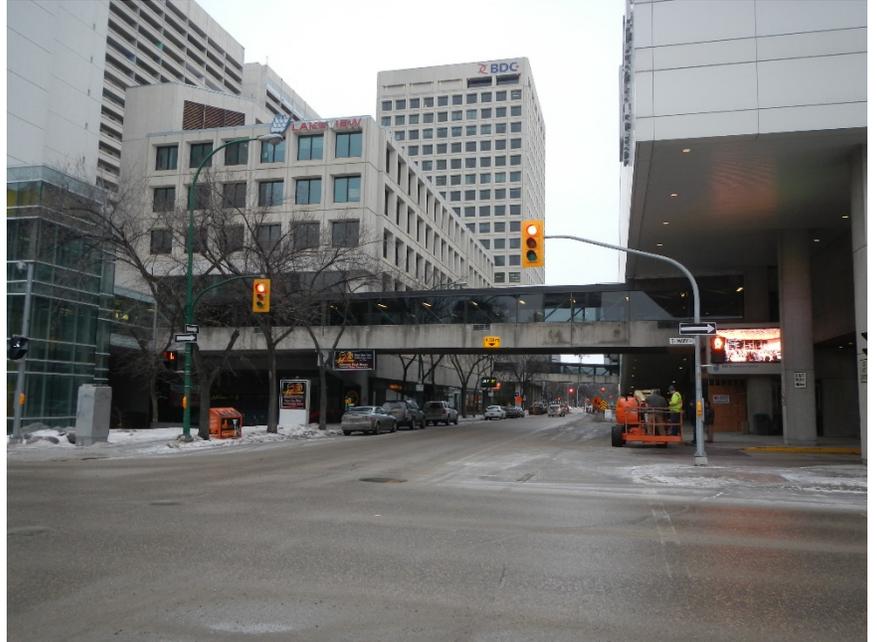
Photograph #1:

North elevation of north skywalk.

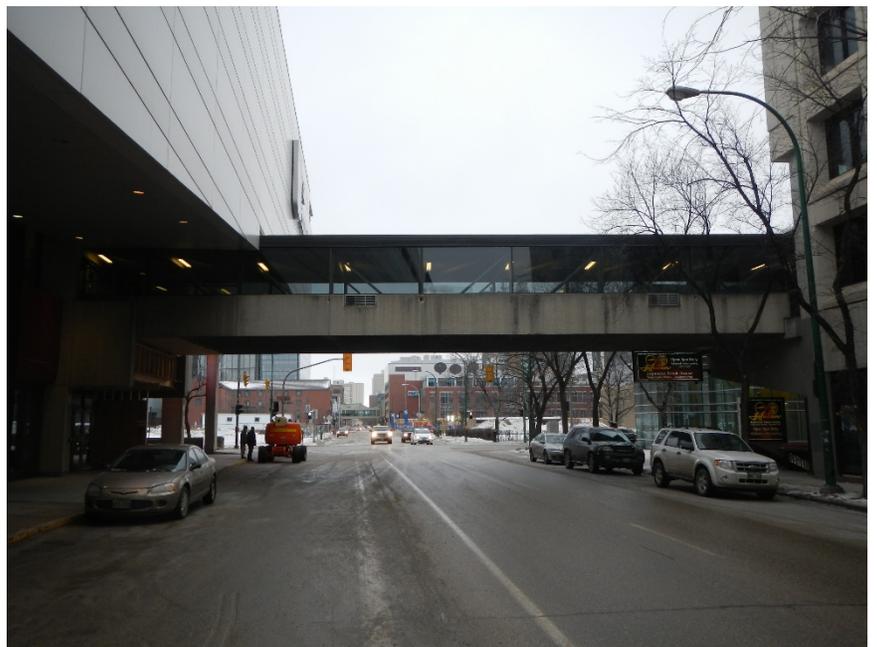
Photograph #2:

South elevation of north skywalk.

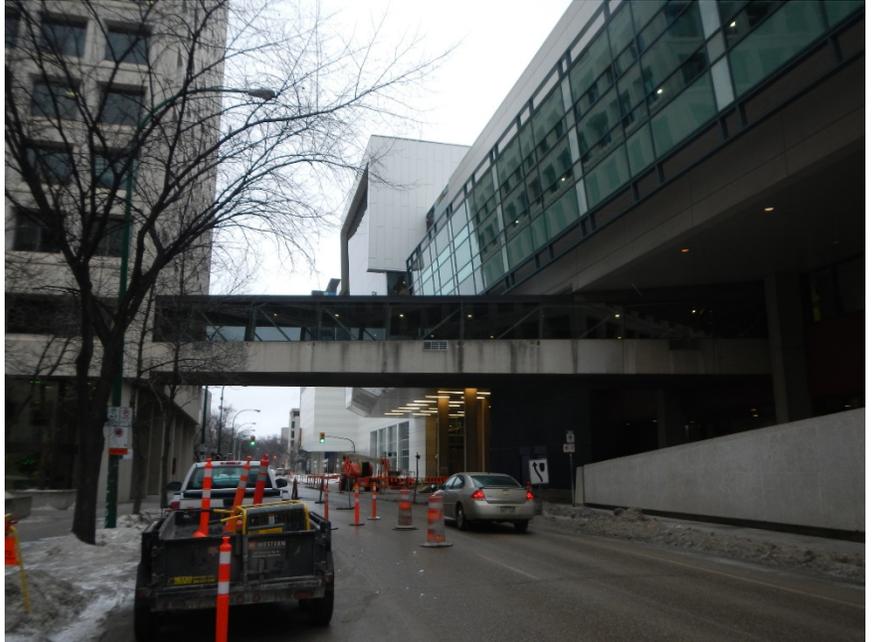
Photograph #3:

North elevation of south skywalk.

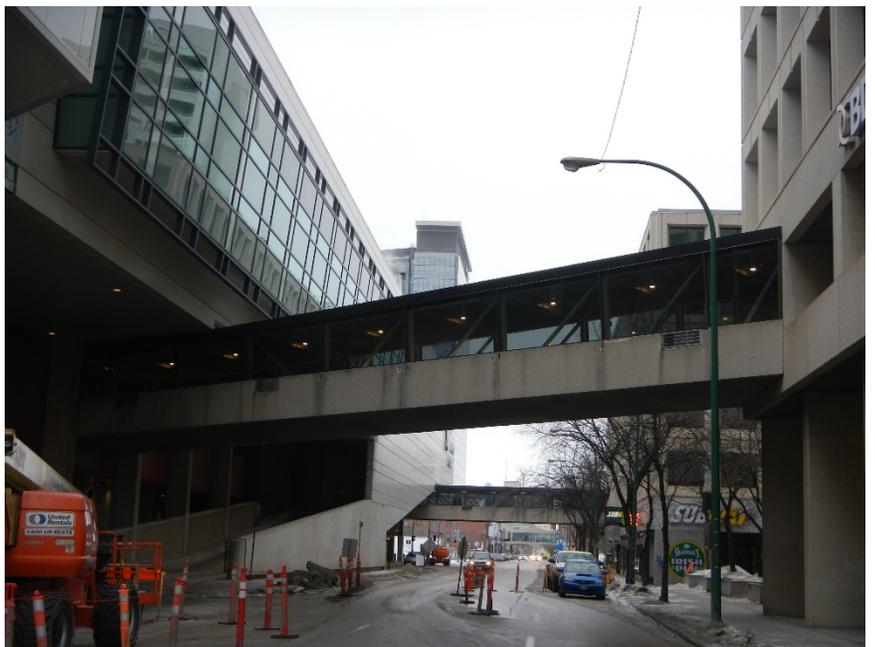
Photograph #4:

South elevation of south skywalk.

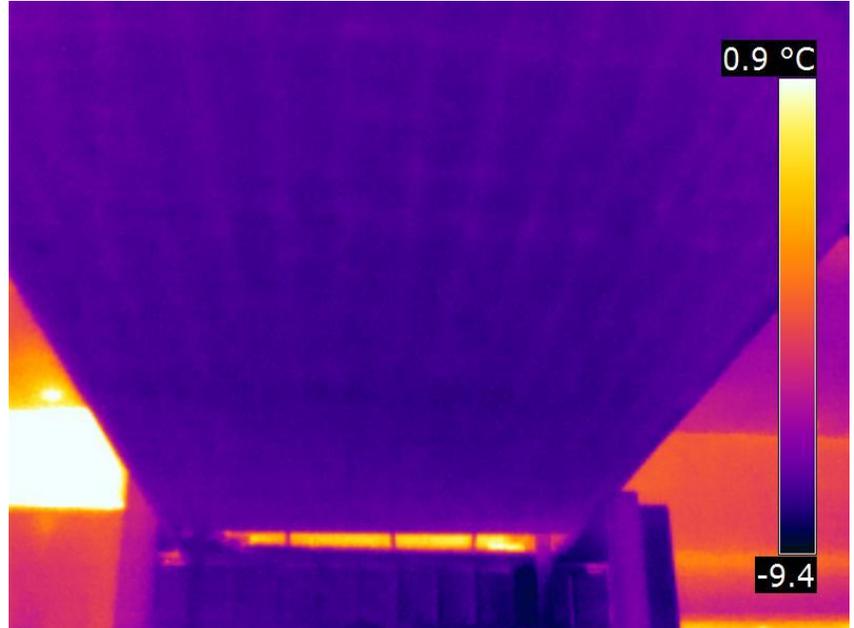
Photograph #65:

Detail view of soffit showing thermal bridging at support members.

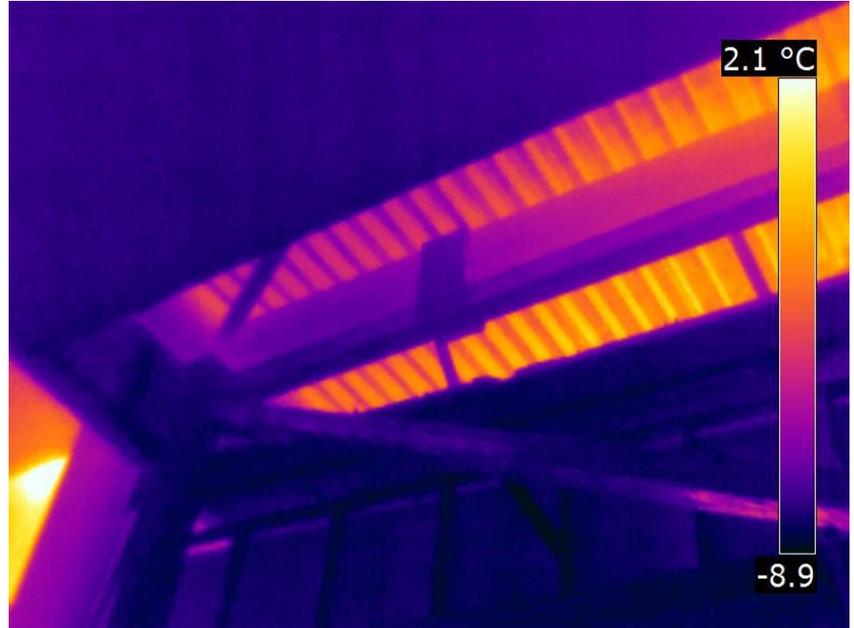
Photograph #69:

Detail view of open soffit at west end.

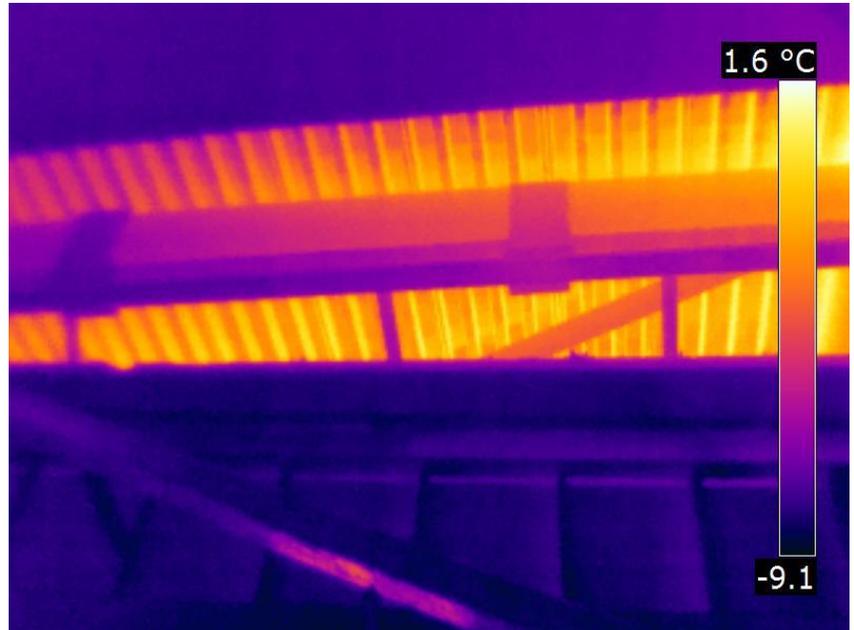
Photograph #71:

Detail view of open soffit at west end.

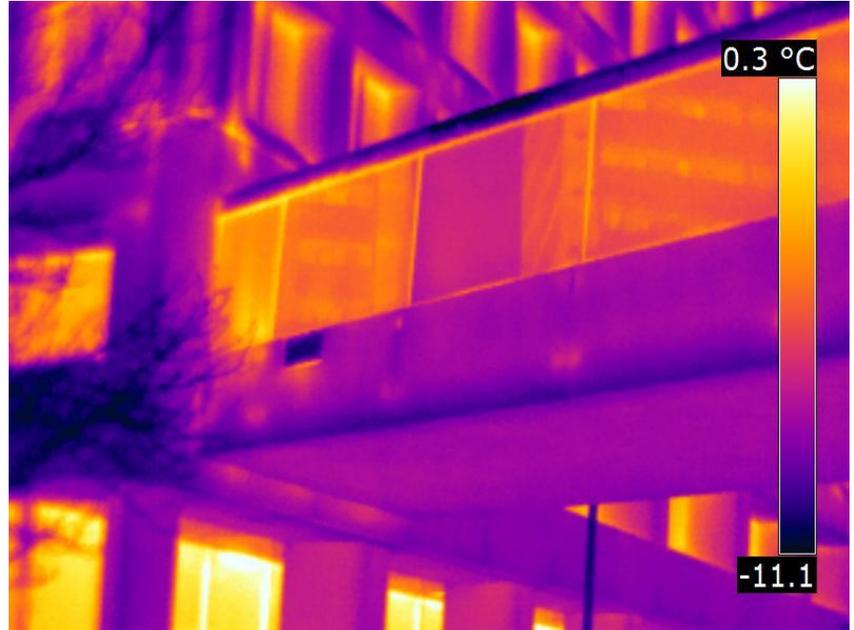
Photograph #85:
Detailed view of north
elevation.

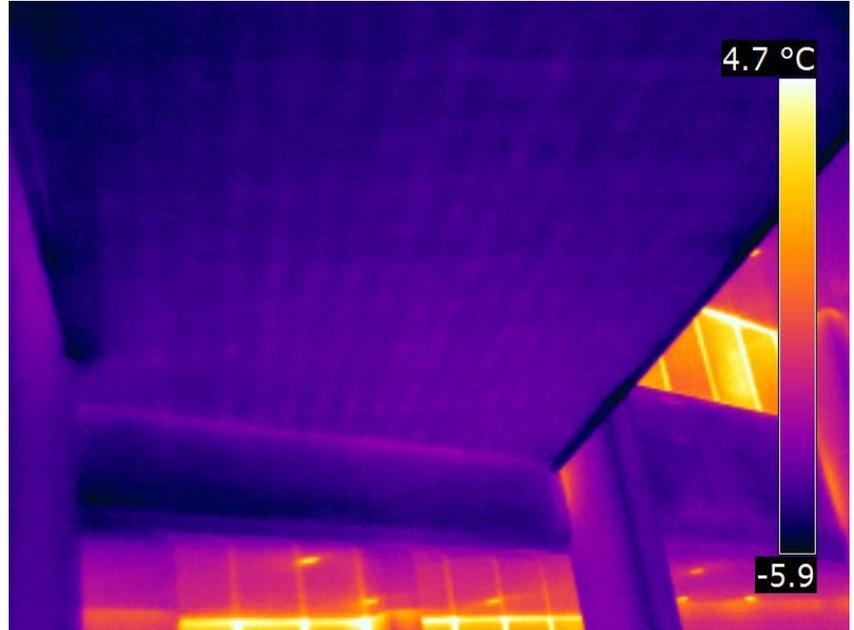
Photograph #113:

West end of soffit showing thermal bridging at support members.

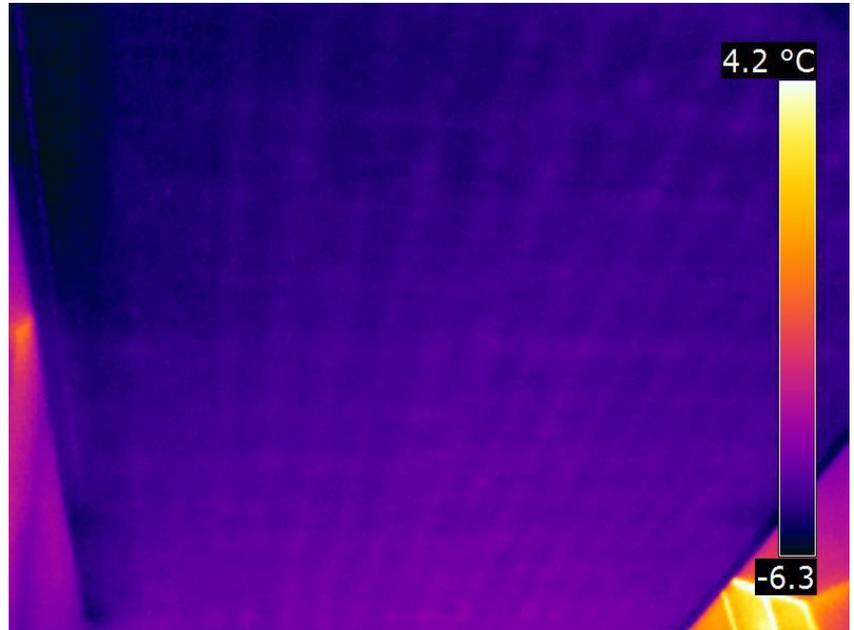
Photograph #115:

West end of soffit showing thermal bridging at support members.

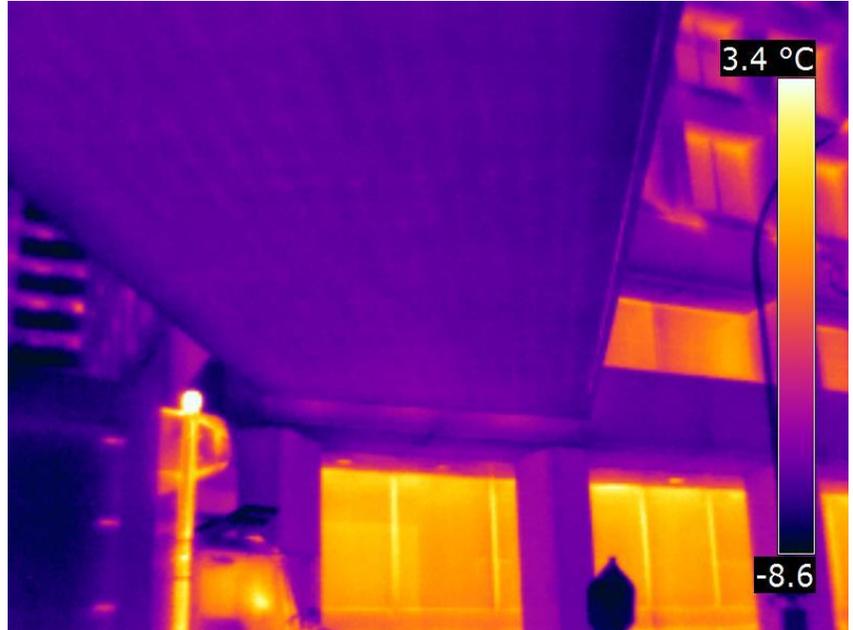
Photograph #117:

East end of soffit showing thermal bridging at support members.

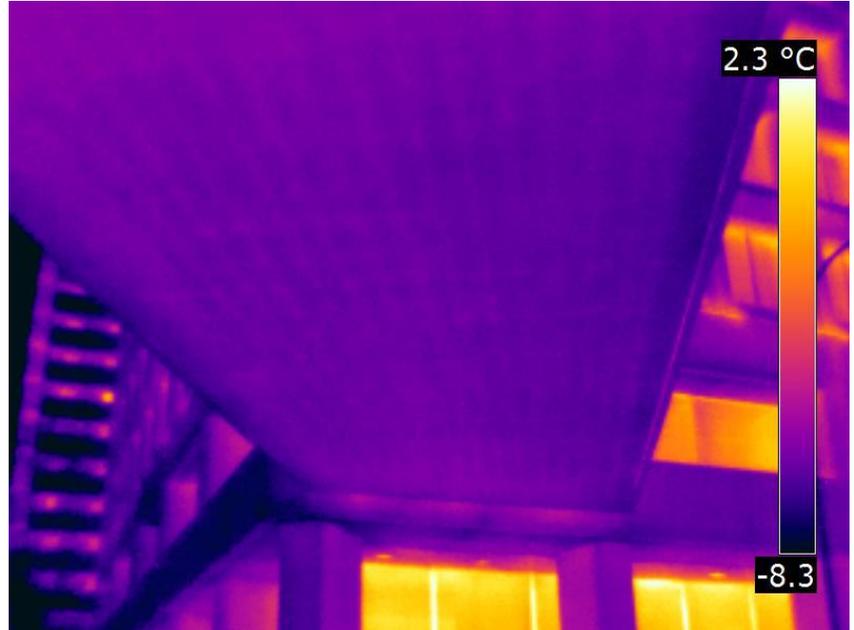
Photograph #119:

East end of soffit showing thermal bridging at support members.
