REPORT FOR:

Seven Oaks Pool 444 Adsum Drive Building Condition Assessment

Submitted to: City of Winnipeg
Planning, Property, and Development Department
Accommodation Services

Date: April 4, 2019

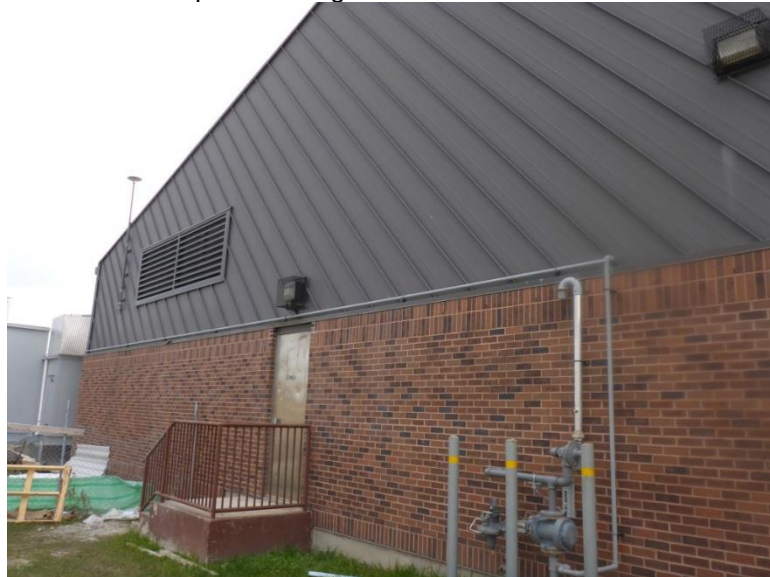
Photograph 3.3.1.4-1: General view of the existing metal cladding along the West elevation of the pool building.

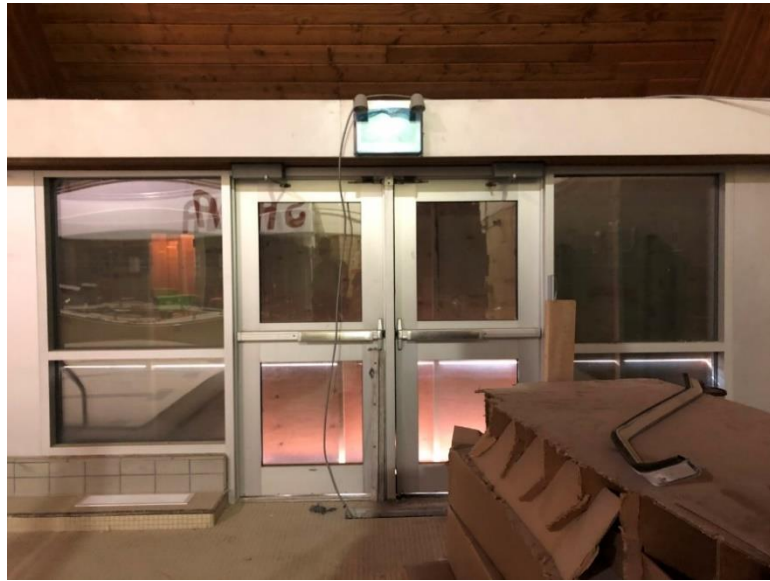
Photograph 3.3.2.2-1: Partial interior south elevation showing one of two entrances, complete with glazed aluminum doors and aluminum curtain wall framed exterior glazed sidelights.

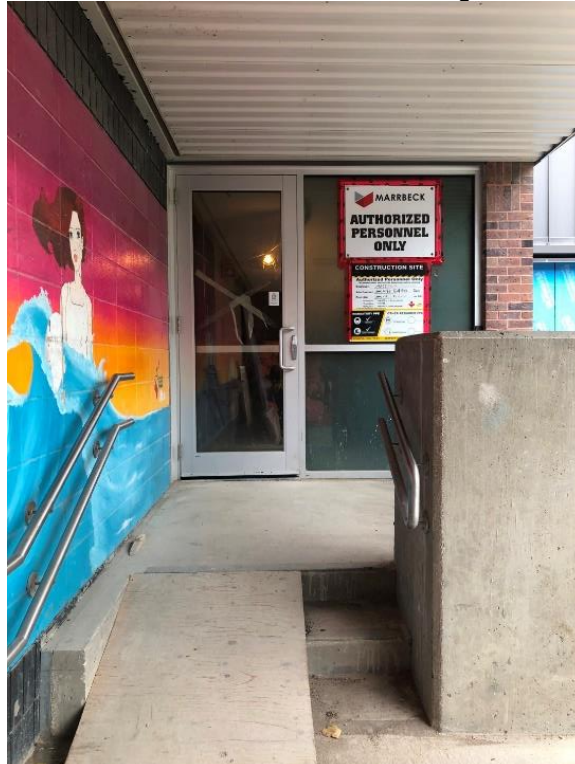
Photograph 3.3.2.2-2: North elevation entrance showing glazed aluminum door and aluminum curtain wall framed exterior glazed sidelight.

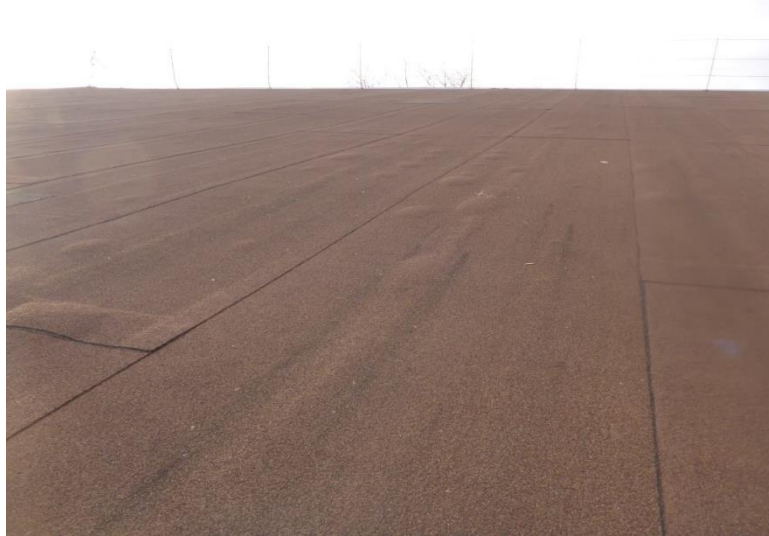
Photograph 3.3.3.1-1: View of random blistering.

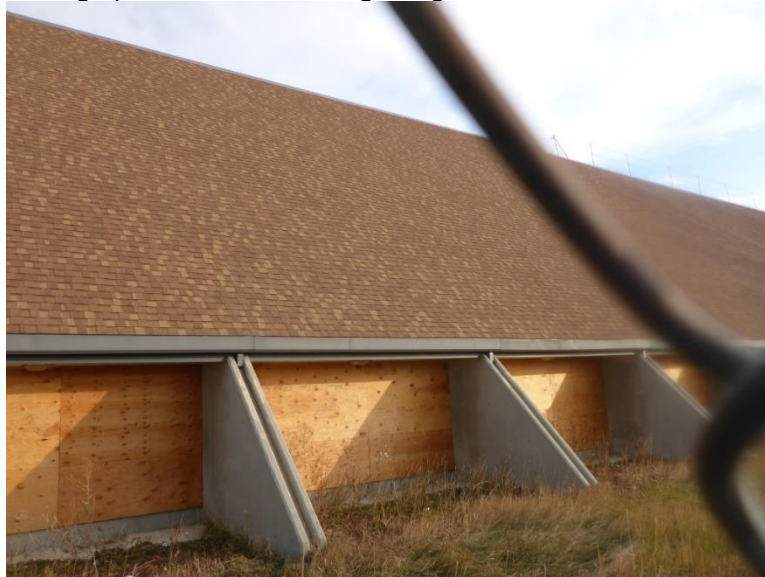
Photograph 3.3.3.2-1: Showing shingled roof facet.

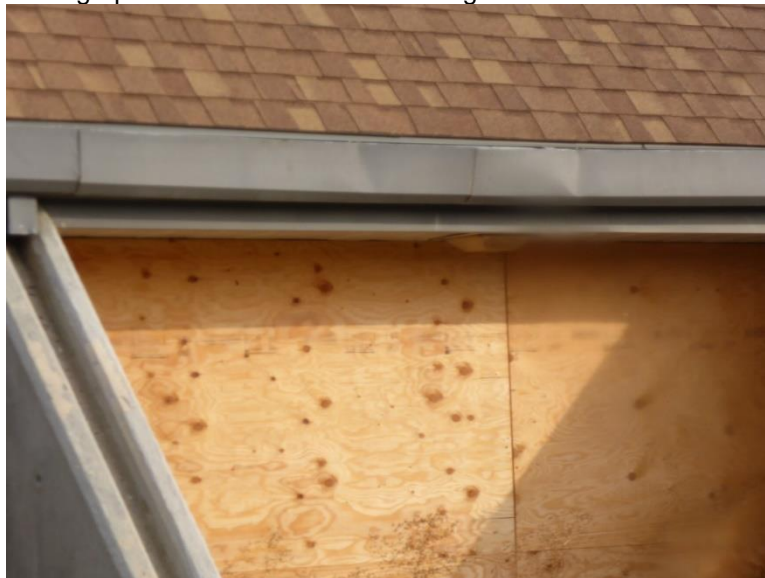
Photograph 3.3.3.2-2: View roof metal gutter.

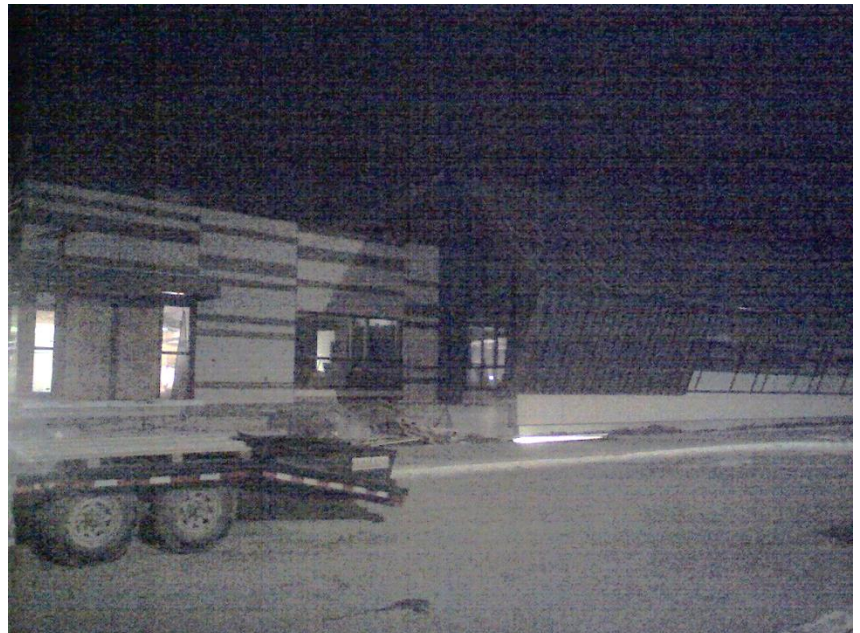
Photograph #19:

Partial east elevation. Note thermal bridging at curtainwall mullions.

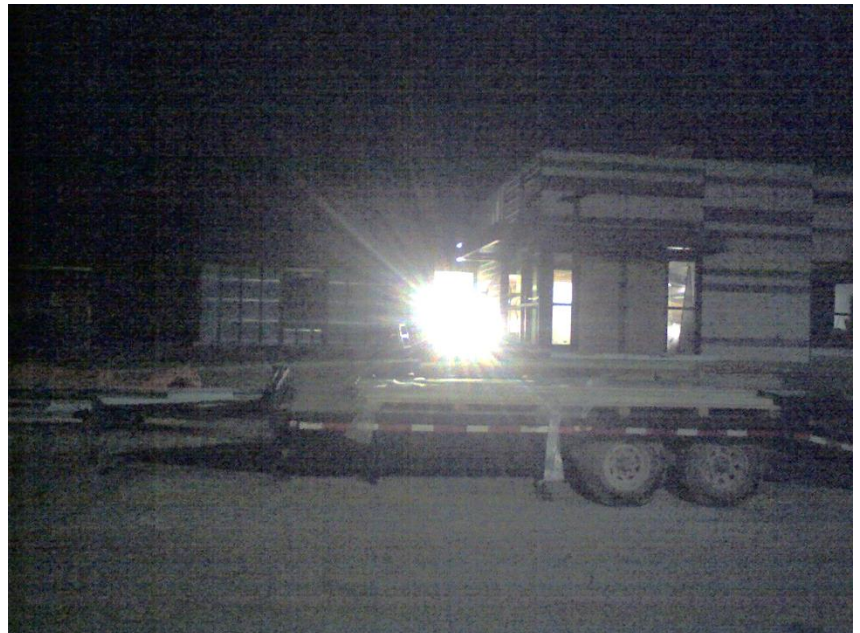
Photograph #21:

Detail view of east portion of north elevation. Note thermal bridging at cladding supports.

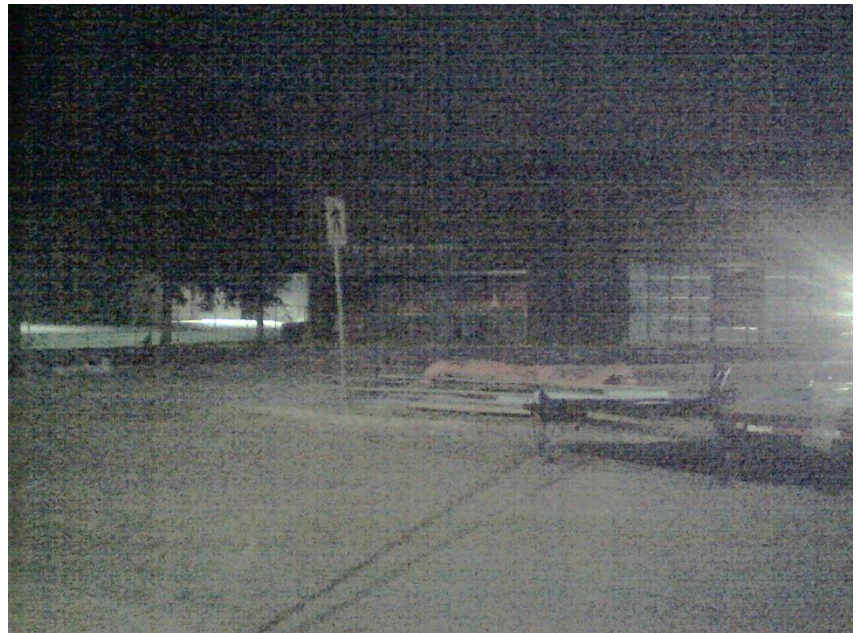
Photograph #23:

Detail view of east portion of north elevation. Note thermal bridging at cladding supports.

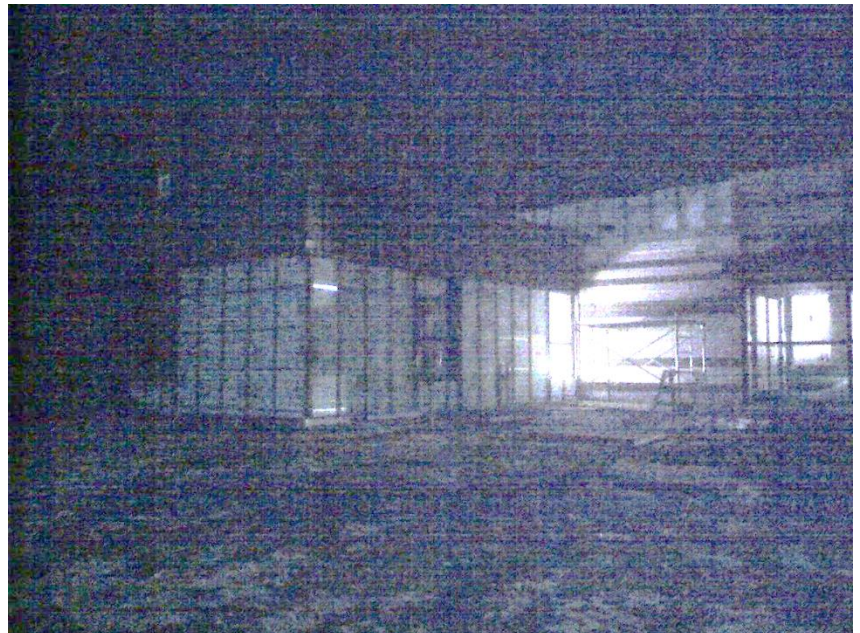
Photograph #33:

Partial north and east elevations. Note thermal bridging at cladding supports. Also note thermal anomalies in fascia.

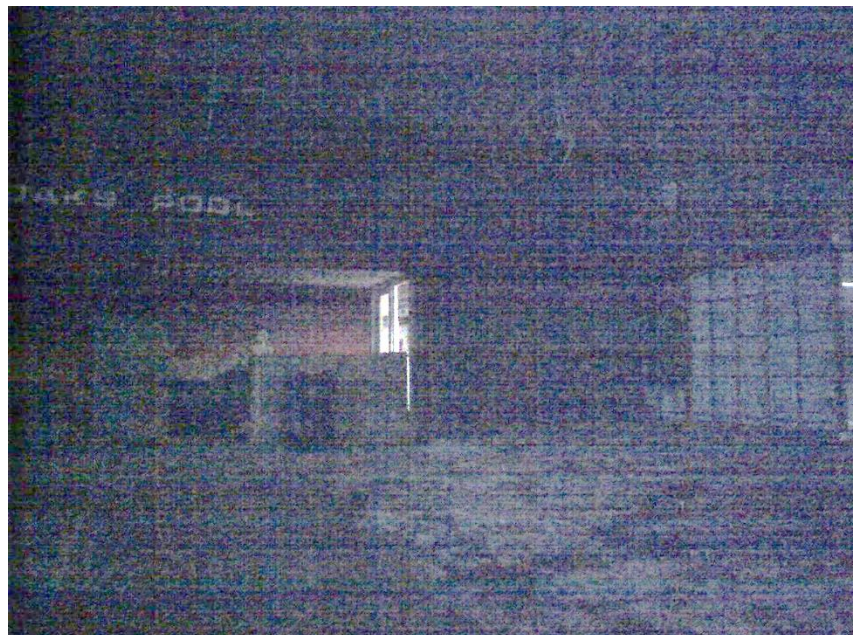
Photograph #35:

Partial north elevation. Note thermal bridging at cladding support locations.

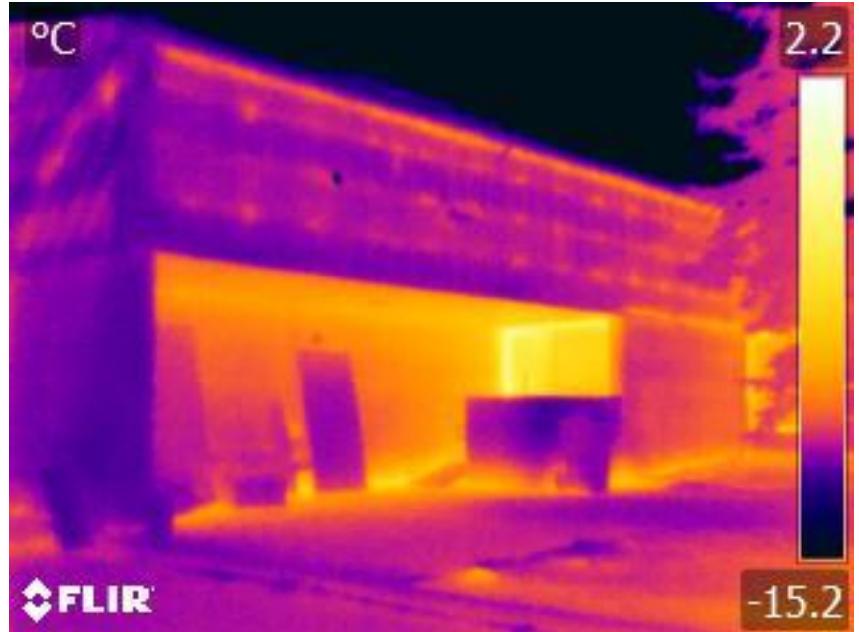
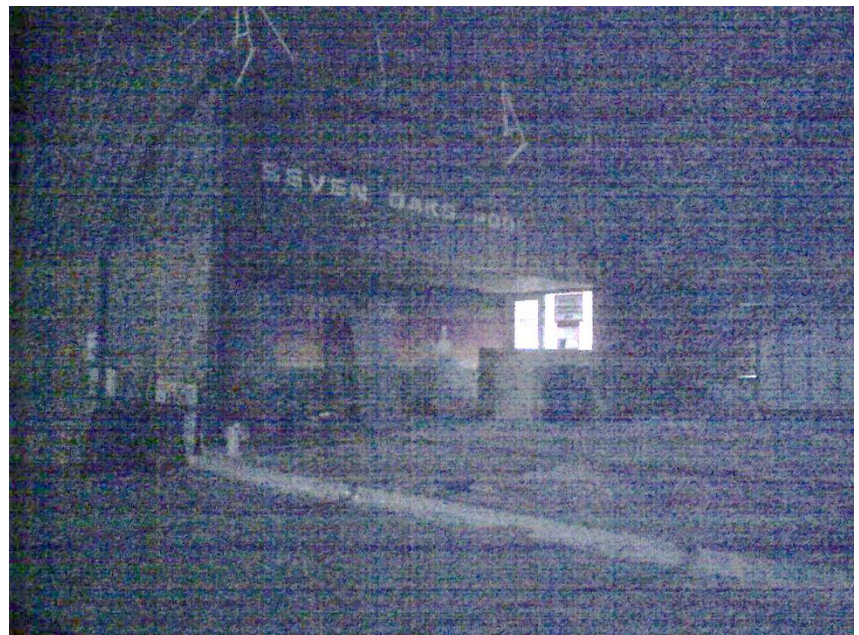
Photograph #37:

Partial north elevation. Note thermal bridging at cladding support locations.

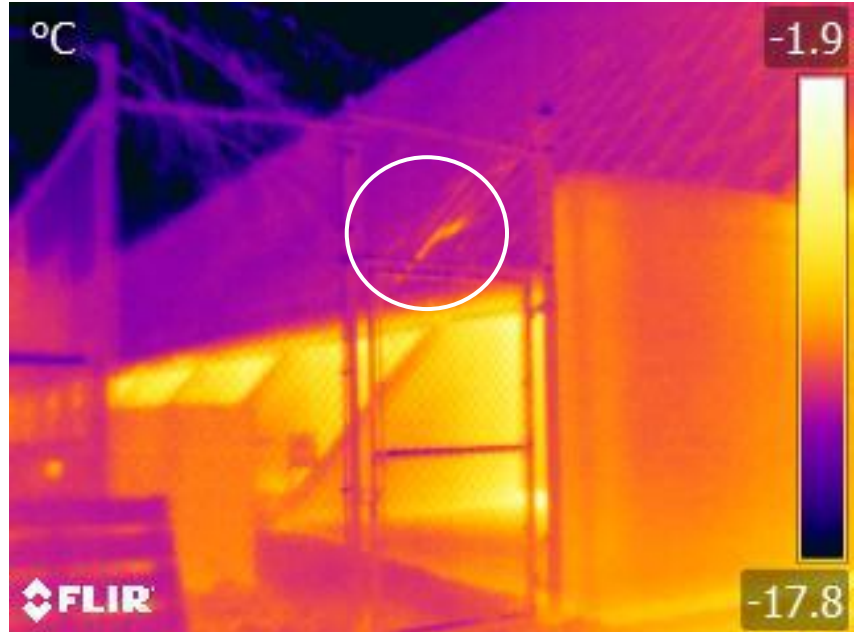
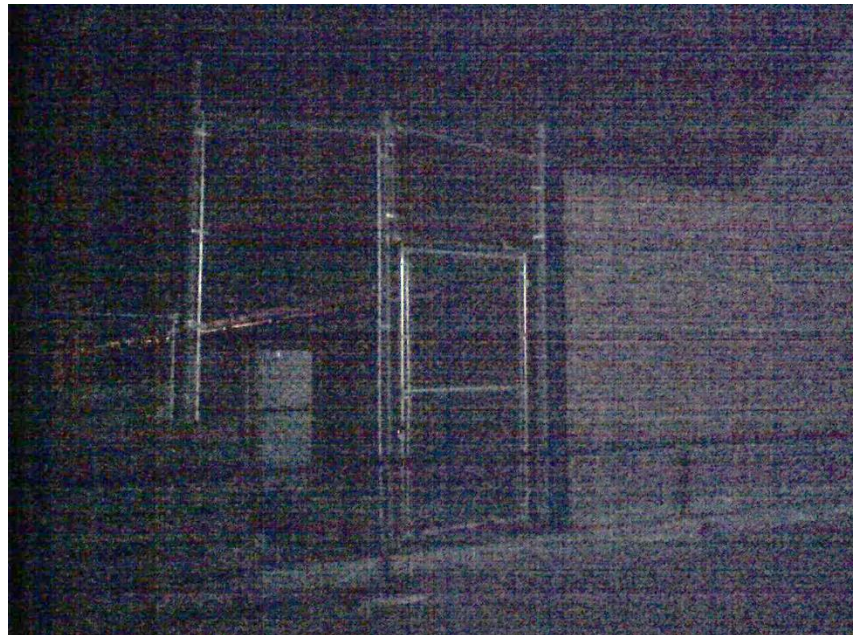
Photograph #47:

Overall view at south east corner. note thermal anomaly on roof.

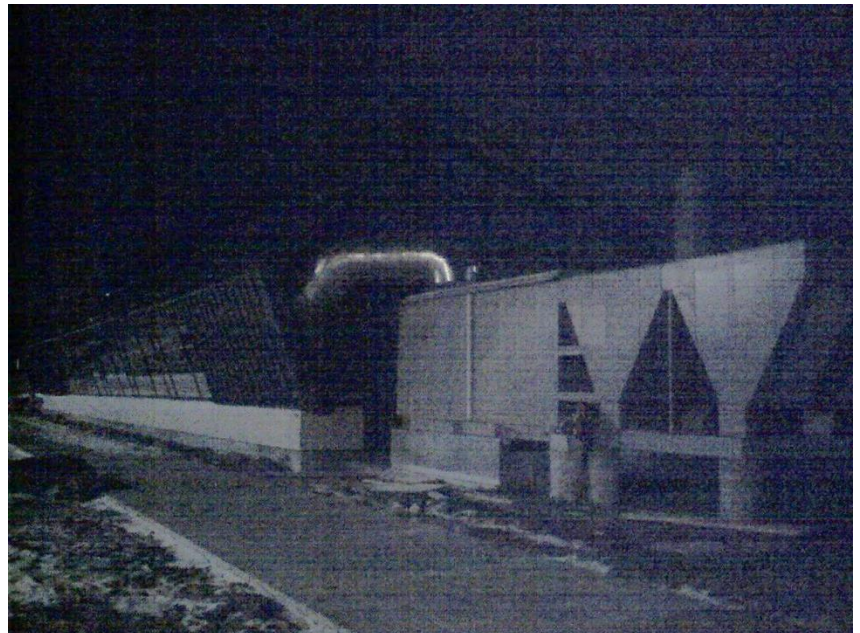
Photograph #49:

Partial west elevation. Note thermal bridging at curtainwall mullions.

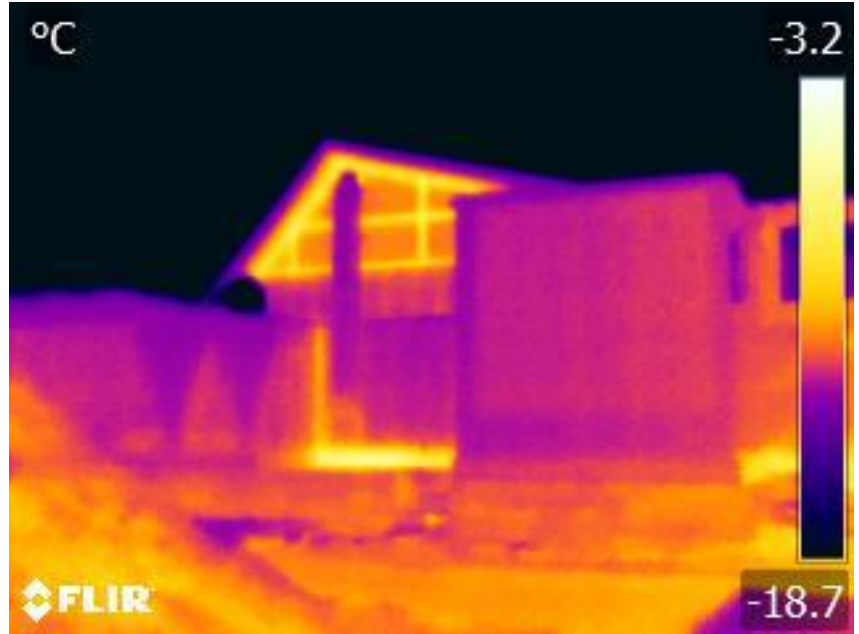
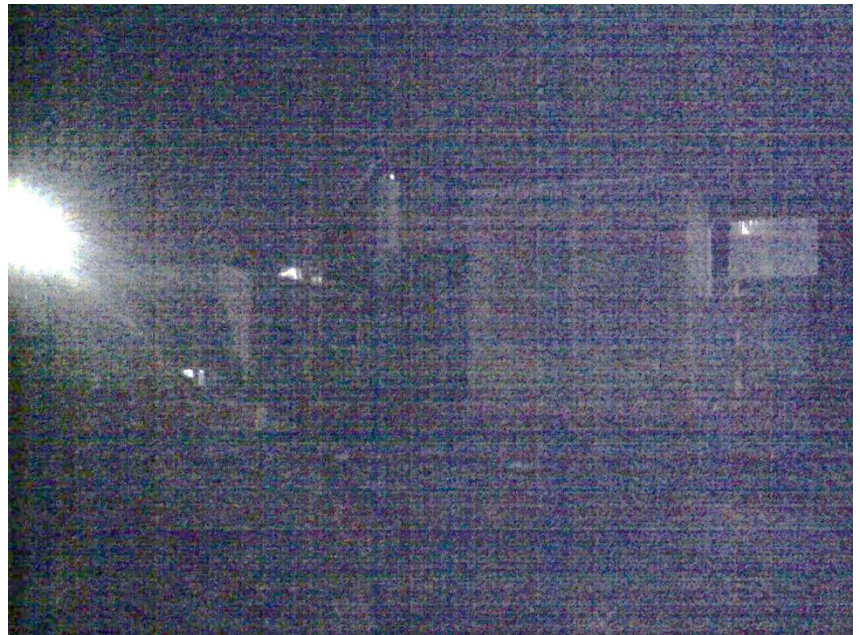
Photograph #53:

Partial west elevation. Note thermal bridging at curtainwall mullions.
