## **APPENDIX 'A' – GEOTECHNICAL REPORT**

## Hartford Avenue - McGregor St / Salter St.

ATTENTION:  
PROJECT: Local Streets Package 24-R-05 (751-2023.5)  
Sanford, Winnipeg, MB

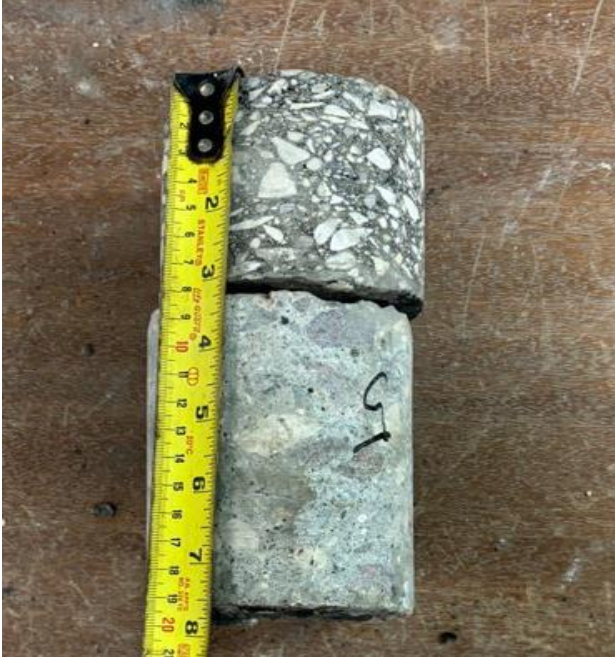
Hartford Ave, WBL, Core 23  
(Asphalt Thk 76.2mm, Conc Thk 120.7mm)

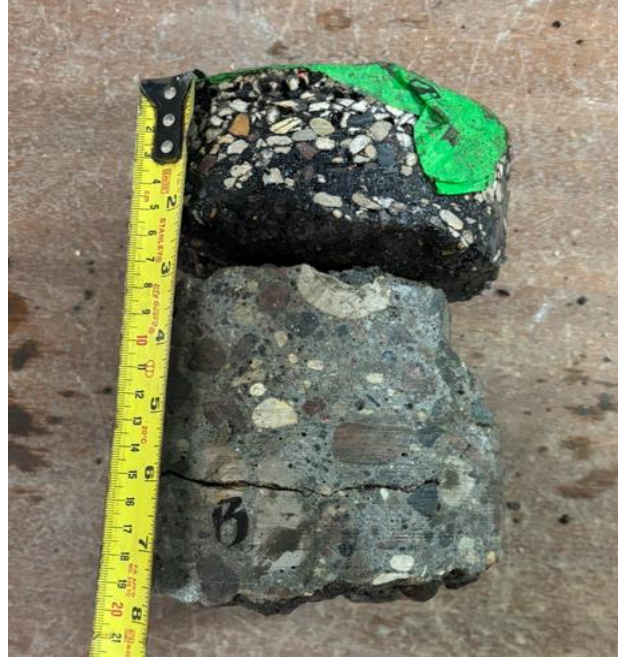
Hartford Ave, EBL, Core 24  
(Asphalt Thk 57.2mm, Conc Thk 139.7mm)

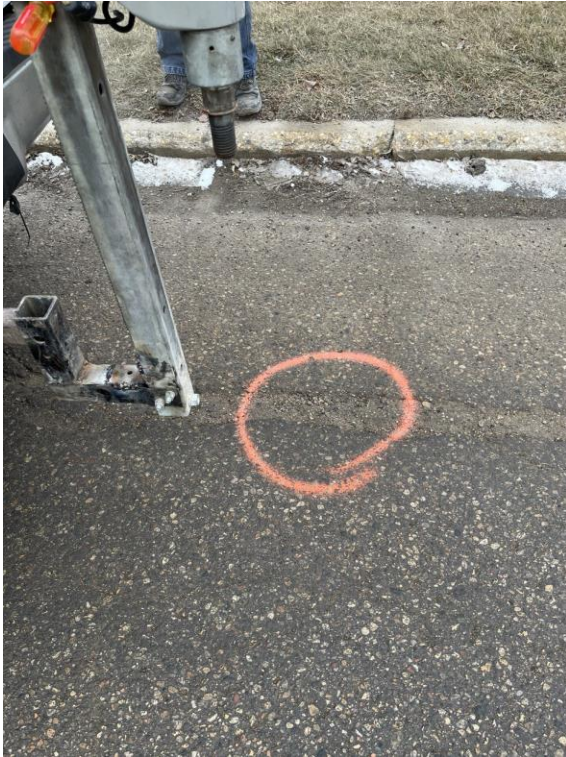
**Core 1 – Sanford (SBL)**

Figure 1. Core 1 pavement surface showing void existed between pavement and subsurface

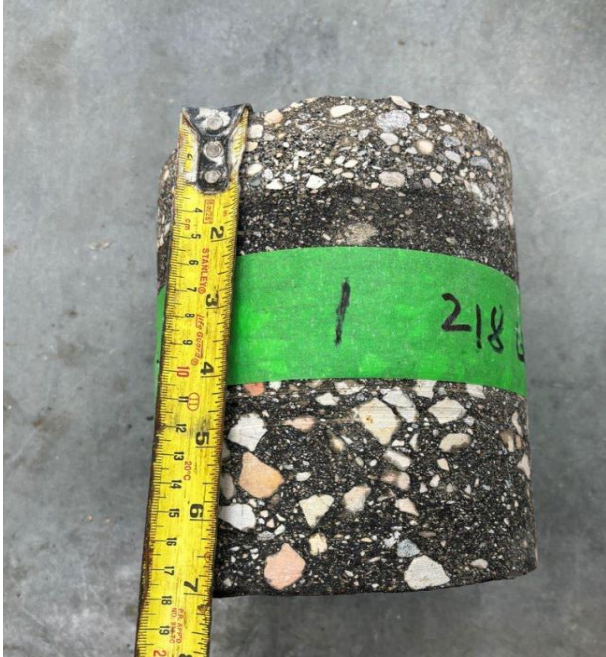
Ruby St - Lenore St Backlane, NBL, Core 37  
(Asphalt Thk 180mm)

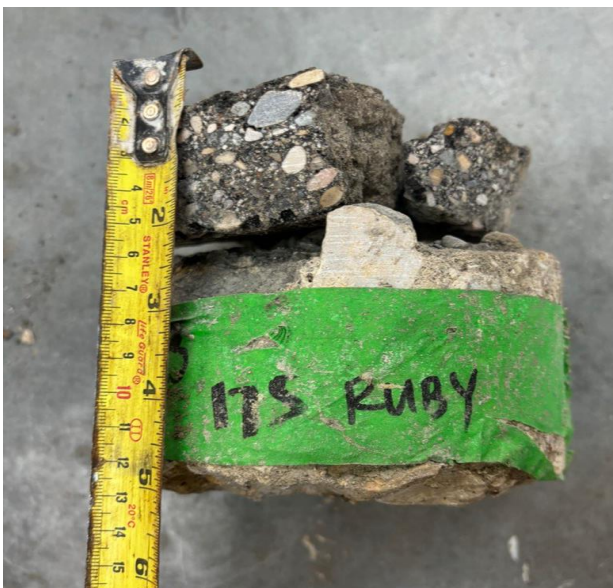
Ruby St - Lenore St Backlane, SBL, Core 39  
(Asphalt Thk 40mm; Conc Thk 80)
