THE CITY OF WINNIPEG  
**ST JAMES CIVIC CENTRE FACILITY EXPANSION**  
**2055 NESS AVENUE**

# **APPENDICES**

City of Winnipeg  
**St. James Civic Centre New Additions and Building  
Geotechnical Investigation**

# **Hazardous Building Materials Assessment**

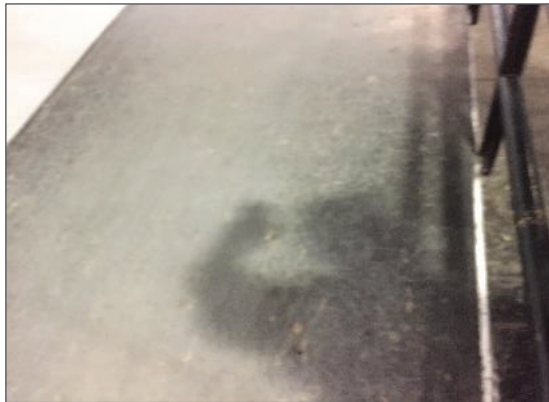
Photograph No. 4: Non-asbestos skate matting within the rink  
 Loc.15 (Samples 0018A-C).

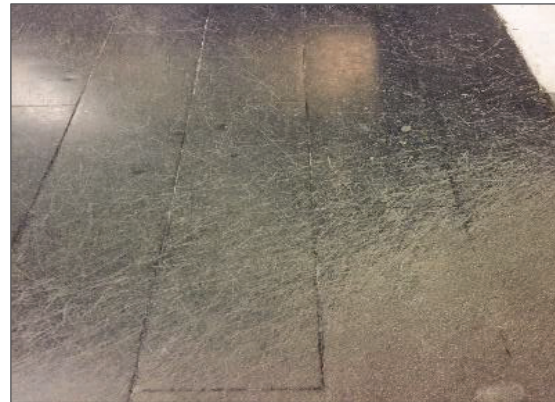
Photograph No. 5: Non-asbestos skate matting within the rink  
 Loc.15 (Samples 0019A-C).

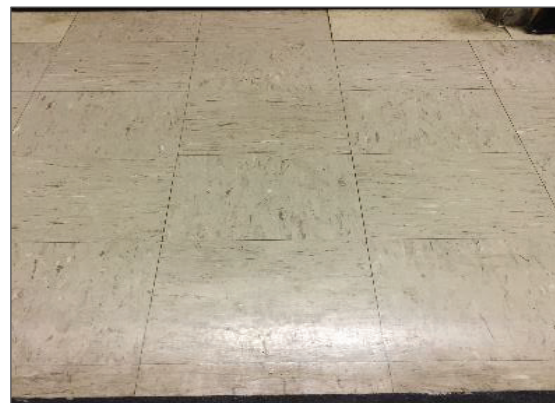
Photograph No.11: Asbestos-containing vinyl floor tiles Various Locations (Samples 0015A-C).

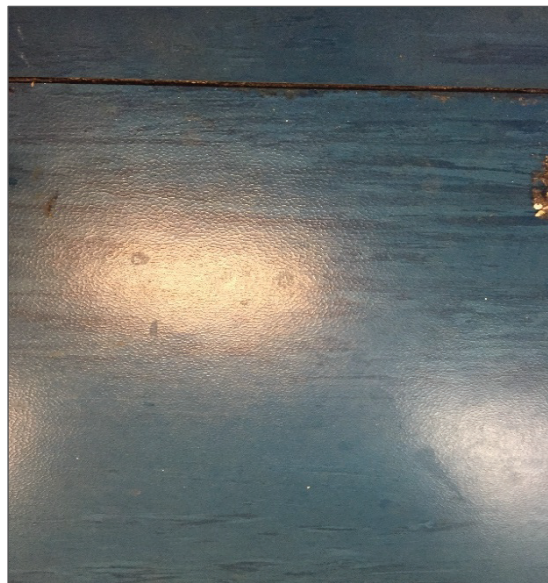
Photograph No. : Non-asbestos blue matting within the Reception area and Gym Loc.'s 30 and 42 (Samples 0030A-C).

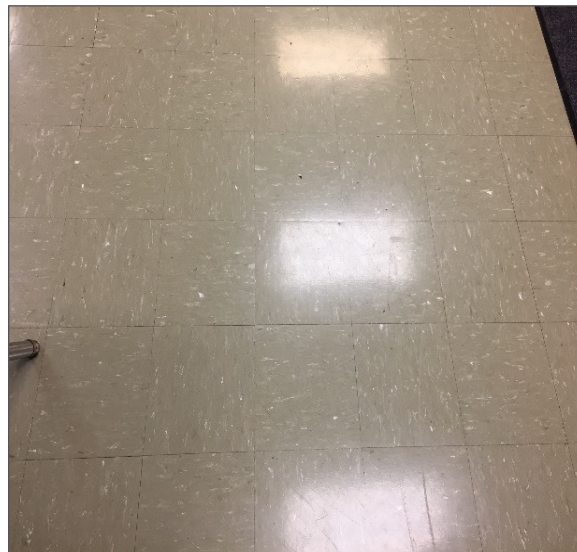
Photograph No. 15: Asbestos-containing vinyl floor tiles within the cloak room Loc.47 (Samples 0038A-C).

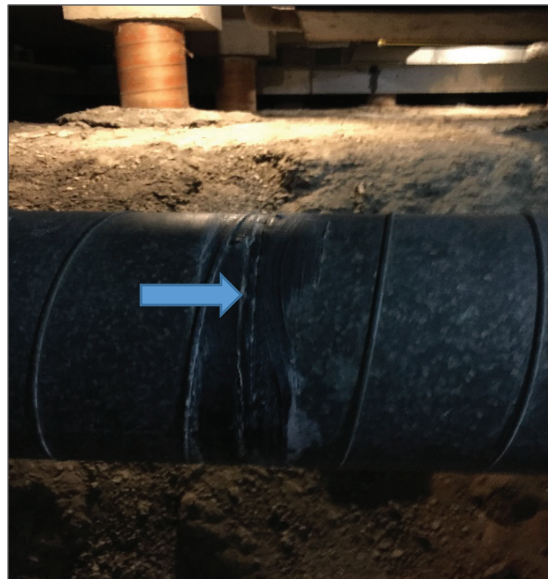
Photograph No. 23: Non-asbestos black/grey mastic present on uninsulated ducting within the south crawlspace and basement (Samples 0005A-C).

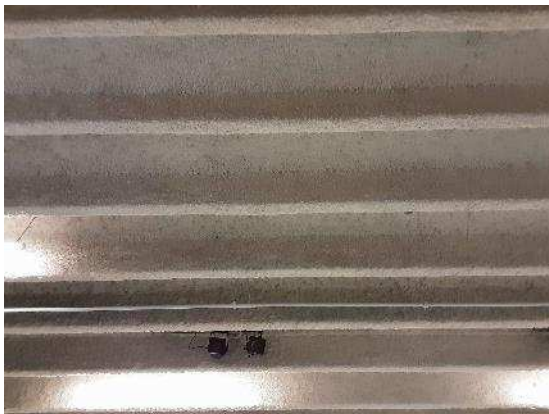
New non-asbestos spray-applied insulation is present on the structure in the Auditorium.

V0000 (None), Structure, Beam, Deck, Acoustic spray, Auditorium (Location #: 1)

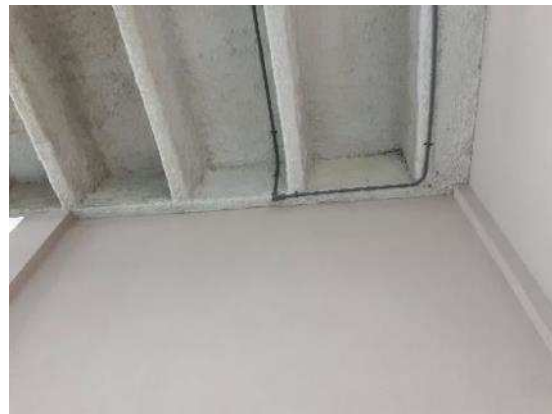
Spray-applied insulation present on the structure throughout the pool area (Location 16) does not contain asbestos (2018 analysis).

V0000 (None), Structure, Fireproofing, Pool Exterior Walls (Location #: 16)

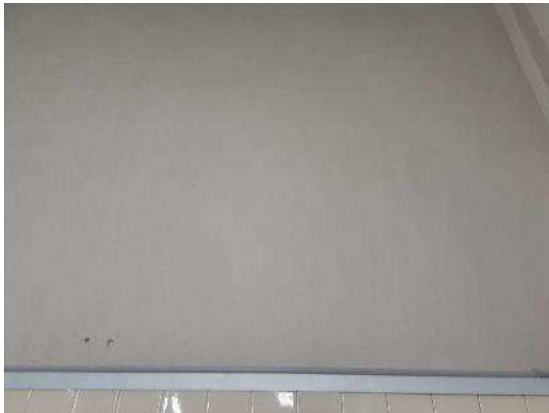
Texture finish wall in the Pool Area (Location 16) does not contain asbestos (samples S0011A-B and 2018 analysis).

S0011A (None), Wall, Texture Coat, Pool Exterior Walls  
(Location #: 16)

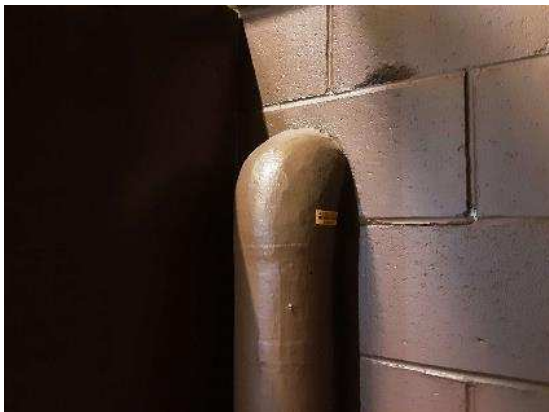
V9000 (Confirmed Asbestos), Piping, Parging Cement, Stage  
(Location #: 2)

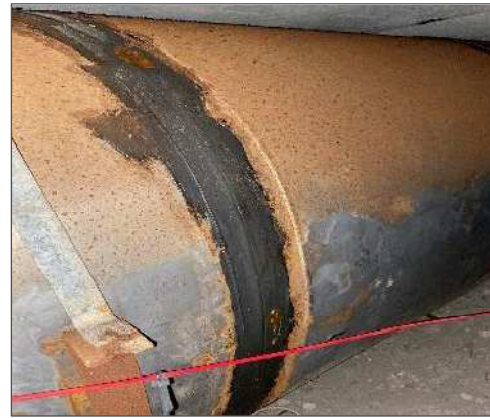
V0000, (None), Duct, blackish grey mastic,  
Crawlspace (Location # 20)

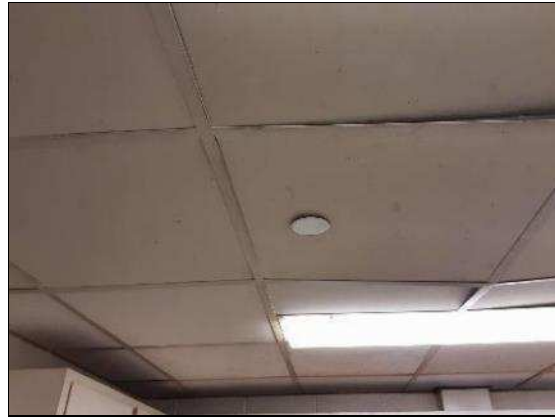
V0000 (None), Ceiling, Ceiling Tiles (lay-in),  
Kitchen (Location #: 9)

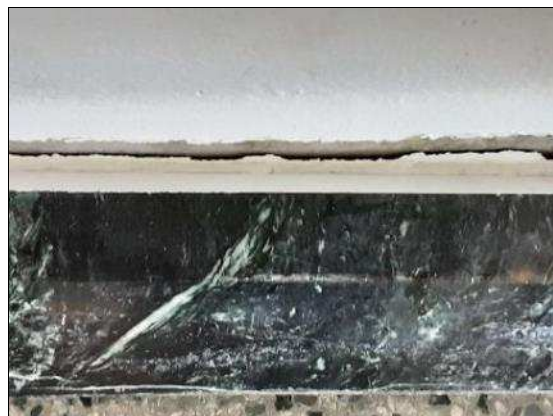
S0007C (None), Wall, Base,  
Thin-Set Behind, Foyer (Location #: 15)

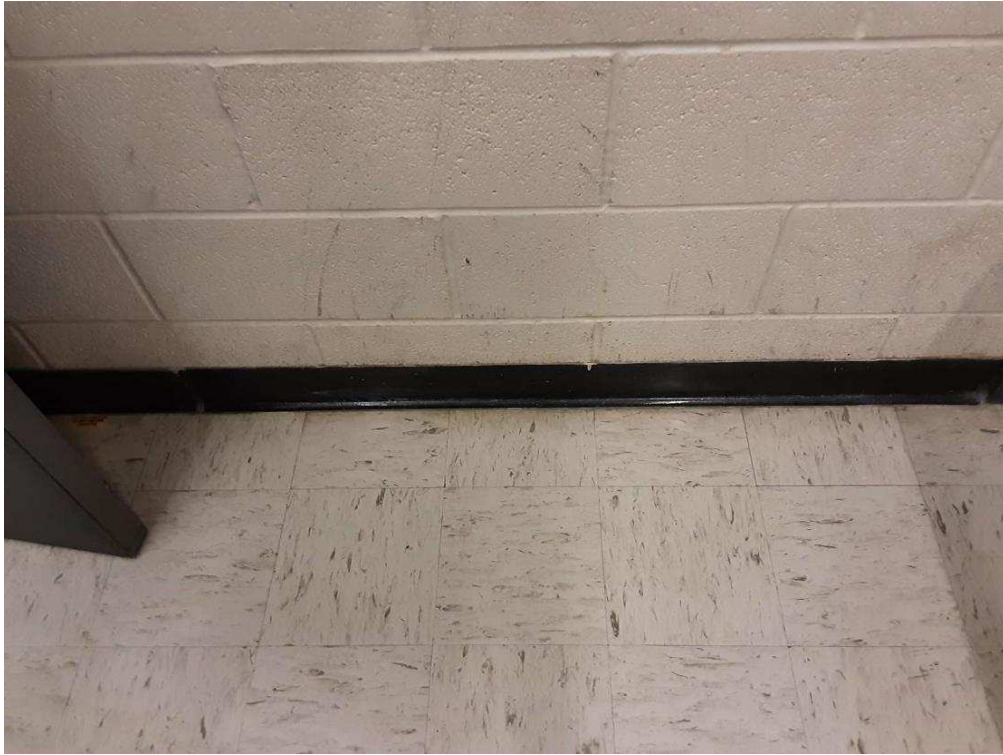
S0004A (None), Wall, Base, Adhesive/mastic, Storage Room (Location #: 3)

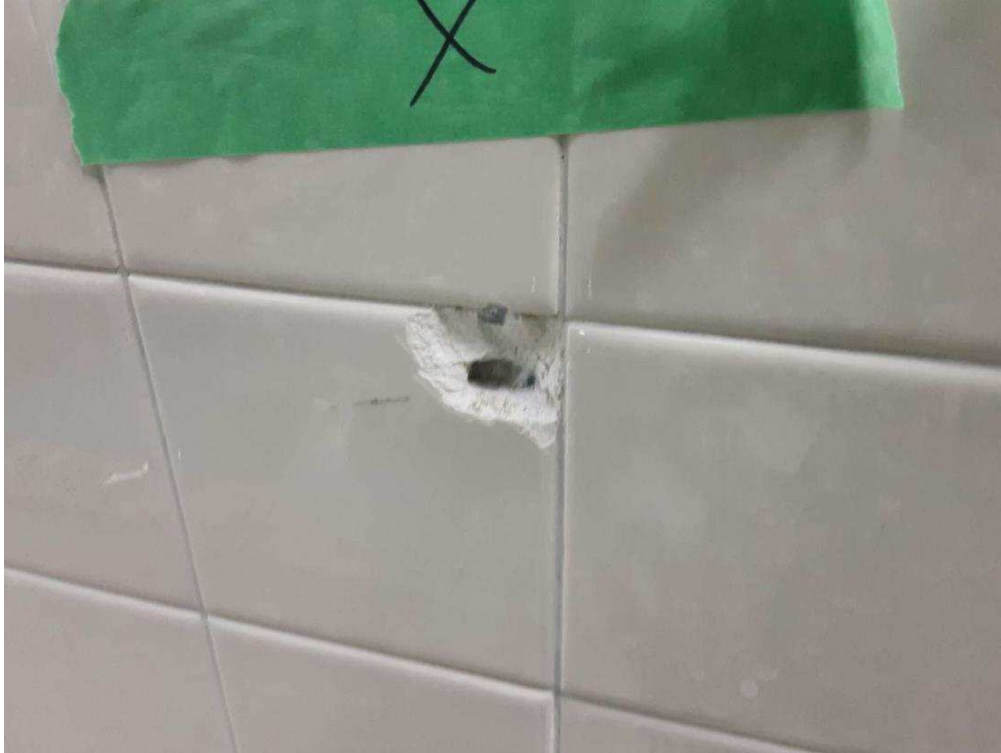
S0010A (None), Wall, Ceramic Tile Thin-Set, Pool Exterior Walls (Location #: 16)

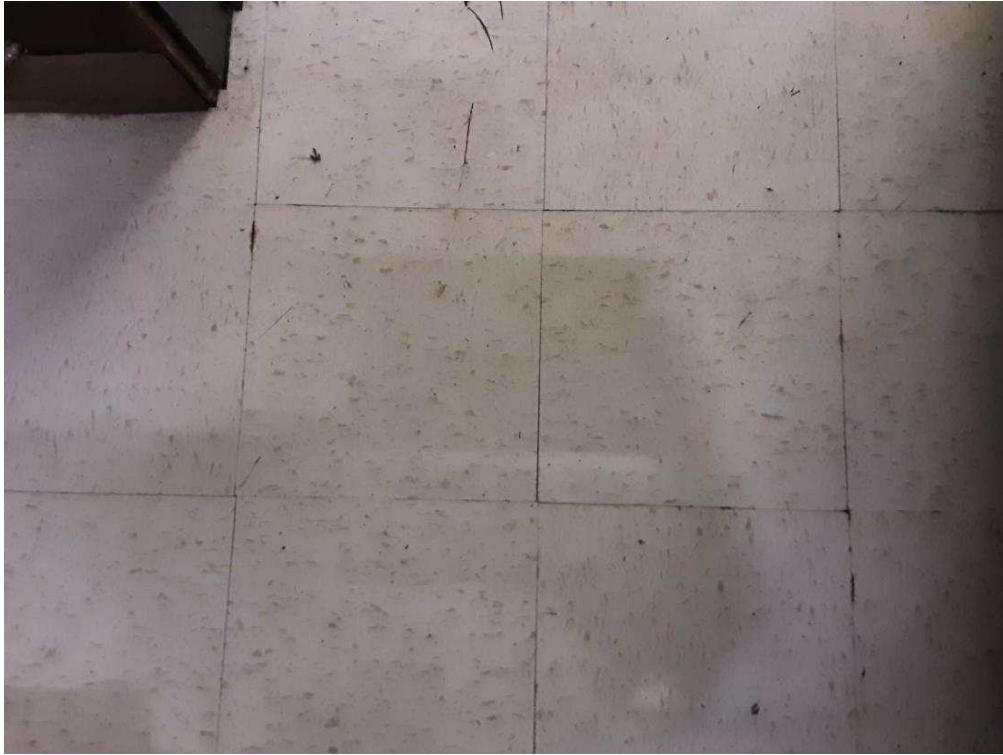
V0000 (None), Floor, Vinyl Floor Tile and Mastic, Stage (Location #: 2)

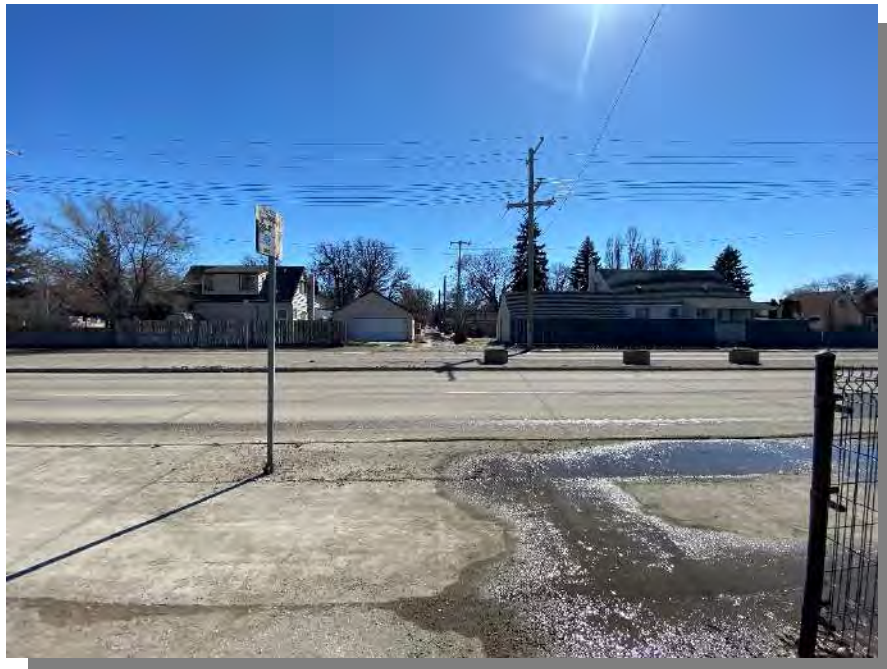
Photograph 4 – Exterior, south site boundary

*Looking south towards residential housing along Ness Avenue, from the south elevation.*

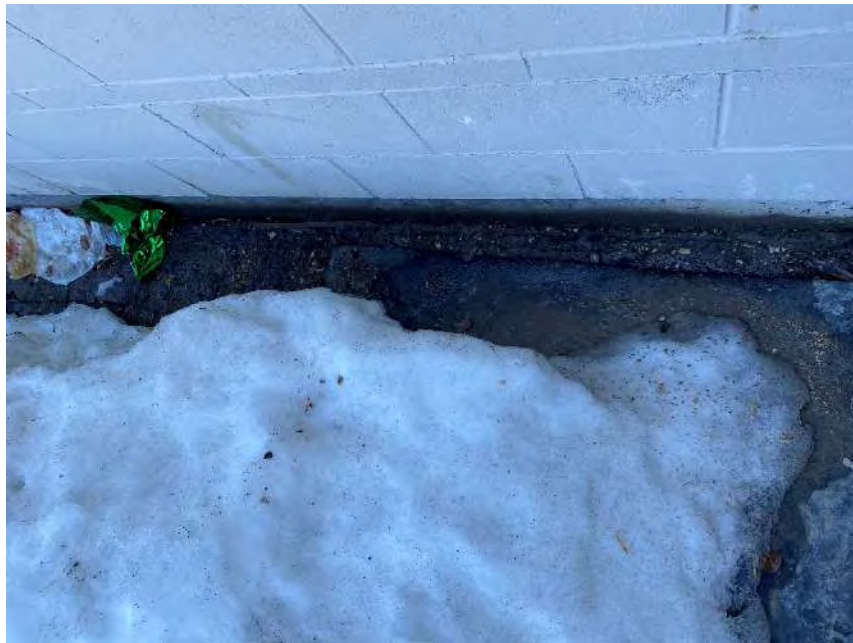
Photograph 38 – Exterior, oil contamination  
*Looking along the northwest corner of the building at oil contamination that has not been cleaned up.*

- A Limited Phase II ESA is recommended based on the identified APEC located at the northwest Site building corner associated with an oil spill in 2022. As a large quantity of absorb-all was used in the contaminant source removal at ground surface, the main objective of the Limited Phase II ESA would be to determine the presence or absence of residual impacts in the subsurface associated with the oil spill. Based on the results of the limited Phase II ESA, several outcomes are possible:

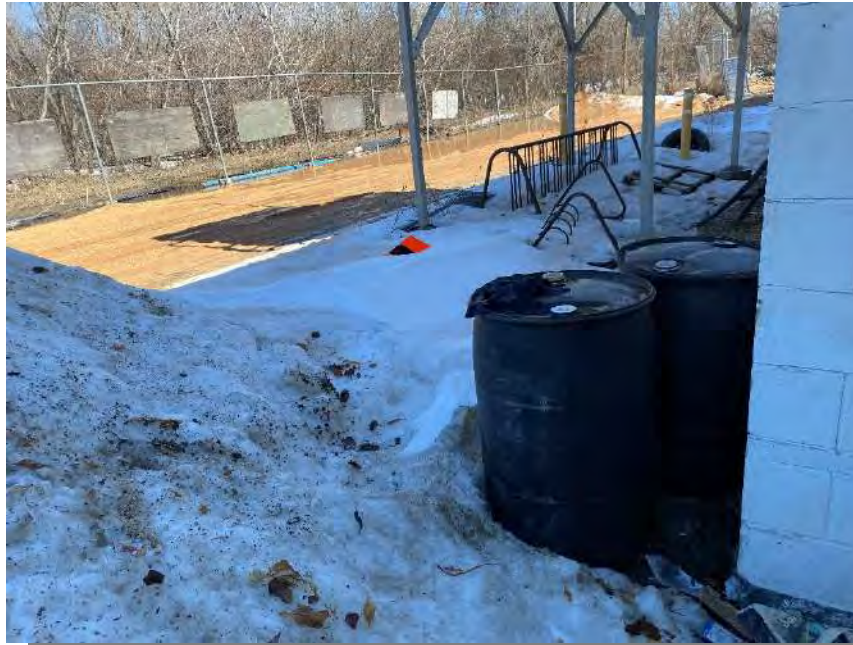
Photograph 39 – Exterior, oil barrels

*Looking along the northwest corner of the building having two oil storage barrels.*

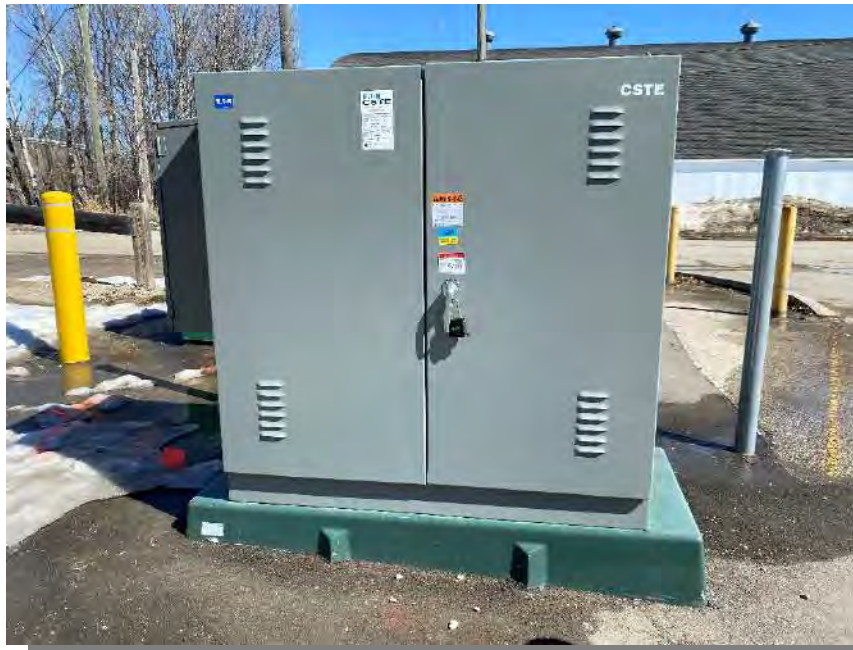
Photograph 46 – Exterior, transformer

*Looking at the transformer located to the east of the building with the Deer Lodge Curling Club in the background.*
