Alexander Dock Condition Assessment Report

City of Winnipeg

June 2024

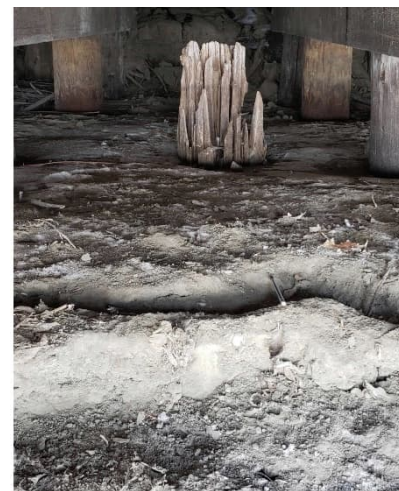
Figure 8: Erosion underside the dock

The stage one inspection was completed in March 2024 to inspect the accessible areas of the underside of the timber deck and substructure during the time window where the river levels dropped to seasonal lows. Overall, erosion protection measures in terms of rip rap layers were not observed in the underside part of the dock. Erosion of soil was observed around Pile C (see **Figure 4**) and extended to the water edge. The erosion was semi vertical around Pile C, turning to very gentle slope for about 2.5 to 5 m, then approximately sloped at 45 degrees or flatter

around the water edges (see **Figure 8 and 9**). In addition to the erosion, multiple gaps were noted around the existing timber piles (see **Figure 10**). These gaps may impact the lateral resistance of the piles due to lack of contact between the pile at the point of load application with the soil providing the required lateral resistance to withstand the loads.

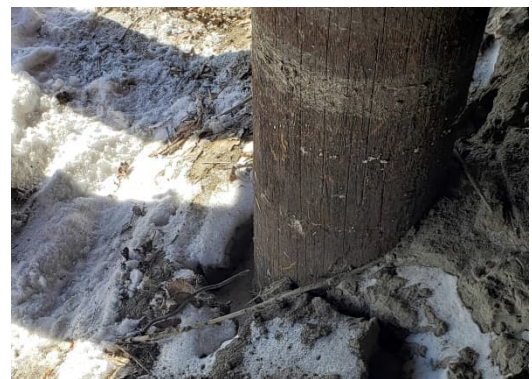
Figure 10: Gap around the piles

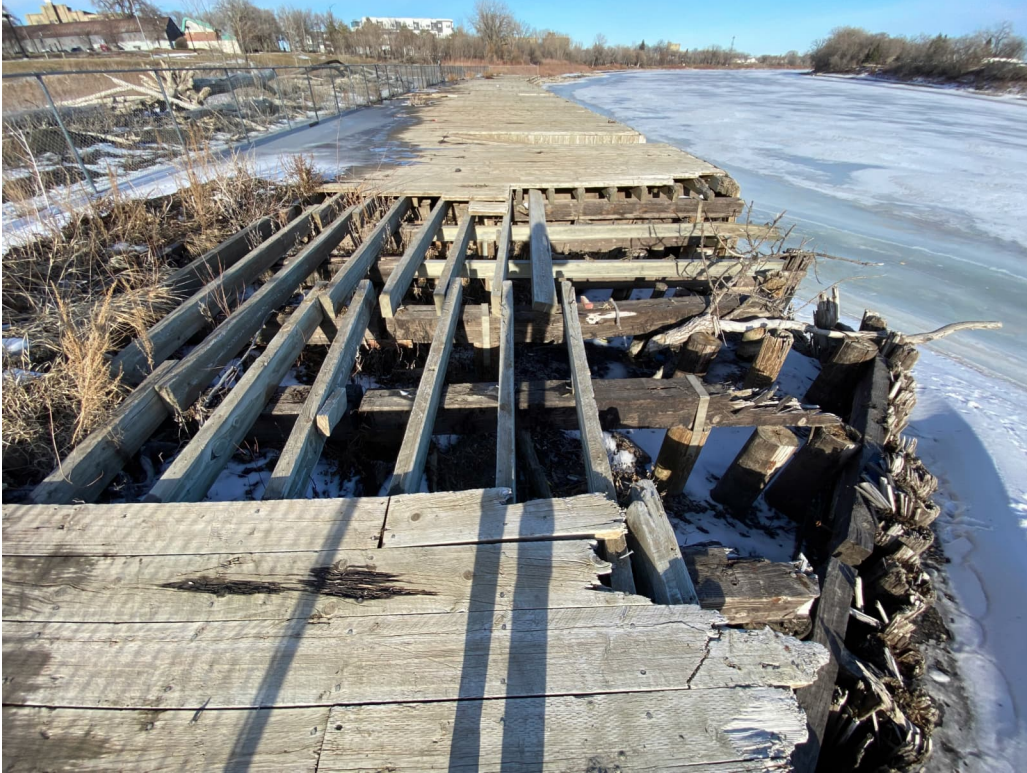
Photograph 11
Deck top. Note: Deck planks removed.

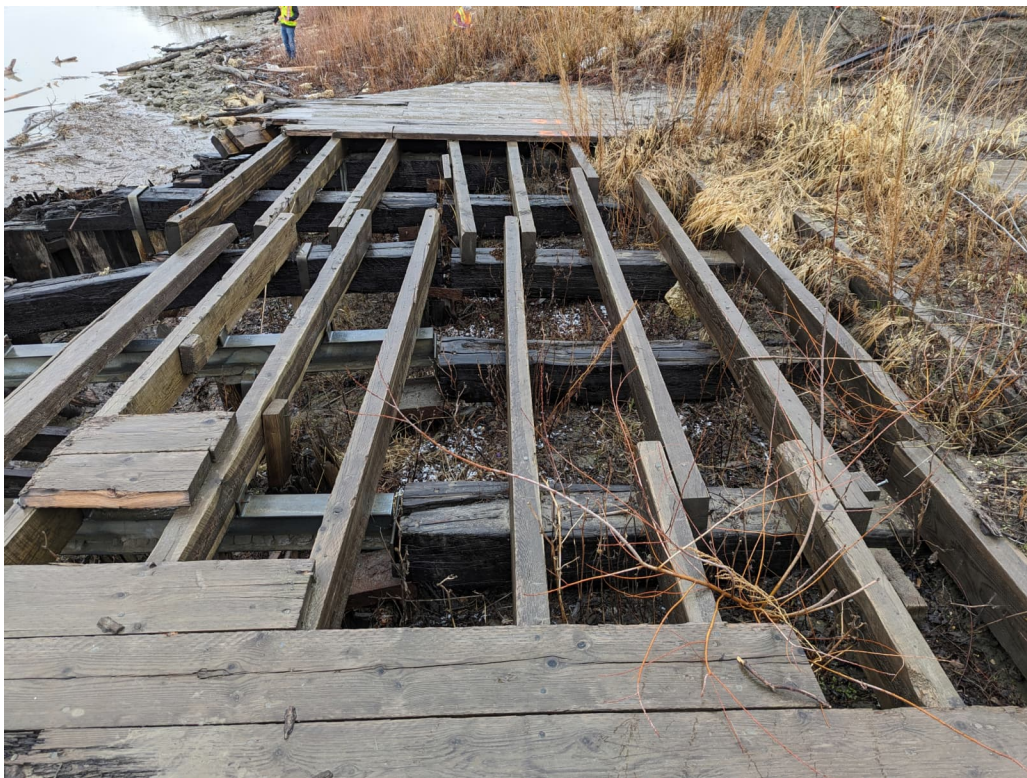
Photograph 16

South end. Note: Removed/damaged deck planks. Damaged stringers and caps. Cap rot.

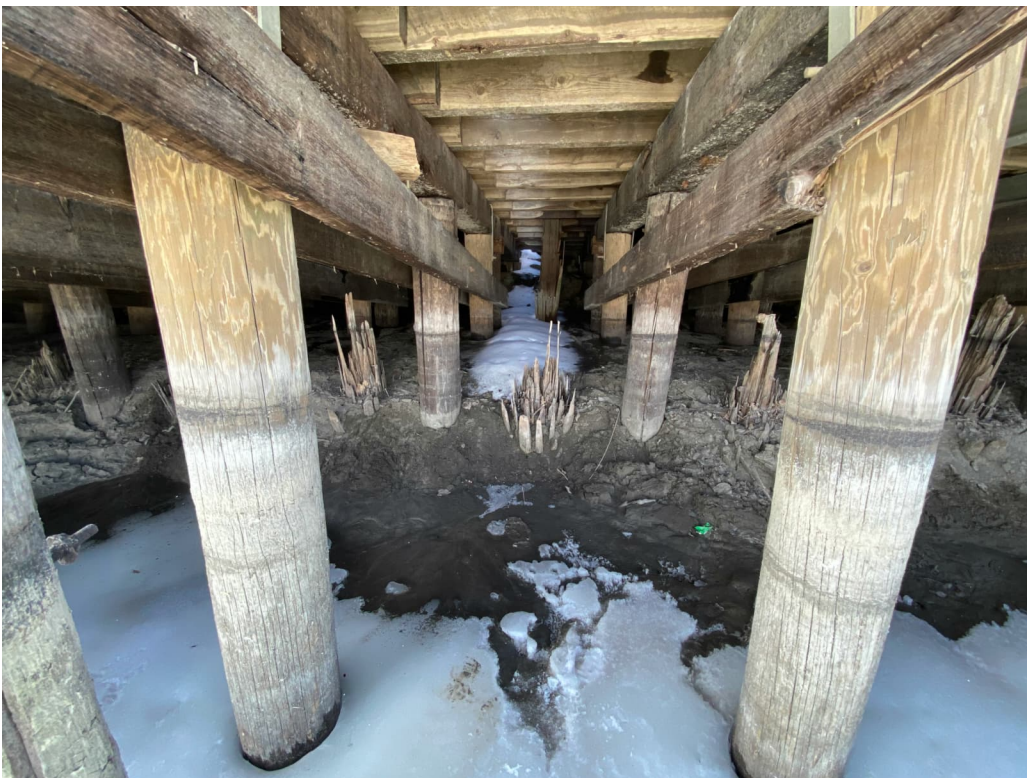
which were installed as part of the 2004 rehabilitation work. Note that Rows 1 to 6 have an irregular pile layout due to the tapered upstream vertical face. Abandoned timber piles were observed between each row of existing C and D Piles from Rows 6 to 60. There were no abandoned piles observed within the enclosed north area.

Photograph 22
Typical bay between pile rows. Note: Typical abandoned piles between Piles C and D.

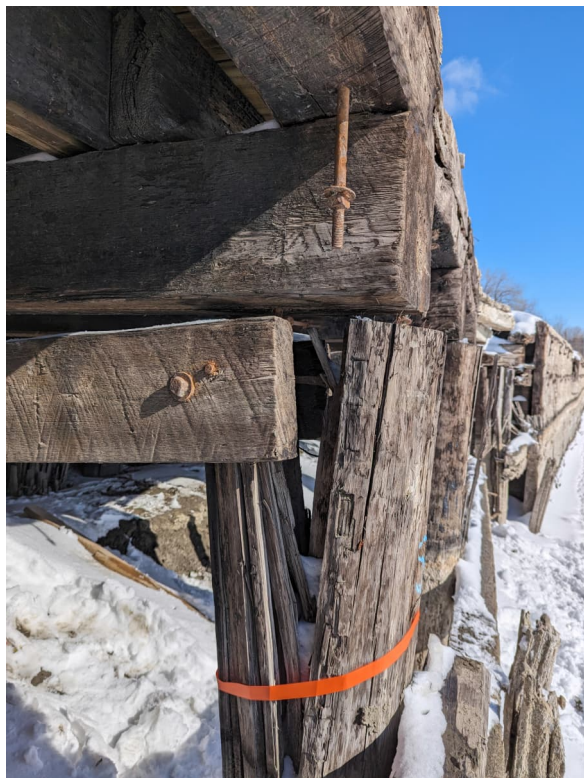
Photograph 24
Typical severely split and not functional pile.

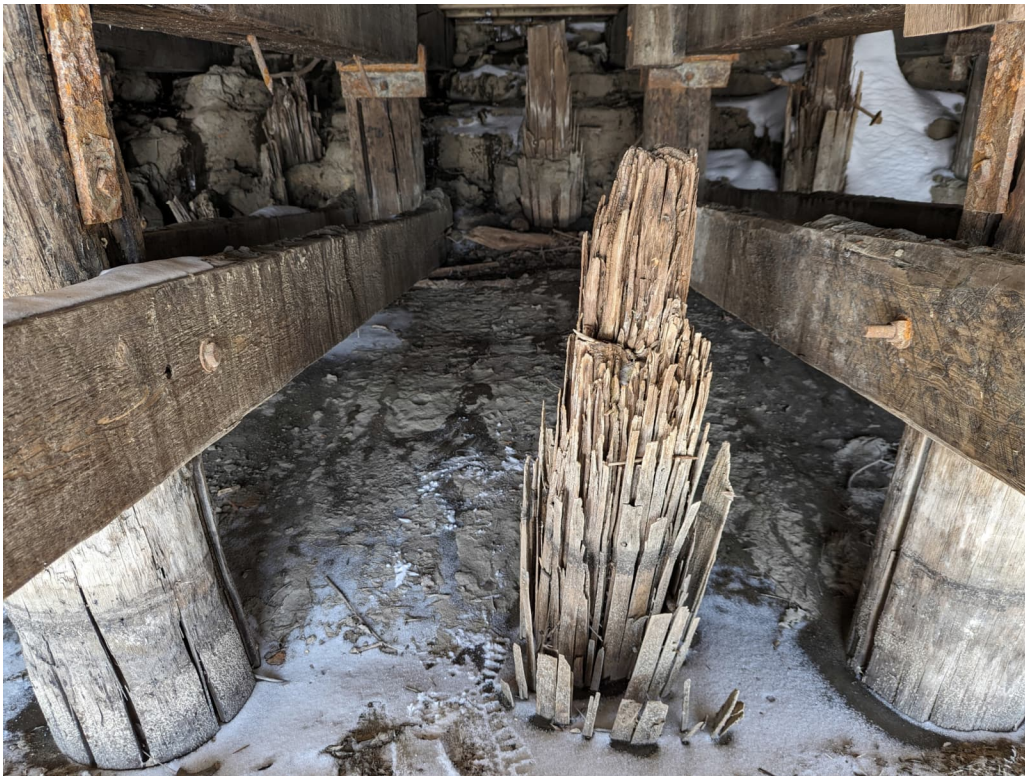
Photograph 26
Typical abandoned pile between existing piles.

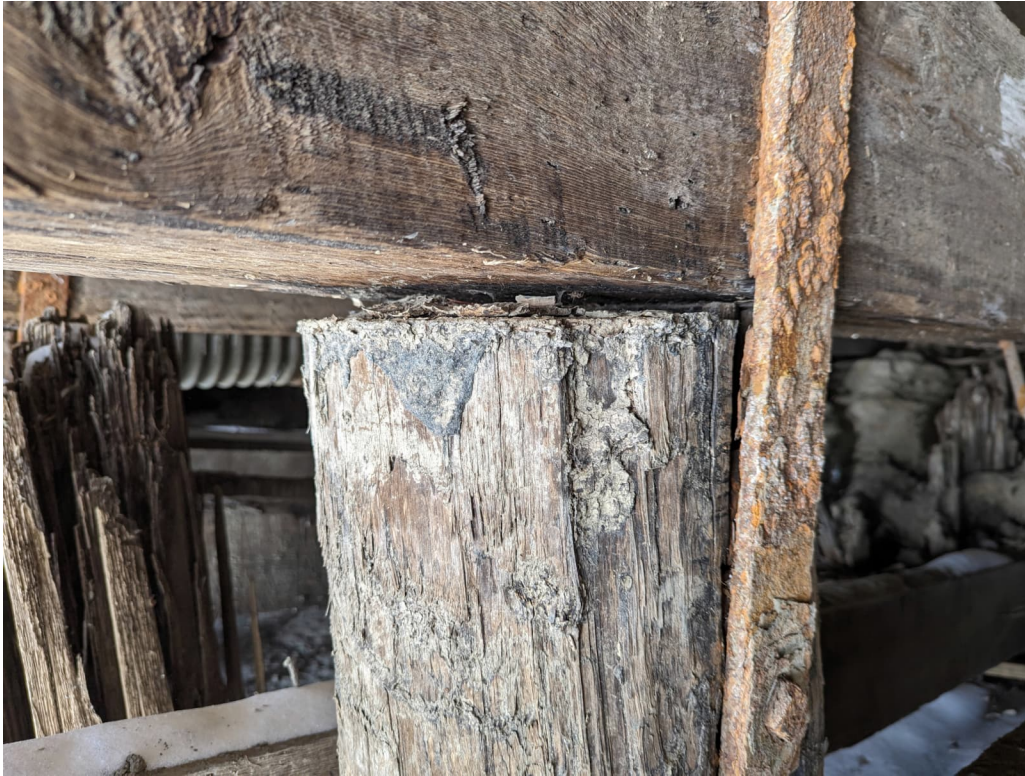
Photograph 27
Typical partailly bearing pile.

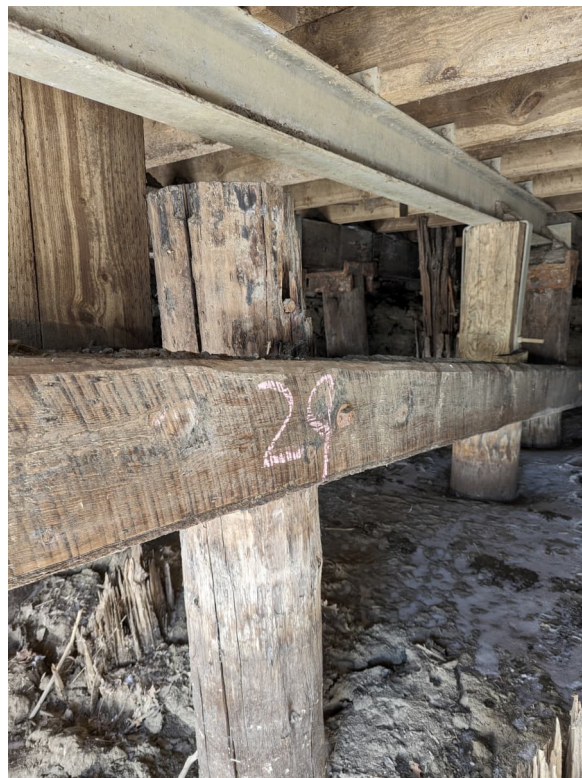
Photograph 28
Typical not bearing/not functional pile.

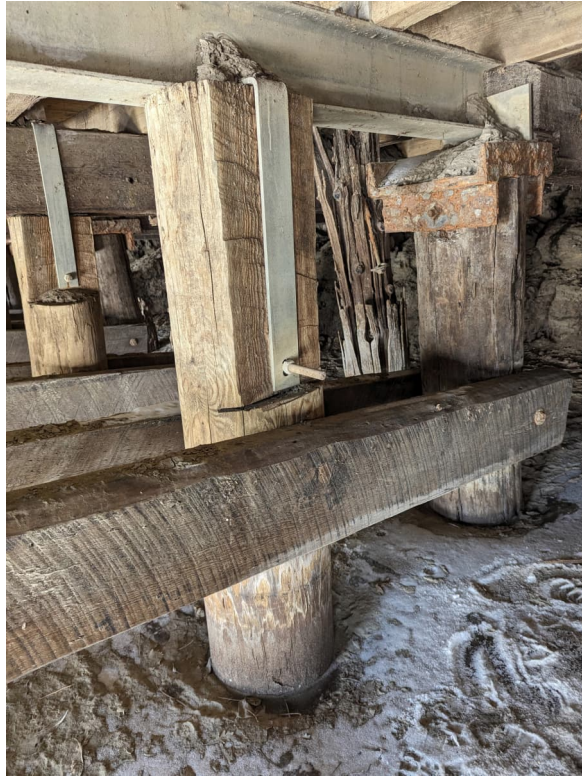
Photograph 29
Typical pile with section removed for connection.

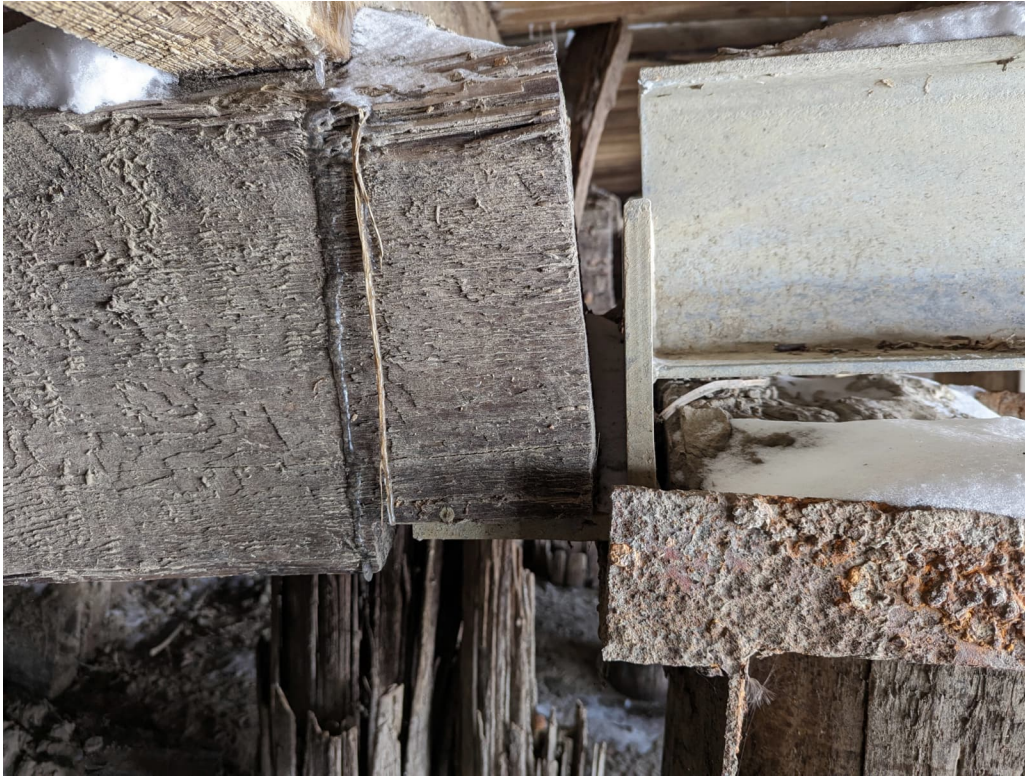
Photograph 33
Typical steel angle bearing at steel pile cap beam and timber pile cap.

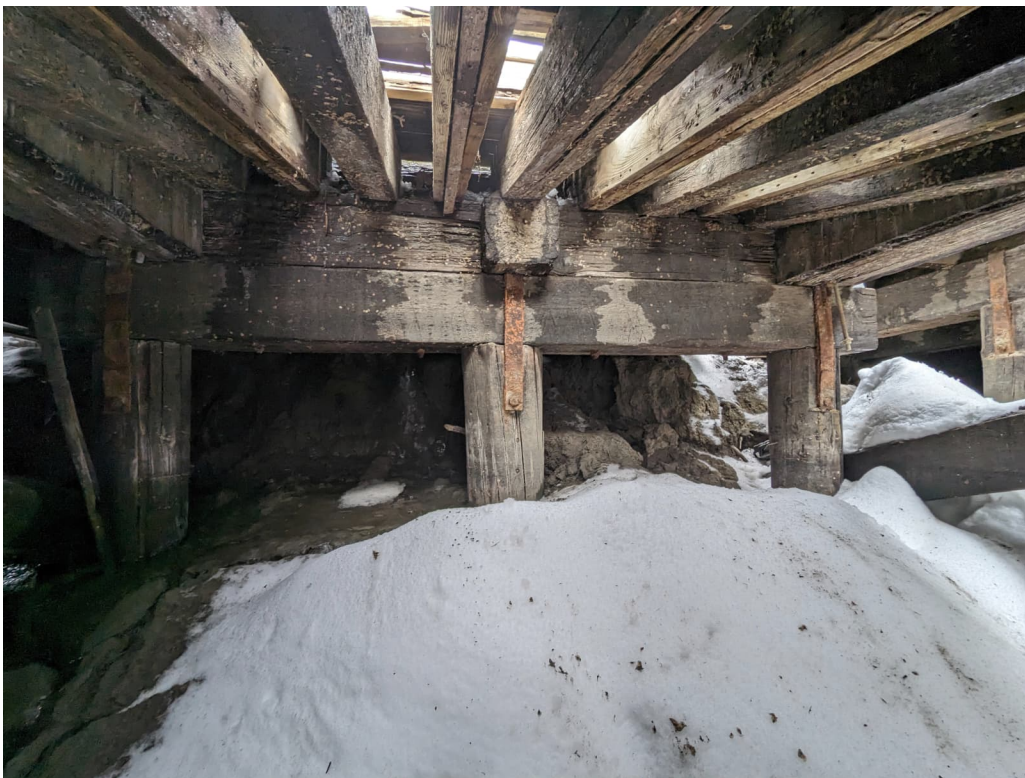
Photograph 34
Typical timber header construction below Slip No. 4.

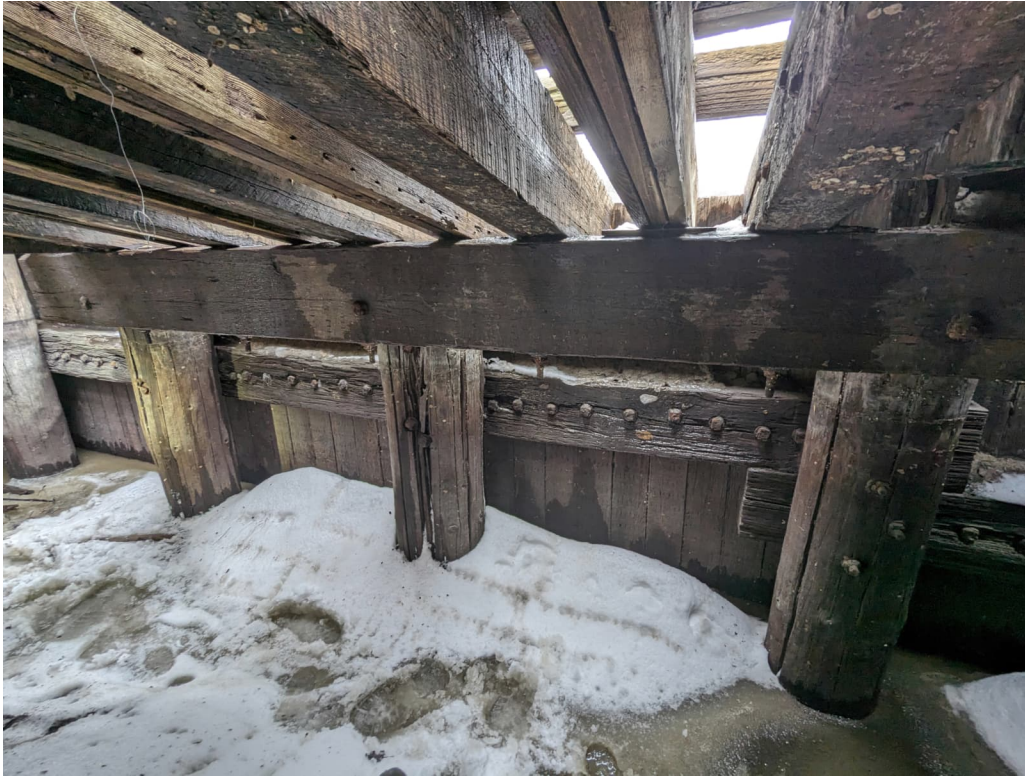
Photograph 35
Typical timber header construction below Slip No. 4.

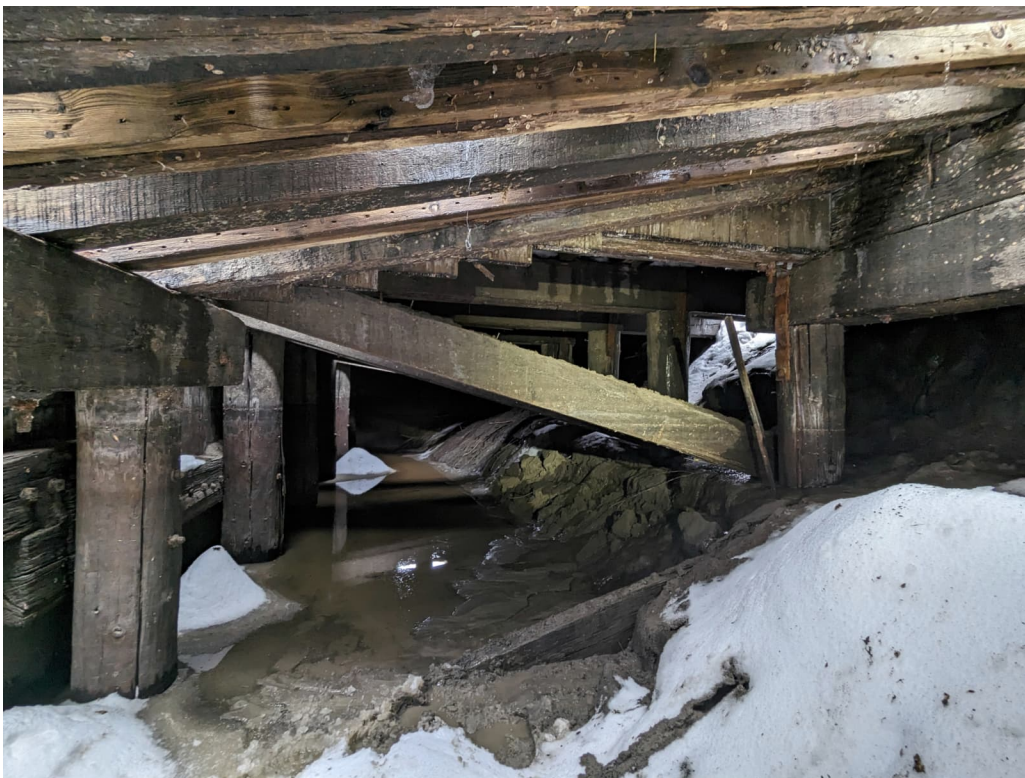
Photograph 36
Looking into enclosed North area.

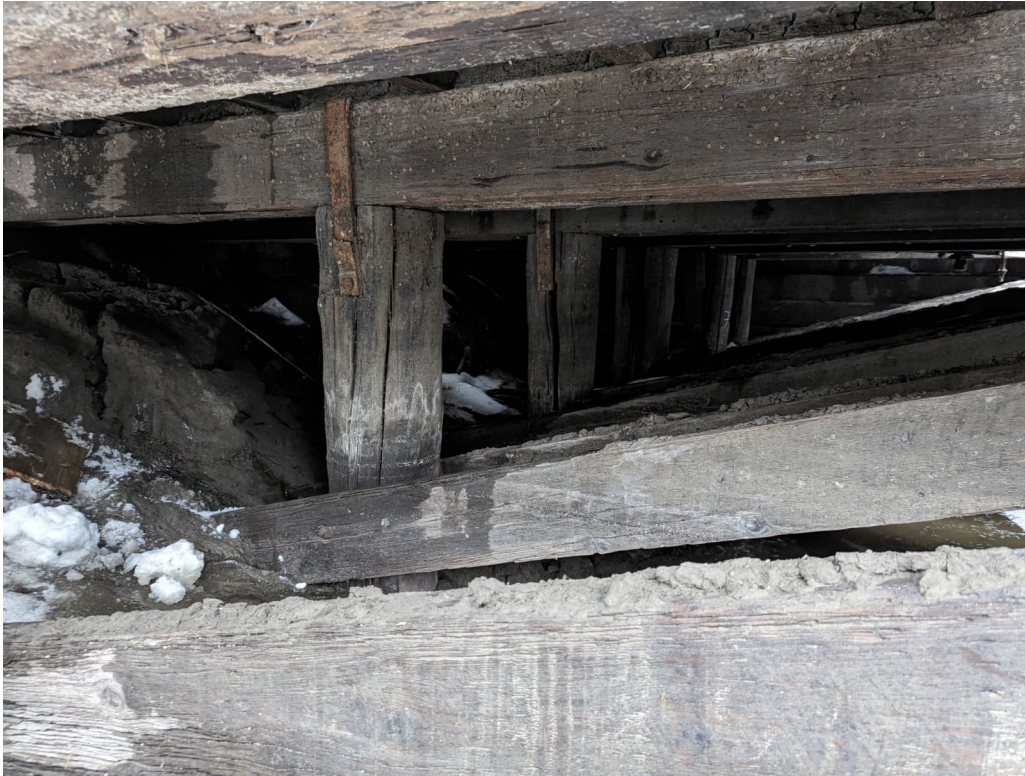
Photograph 37
Looking into enclosed North area. Note: Typical split piles.

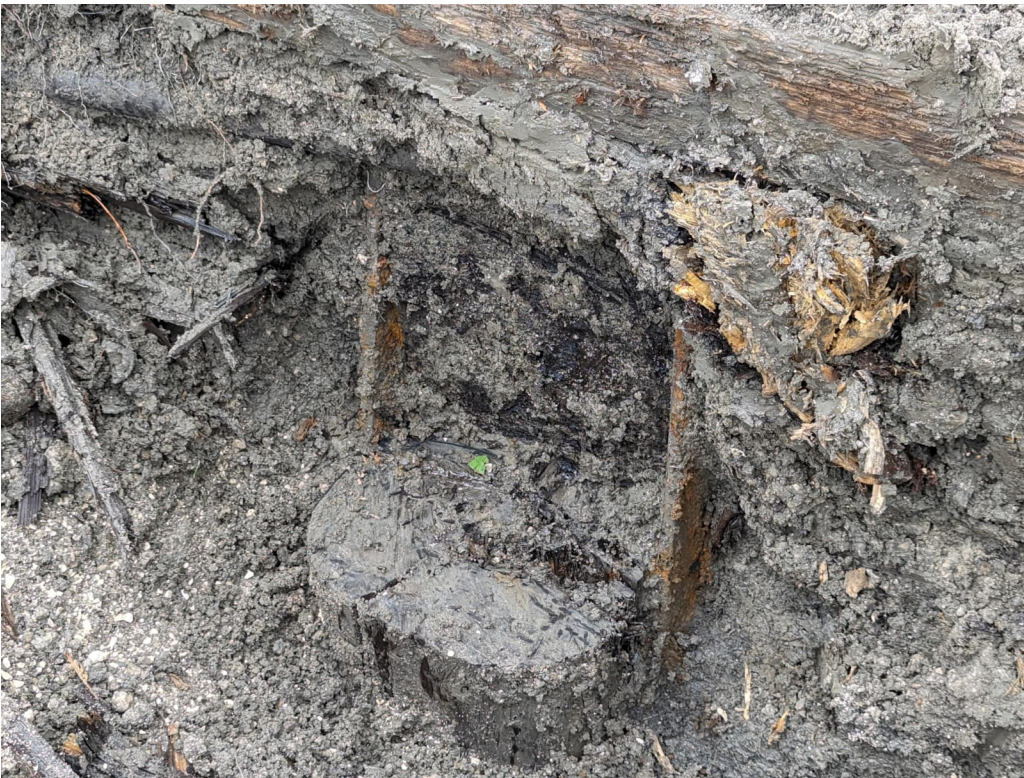
Photograph 42

Exposed pile and pile cap at Test Pit No. 2. Note: Rotten pile and pile cap. Minimal bearing on pile.

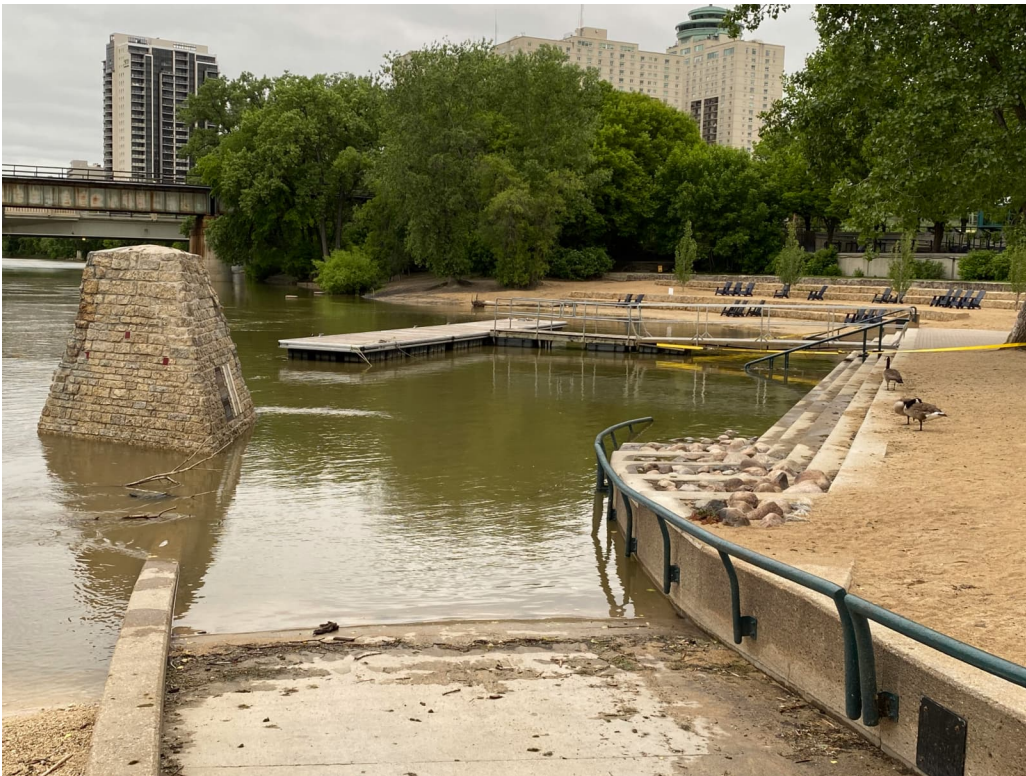
Photograph 46
June 11, 2024 water level at the Forks.

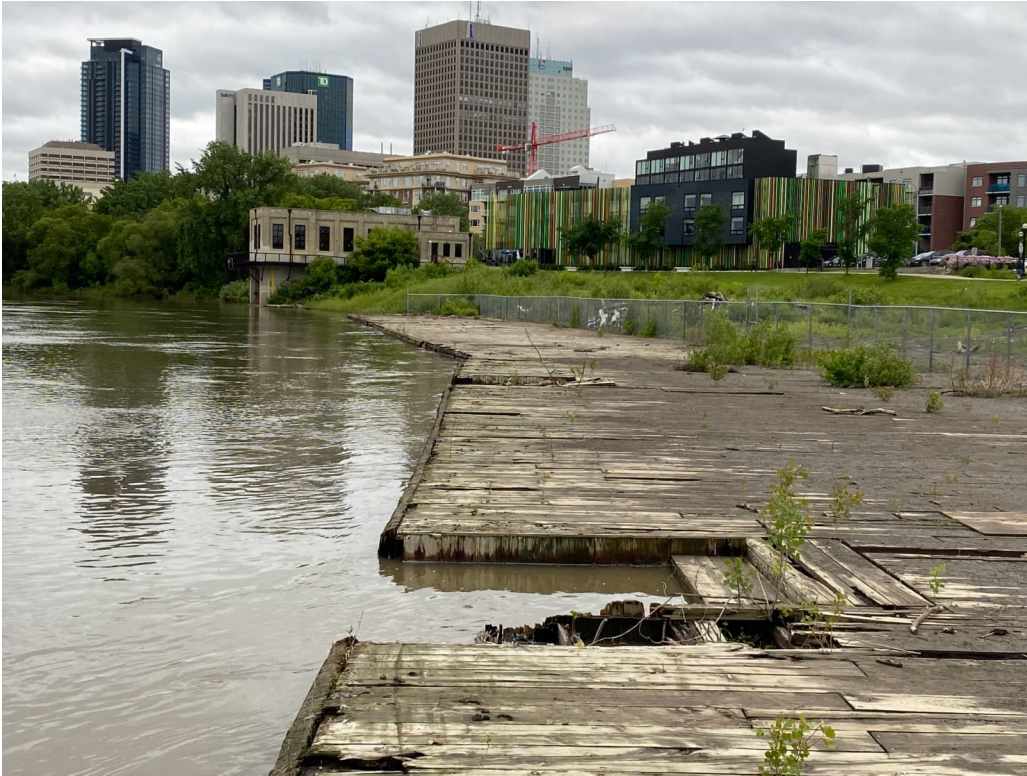
Photograph 49
June 11, 2024 water level at the dock.

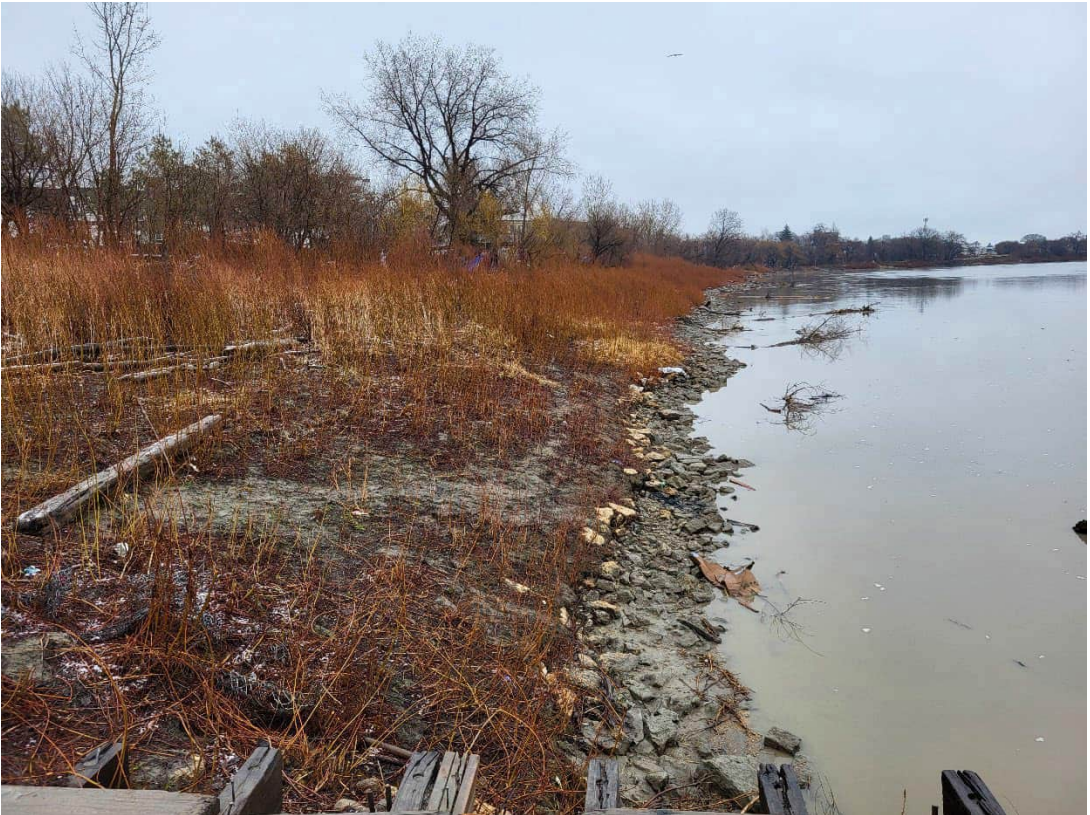
The substrate observed around the dock and the shoreline, in order of dominance, consisted of boulders, cobble, silt, fines, and sand. Banks on both sides of the river showed signs of erosion and instability (**Attachment 1**, Photos 5,6,8,11, and 13). A search for mapleleaf mussel (Species at Risk) shells was conducted around the dock and shoreline surrounding the dock; however, no mussels or mussel shells of any mussel species were observed. Historic satellite imagery of the dock and surrounding area shows that the Project site commonly floods in the spring causing the dock to be submerged. As a result, large amounts of woody debris have washed up on the land behind the dock and the area around the dock (**Attachment 1**, Photos 3,4,11, and 15). This debris will need to be removed prior to construction. The aquatic environment (e.g., substrate characteristics) are not expected to have changed since the detailed environmental site characterization was done at the Project site in 2017 (North/South Consultants Inc. 2017).

<table> <tr> <td>Photo No. 5</td><td>Date 4/18/2024</td></tr> <tr> <td colspan="2">Direction Photo Taken Northeast</td></tr> <tr> <td colspan="2">Description Facing northeast looking at north bank from the north end of the dock</td></tr> </table>	Photo No. 5	Date 4/18/2024	Direction Photo Taken Northeast		Description Facing northeast looking at north bank from the north end of the dock

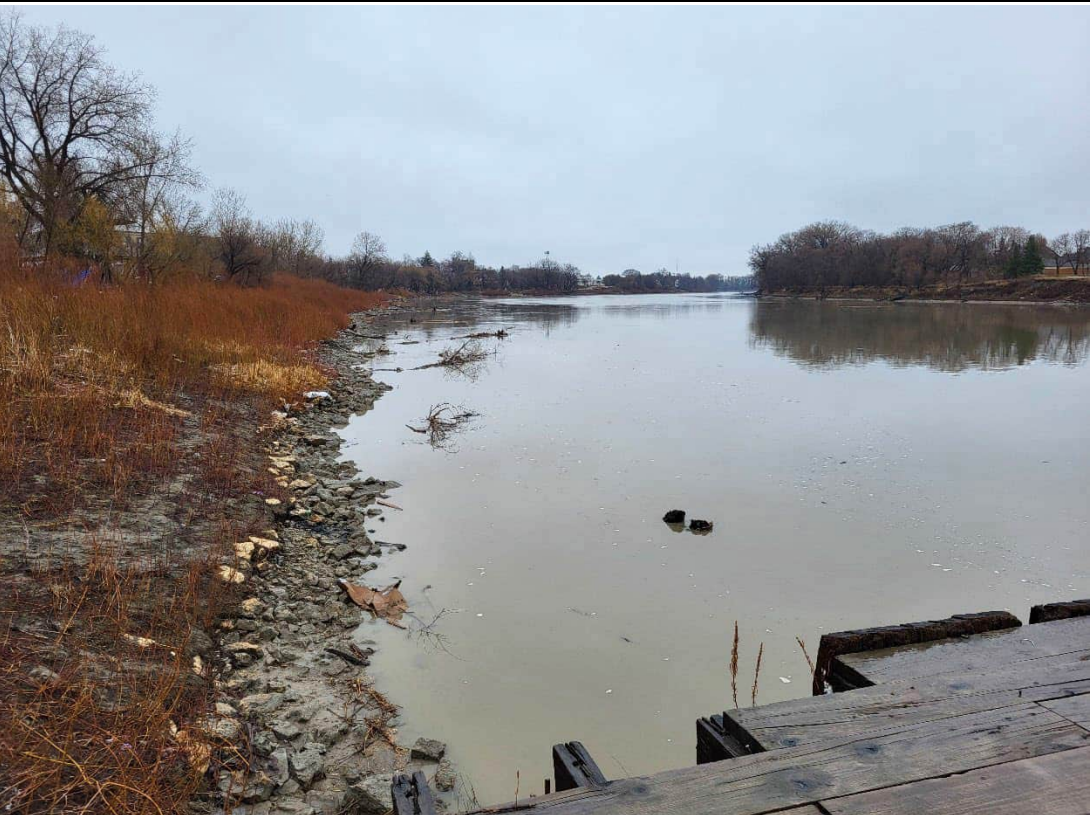
Photo No. 6	Date 4/18/2024						
Direction Photo Taken Northeast							
Description Facing northeast looking at north bank from the north end of the dock

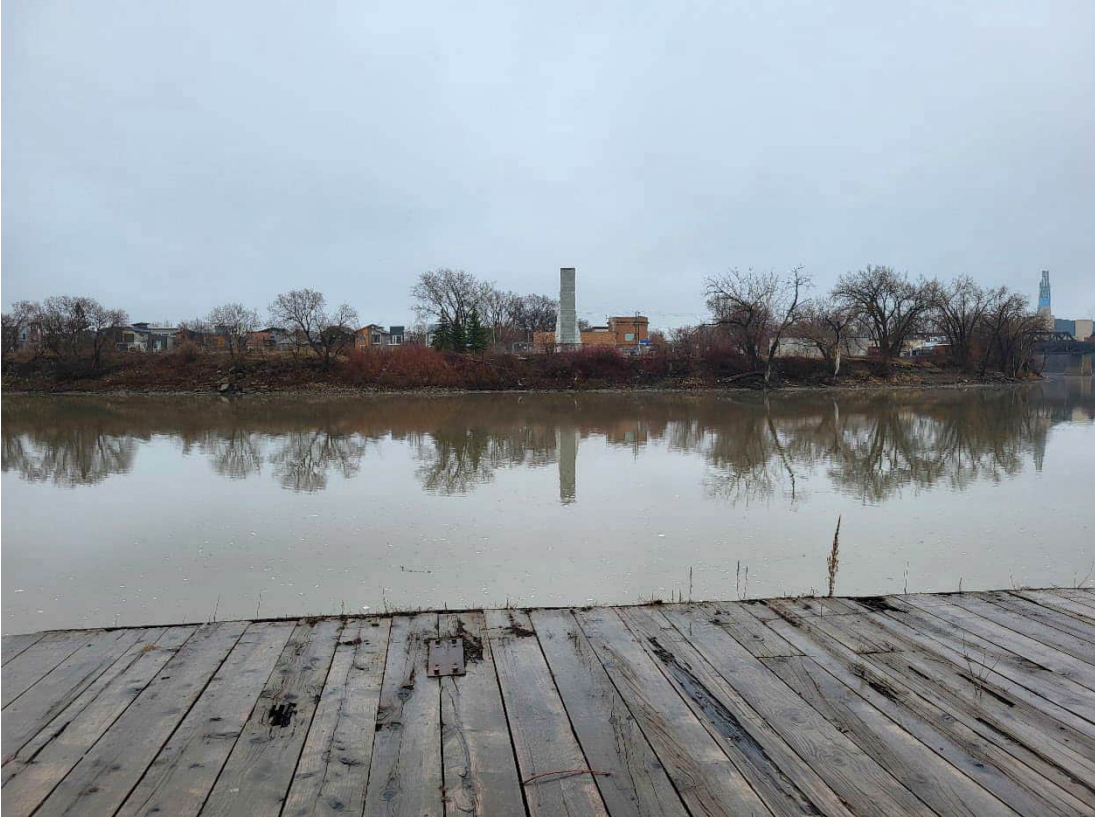
Photo No. 8	Date 4/18/2024						
Direction Photo Taken Southeast							
Description Facing southeast at the opposite side of the river from the north end of the dock

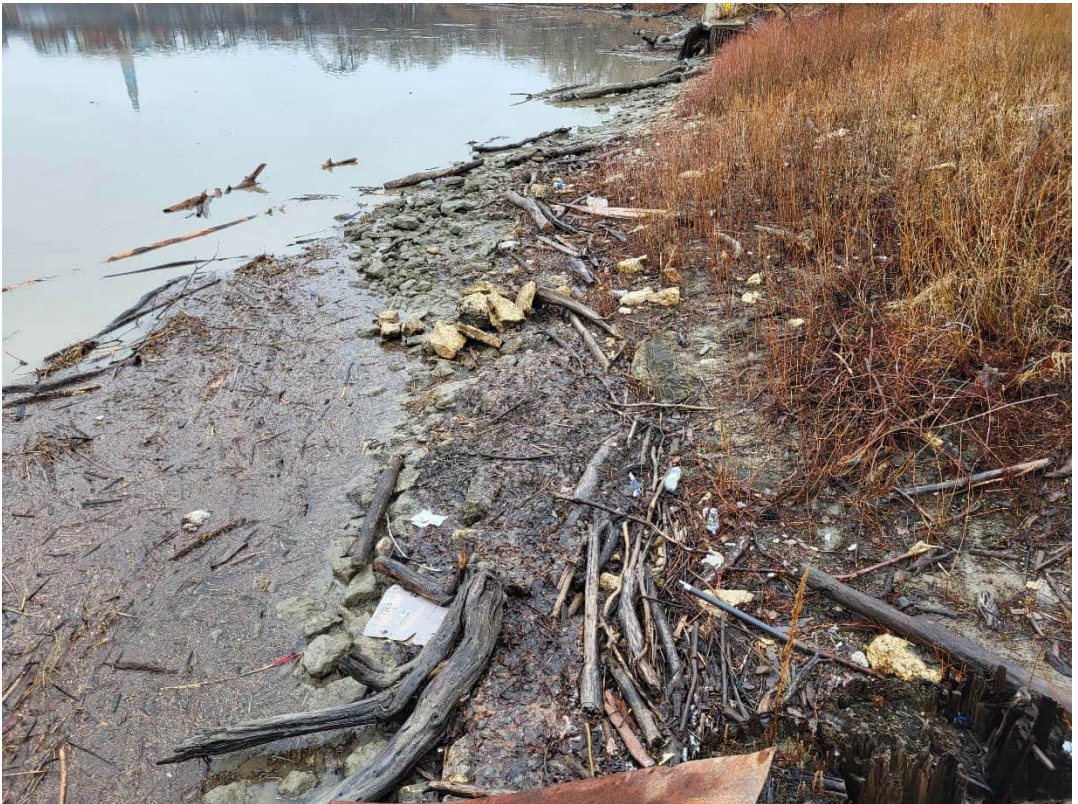
<table> <tr> <td>Photo No. 11</td><td>Date 4/18/2024</td></tr> <tr> <td colspan="2">Direction Photo Taken South</td></tr> <tr> <td colspan="2">Description Facing the north bank next to the south end of the dock</td></tr> </table>	Photo No. 11	Date 4/18/2024	Direction Photo Taken South		Description Facing the north bank next to the south end of the dock

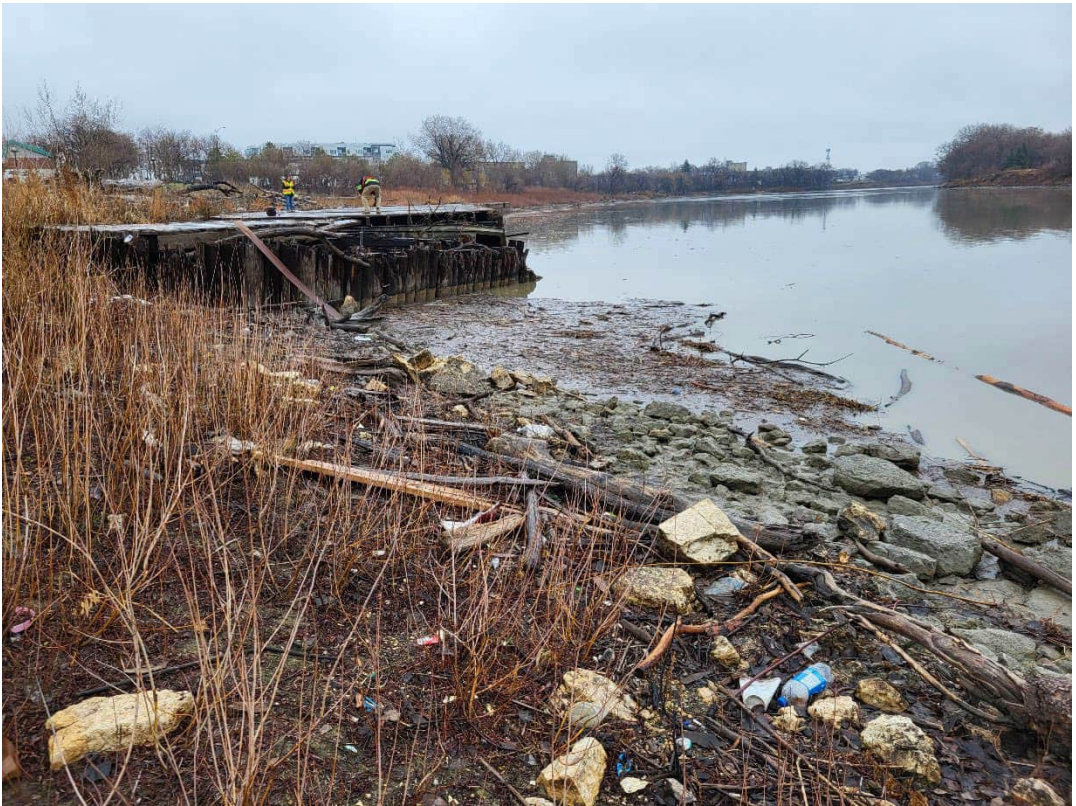
<table> <tr> <td>Photo No. 13</td><td>Date 4/18/2024</td></tr> <tr> <td colspan="2">Direction Photo Taken Northeast</td></tr> <tr> <td colspan="2">Description Facing northeast at the south end of the dock</td></tr> </table>	Photo No. 13	Date 4/18/2024	Direction Photo Taken Northeast		Description Facing northeast at the south end of the dock
