GEOTECHNICAL REPORT

2026 LOCAL STREETS PACKAGE 26-R-02

RENEWAL OF LOCAL STREETS FOR THE CITY OF WINNIPEG

January 19, 2026

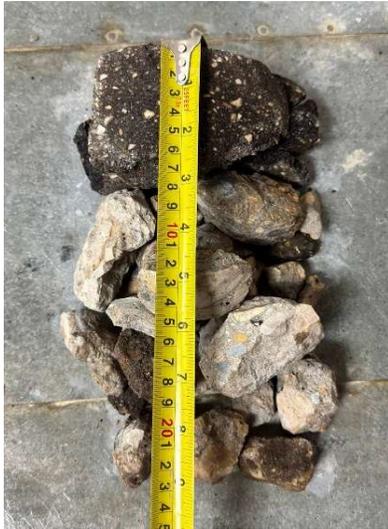
Core 1 - Mid Slab

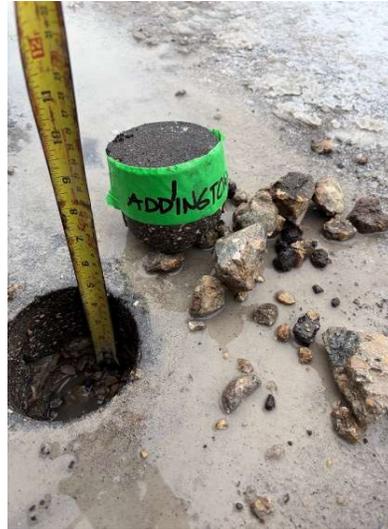
Core 1 - Site Photo

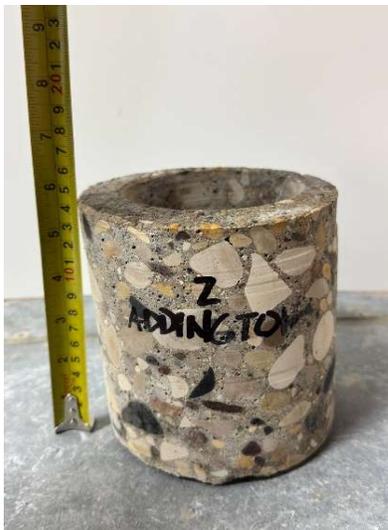
Core 2 - Mid Slab

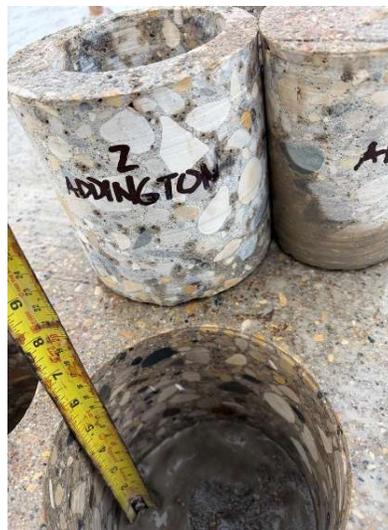
Core 2 - Site Photo

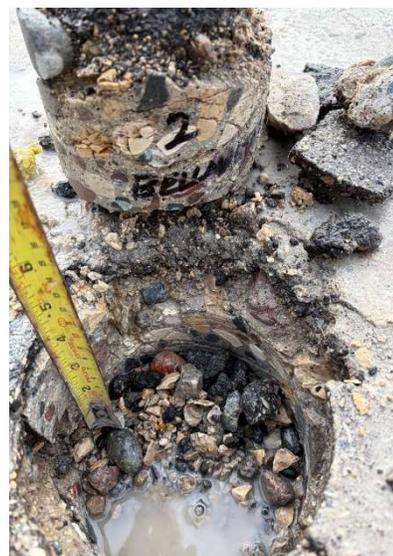
Core 2 - Site Photo

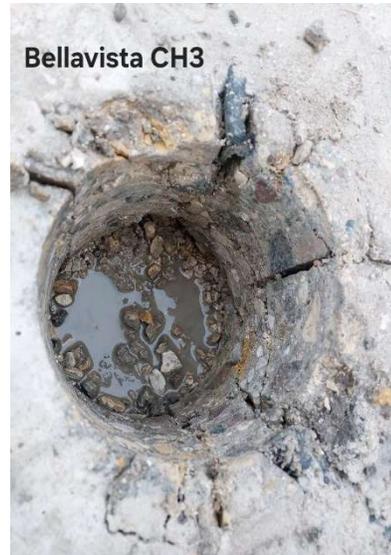
Core 3 - Site Photo

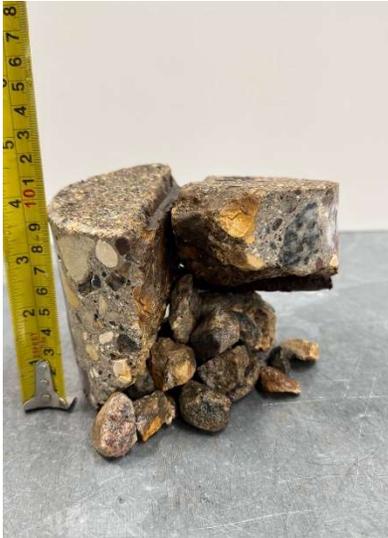
Core 1 - Poor Joint

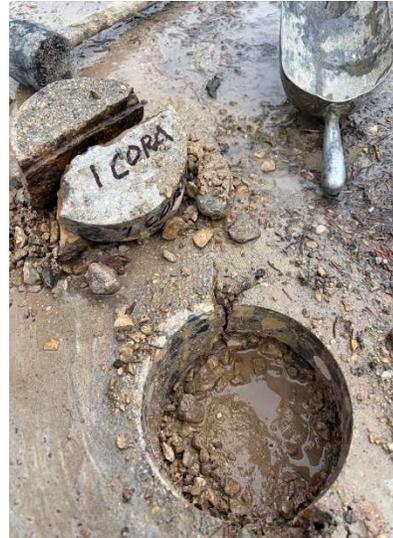
Core 1 - Site Photo

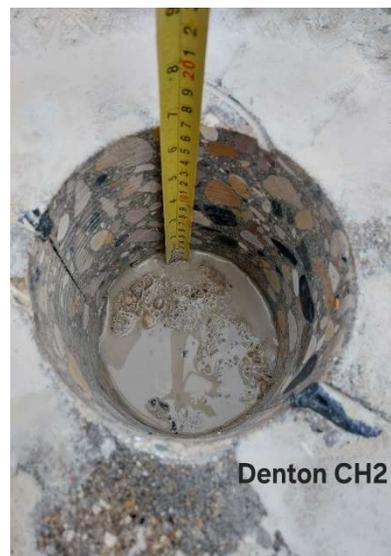
Core 2 - Site Photo

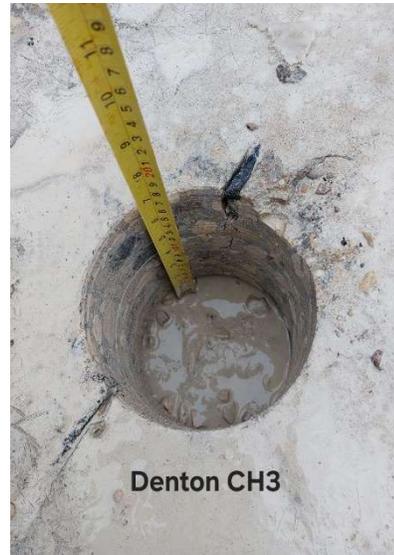
Core 3 - Site Photo

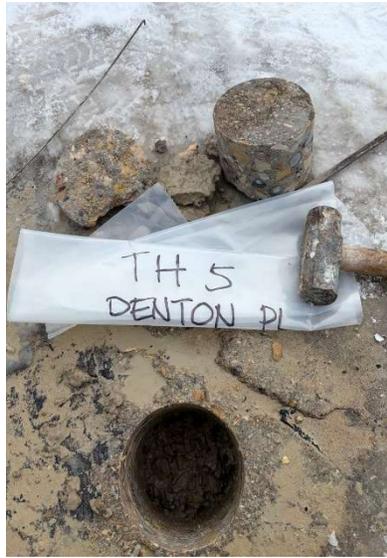
Core 5 - Site Photo

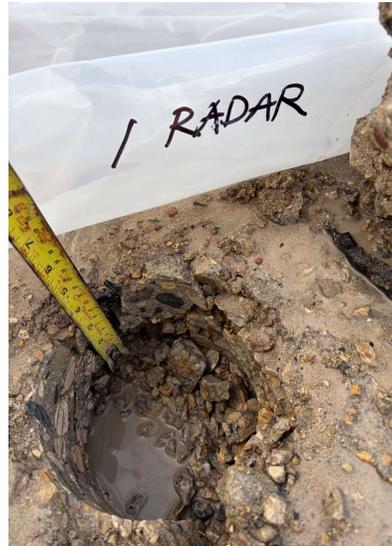
Core 1 - Poor Joint

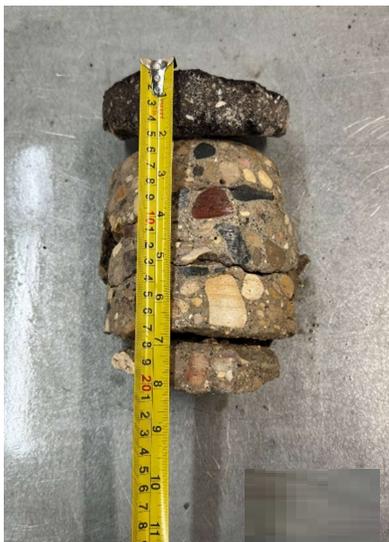
Core 2 - Poor Joint

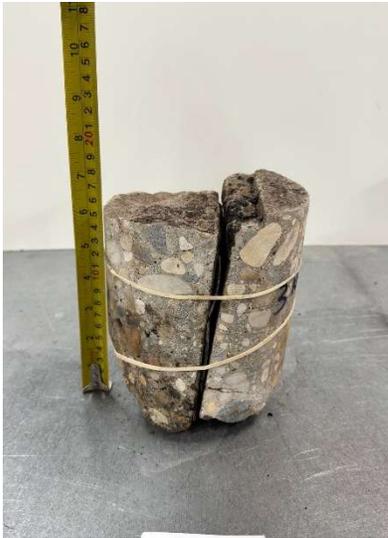
Core 3 - Poor Joint

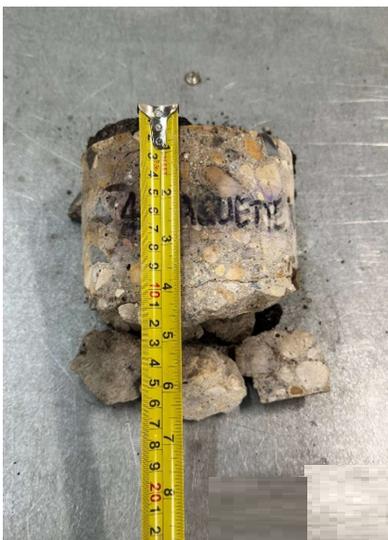
Core 4 - Poor Joint

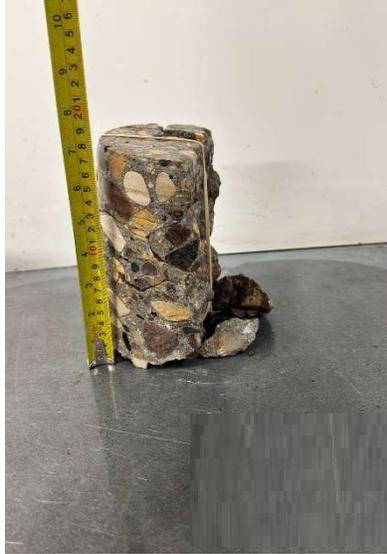
Core 5 - Poor Joint

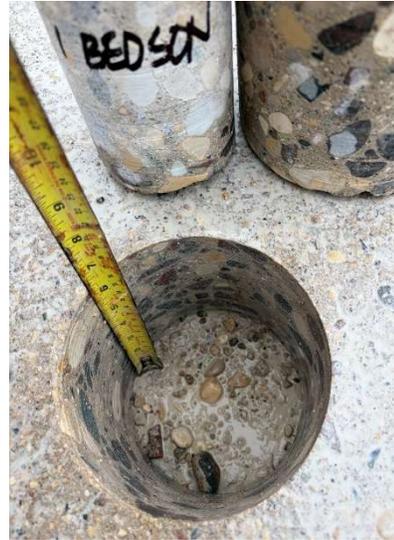
Core 1 - Site Photo

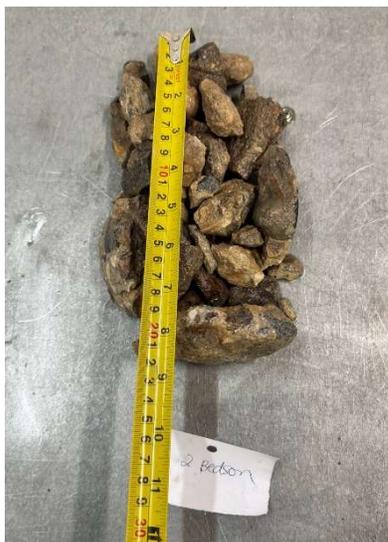
Core 2 - Poor Joint

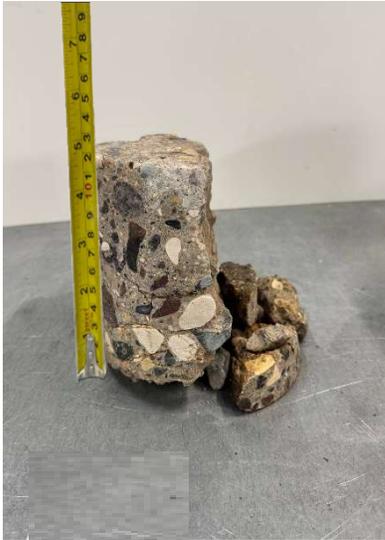
Core 3 - Poor Joint

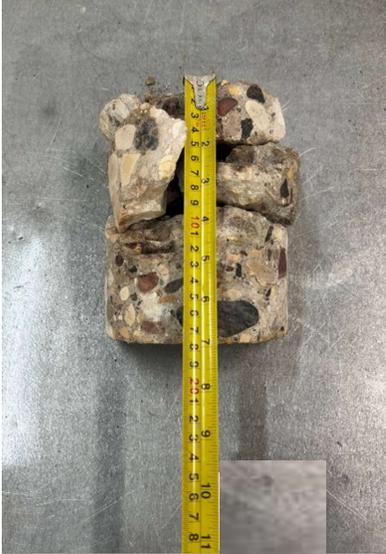
Core 5 - Poor Joint

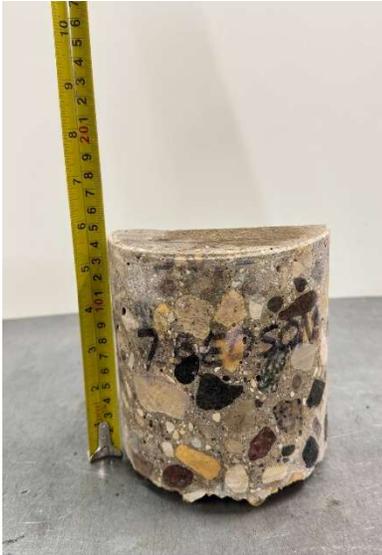
Core 7 - Poor Joint

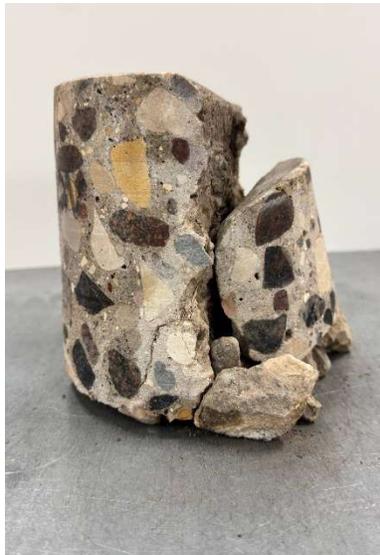
Core 7 - Side View

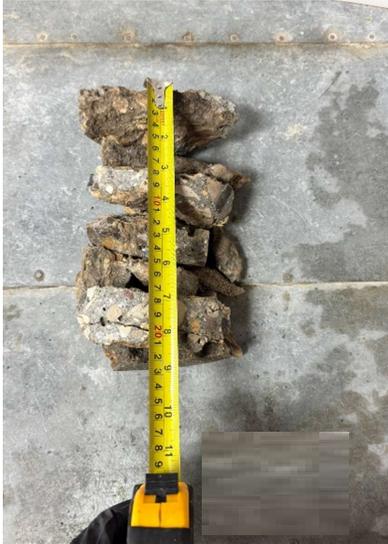
Core 1 - Poor Joint

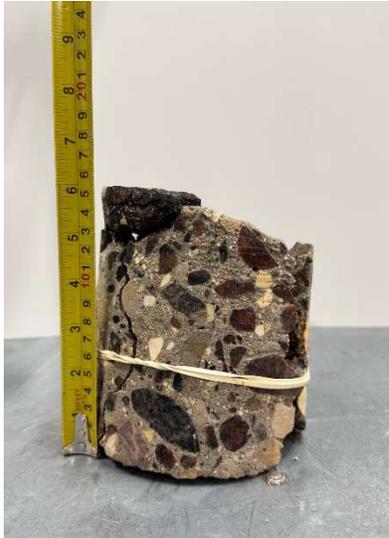
Core 1 - Poor Joint

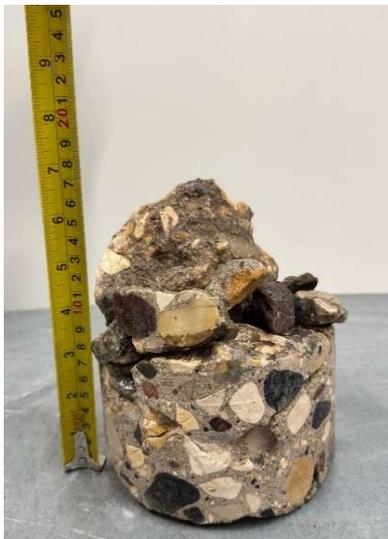
Core 2 - Poor Joint

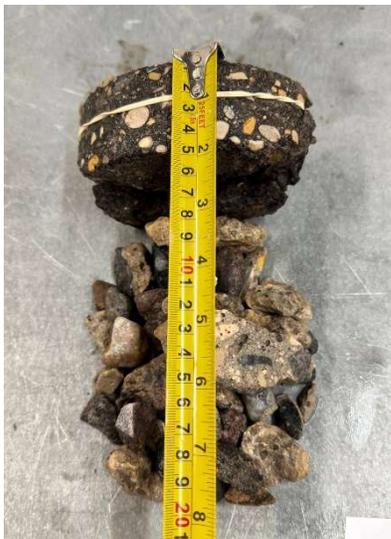
Core 2 - Poor Joint

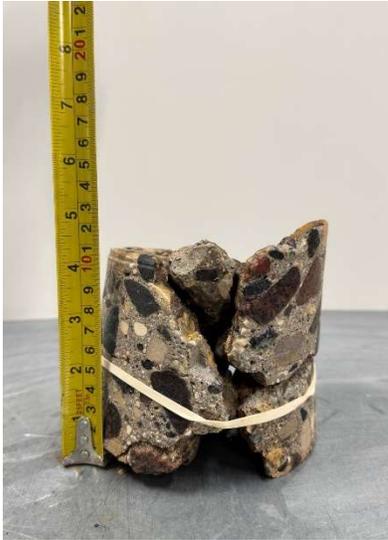
Core 1 - Poor Joint
