**September 2015**

# **Landfill Status Report for Closed Landfills Winnipeg, Manitoba**

**Submitted to:**  
City of Winnipeg

**Report Number: 1522283/1000**

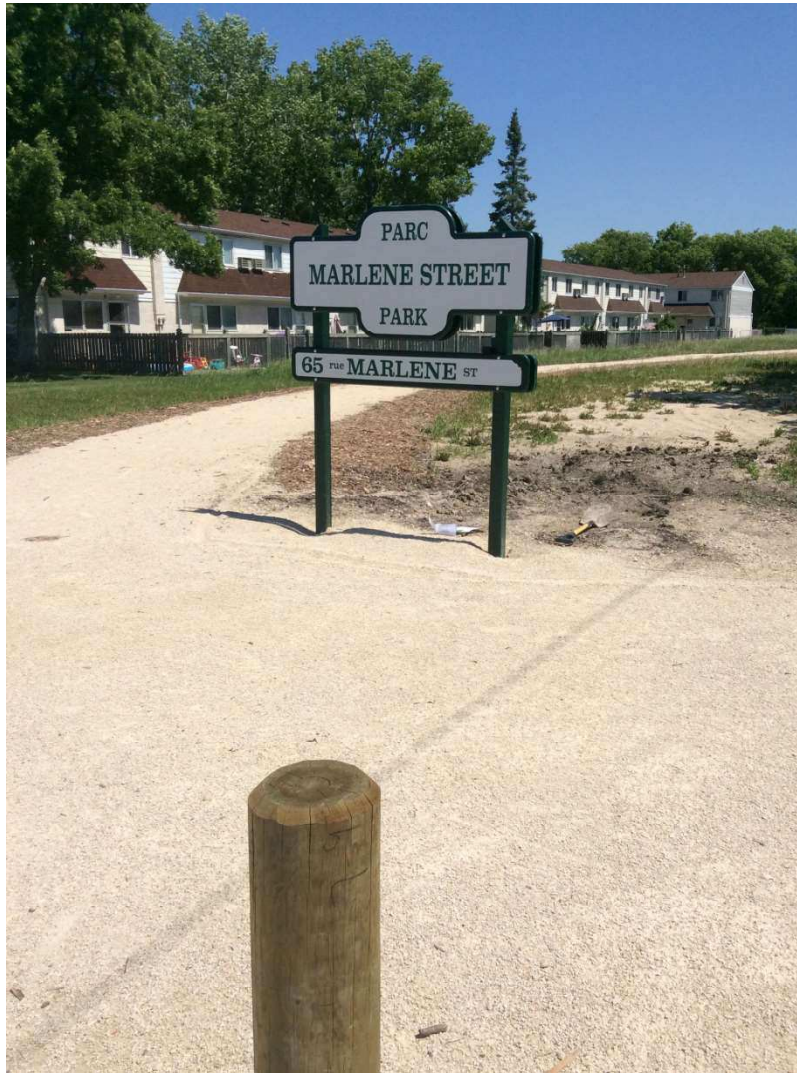
Photo A1  
Entrance to Dump Site off Marlene Street  
looking northeast

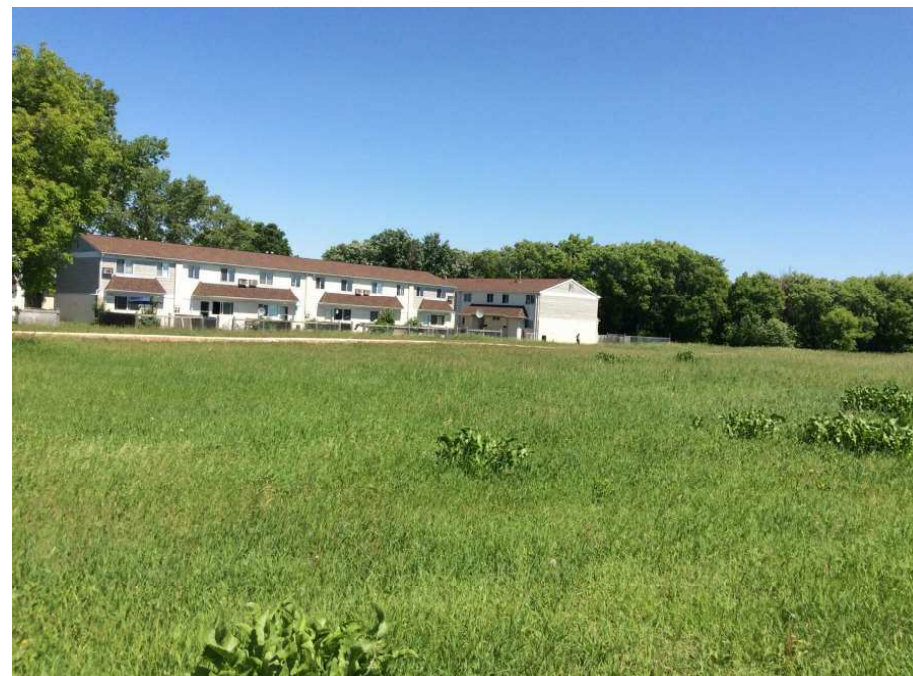
**Photo A4**  
Northern portion of the Dump Site  
looking north

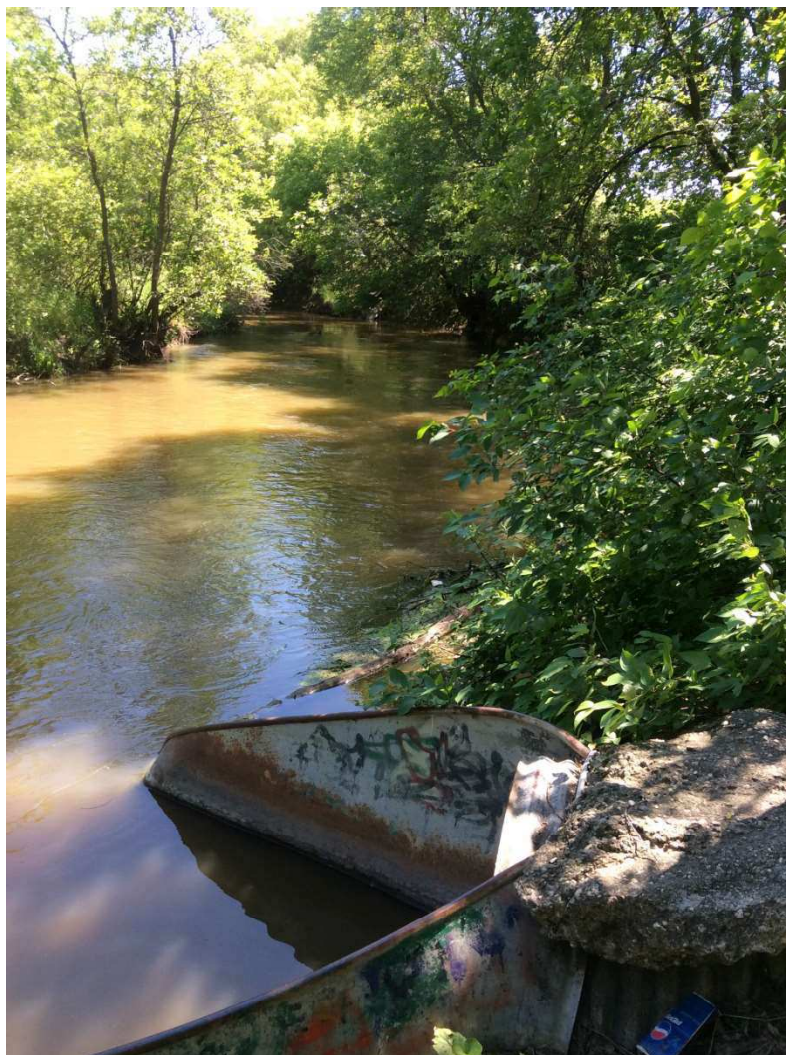
**Photo A5**  
**North side of Dump site looking east along  
the Seine River**

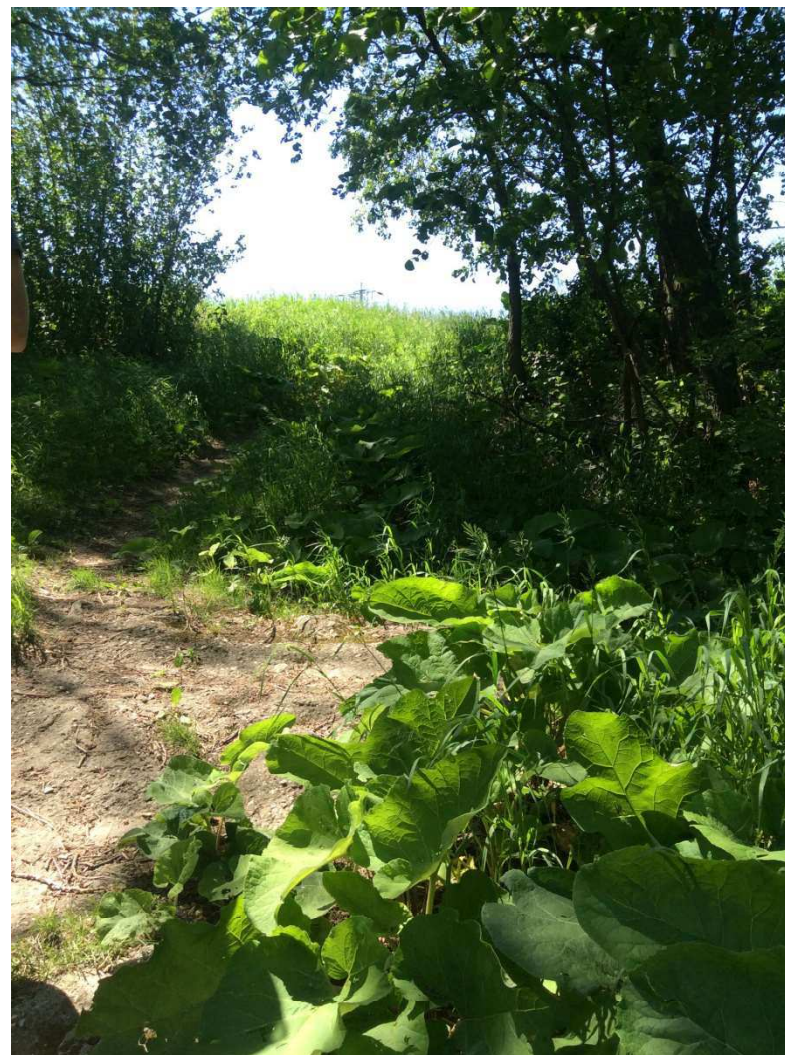
At the time of the Site visit, the Site was flat at the top of the landfill and sloped downward to the Seine River, which surrounds the Site on the north, east, and south sides. A residential development was noted to the west of the Site. The Site was mainly grass covered and treed in the buffer zones. Very little exposed debris was noted, although some debris could be seen at the southwest corner of the landfill as it slopes towards the river if the grass was removed. Previously exposed concrete debris noted along the slope to the Seine River was not readily evident.

**Photo A6**  
**North slope of landfill to Seine River looking  
south up the bank**

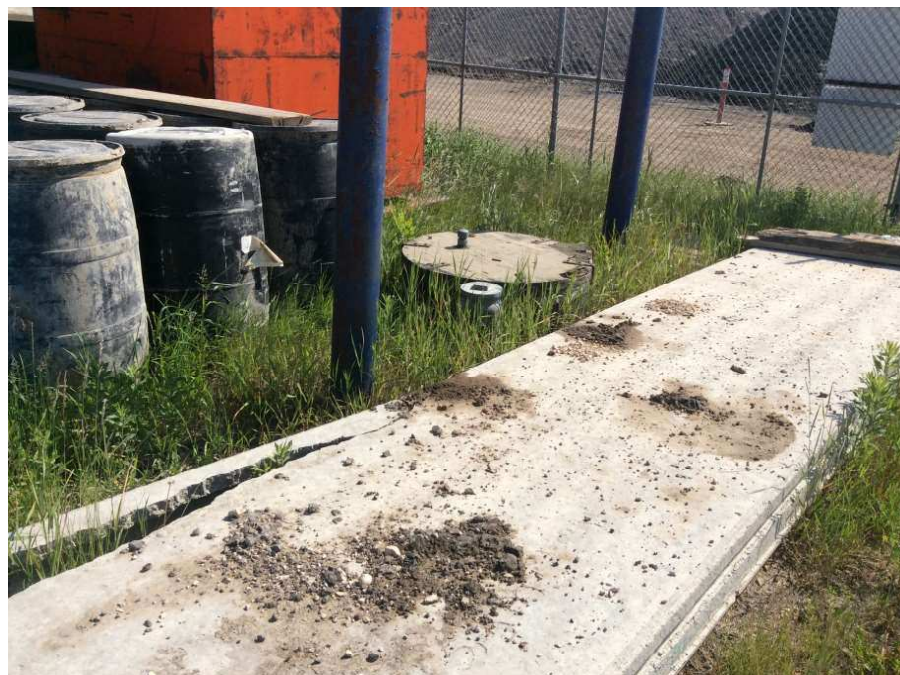
**Photo C2**  
**Manhole MH2 located within**  
**asphalt plant yard**

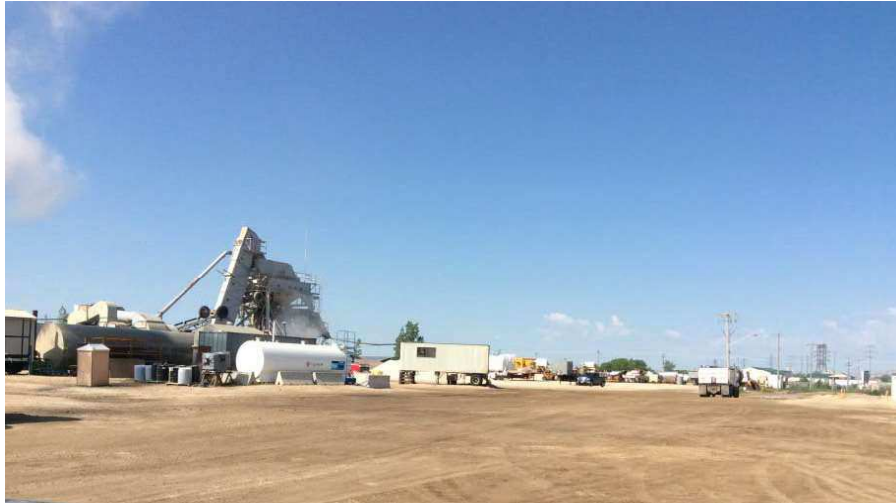
**Photo C3**  
**Asphalt plant at southwest portion of Site**

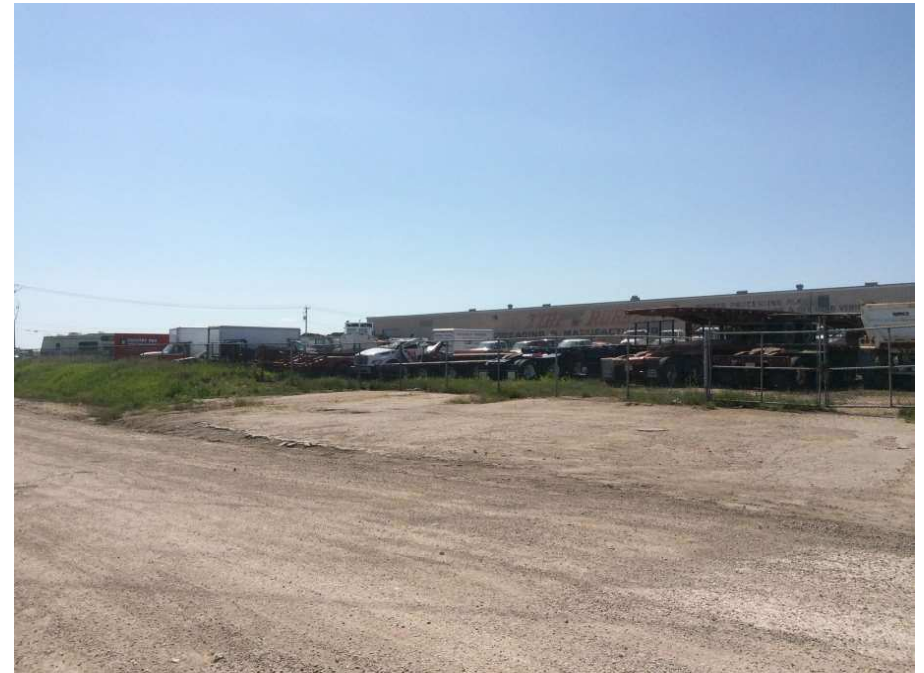
**Photo C4**  
**Storage building east of  
 Lagimodiere Boulevard**

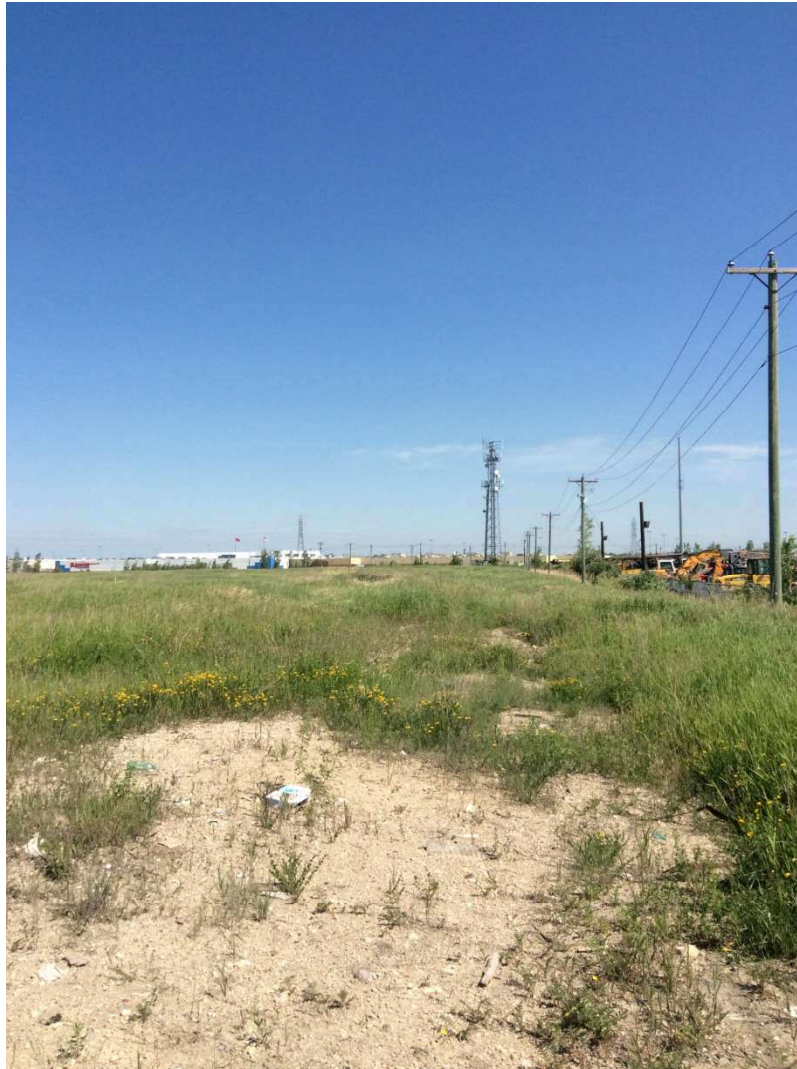
**Photo D1**  
**Looking north across the Site**  
**at the eastern edge**

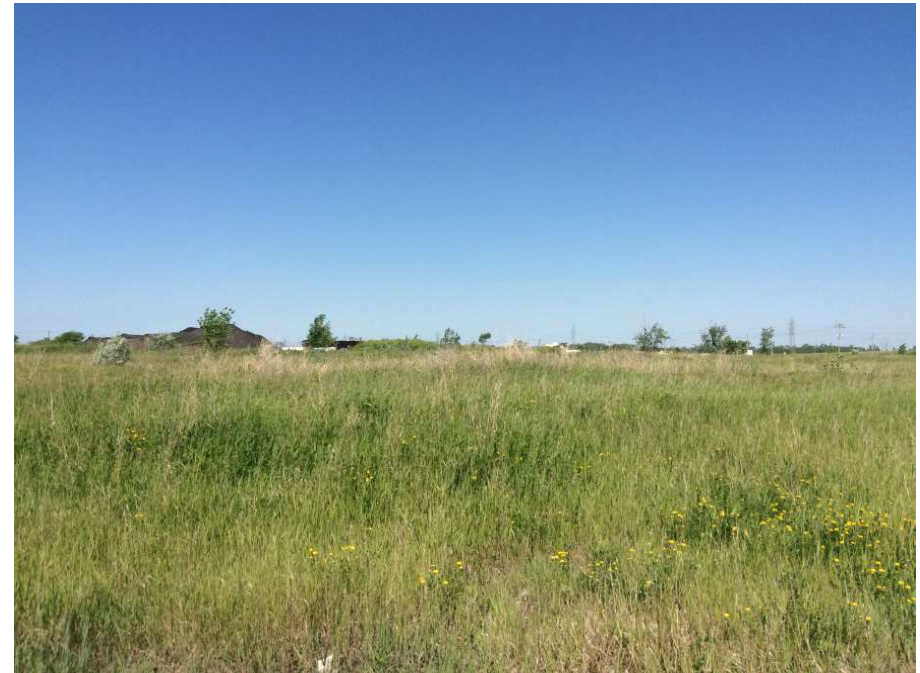
**Photo D2**  
**Looking west across the Site**

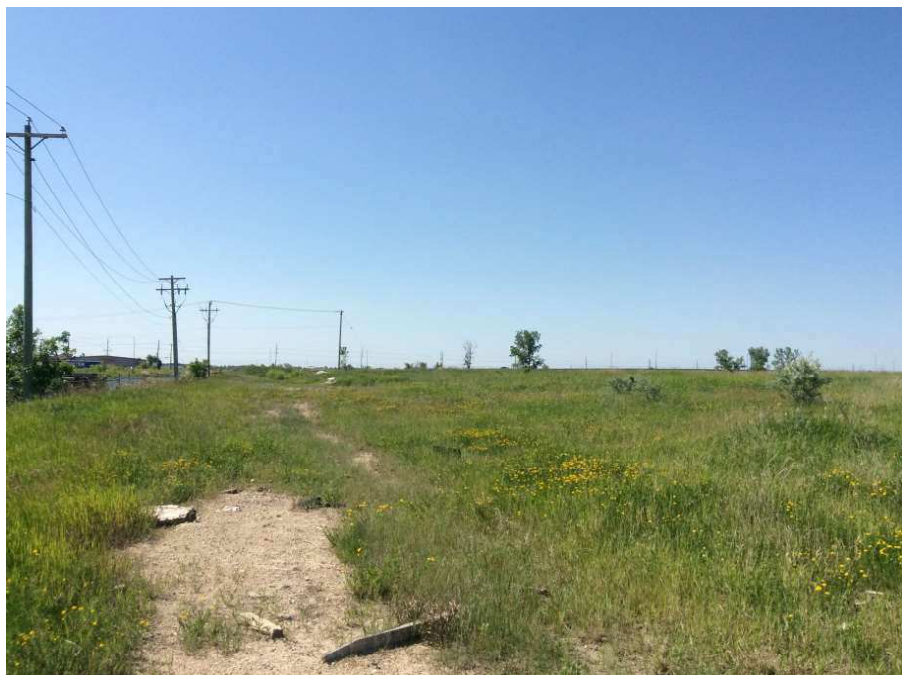
**Photo D3**  
Looking south across the Site  
at the eastern edge

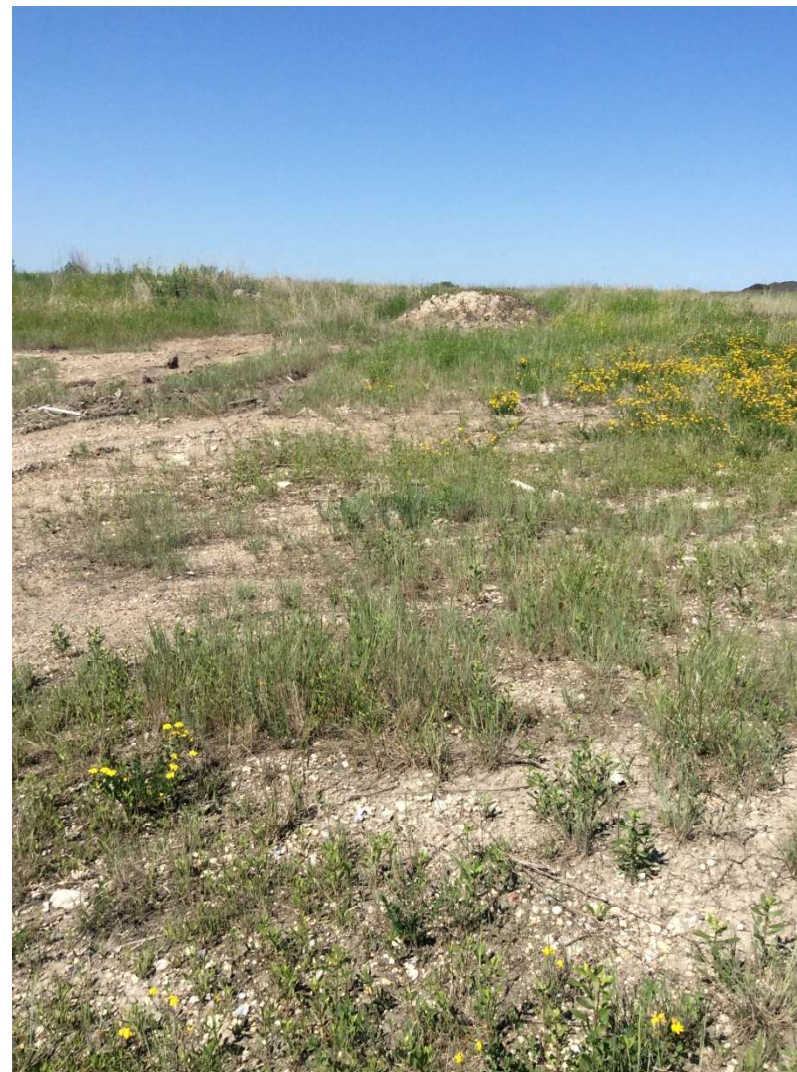
**Photo D4**  
Stressed vegetation and/or presence of fill

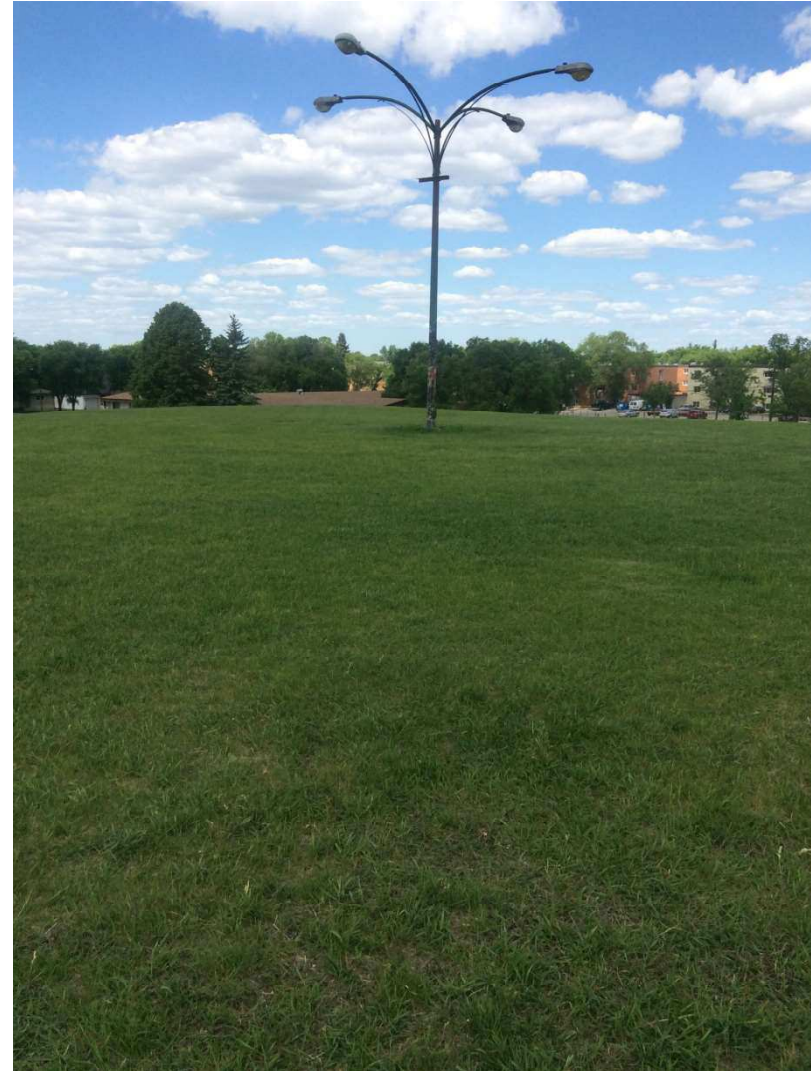
**Photo E2**  
**Top of Redonda Dump, looking northwest**  
**Note: light standard at center of Site**

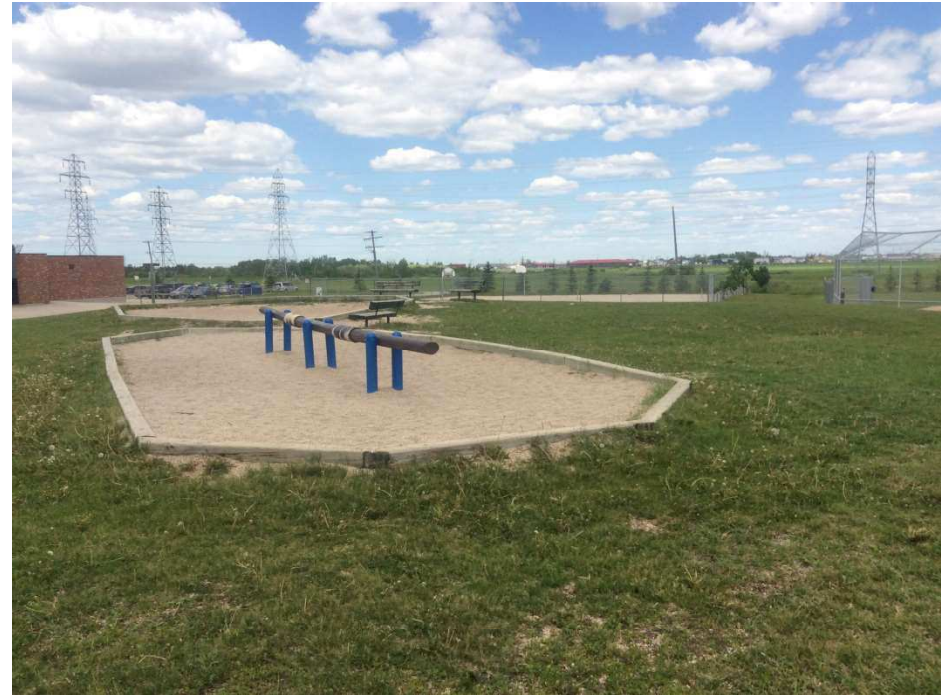
**Photo F2**  
**Top of waste mound at Redonda Landfill,  
 east of the school looking northwest**  
**Note: Hydro lines in the background**

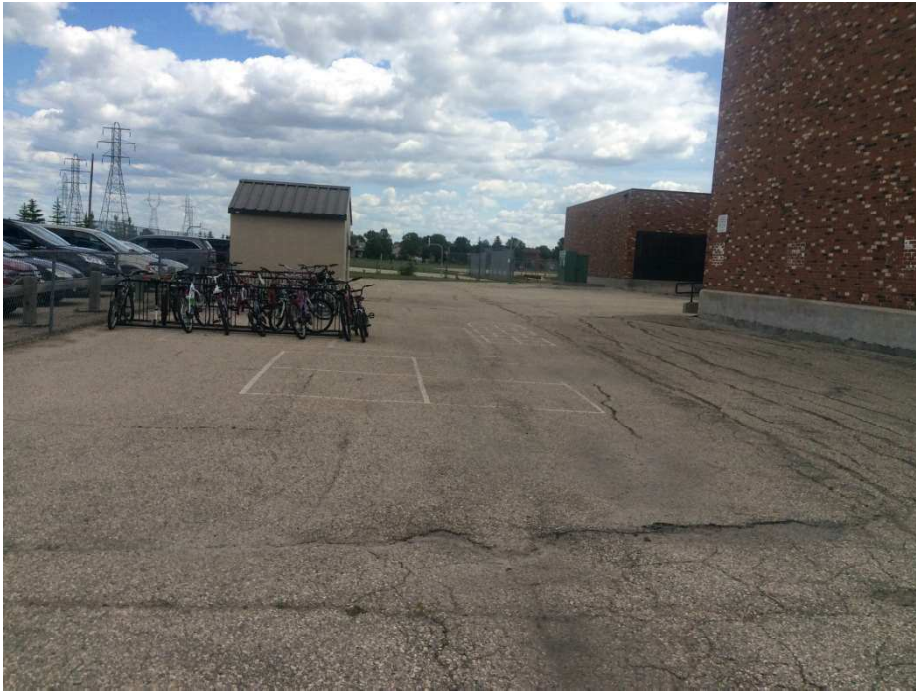
**Photo F5**  
**North side of building between parking area and  
 school looking east**

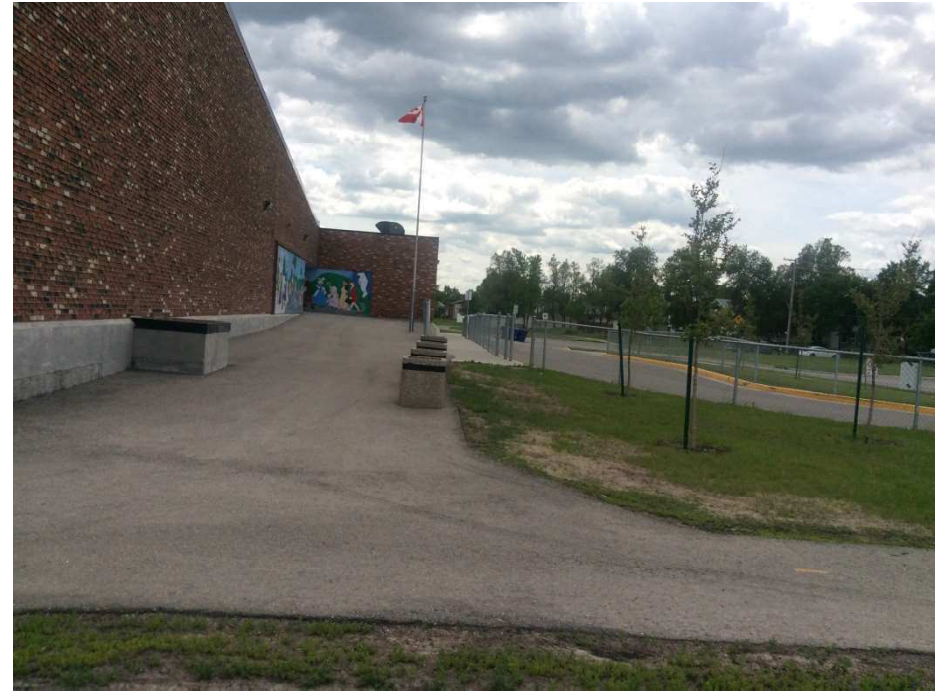
**Photo F6**  
**West side of school looking south**

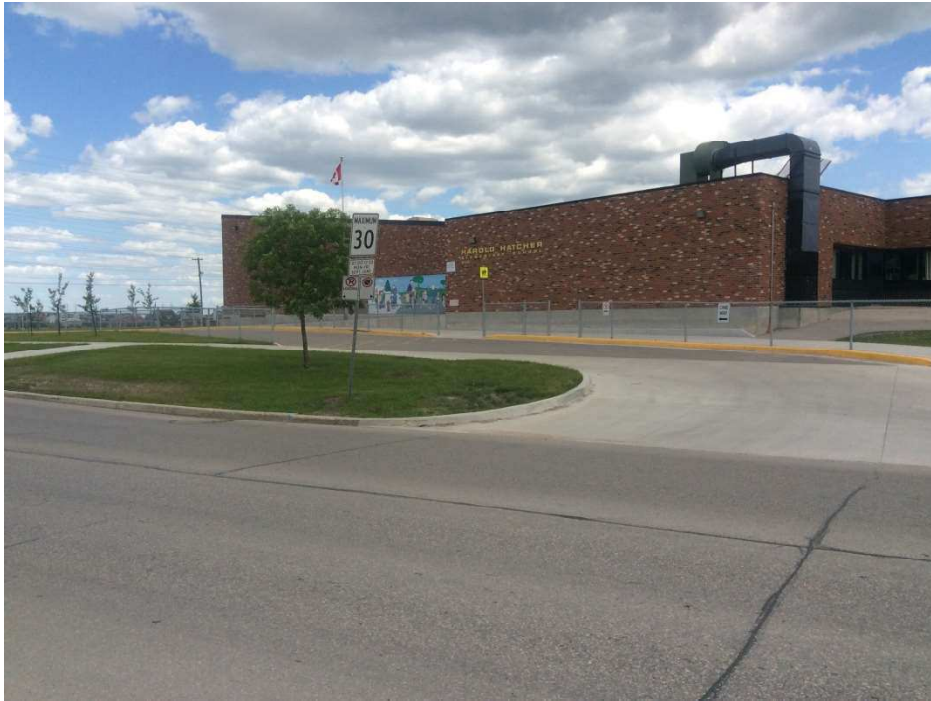
**Photo F7**  
**West side of school looking east from the**  
**west side of Redonda Street**

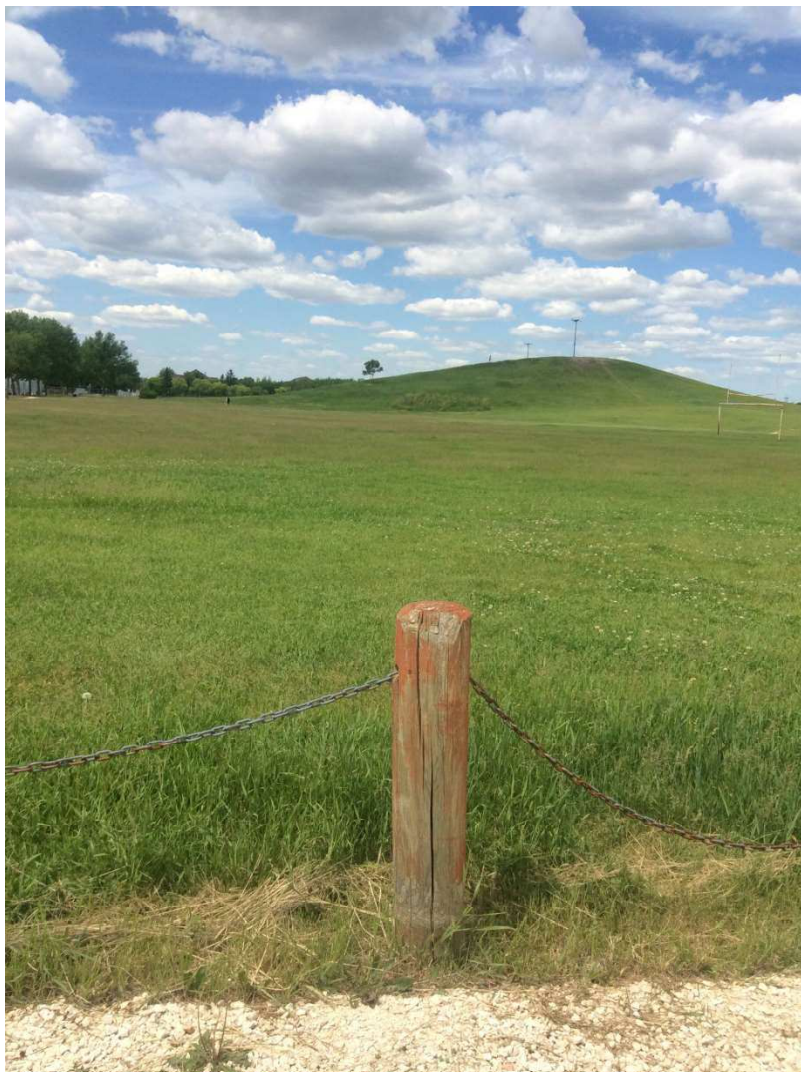
**Photo G1**

**Facing west across Site from parking lot at arena**

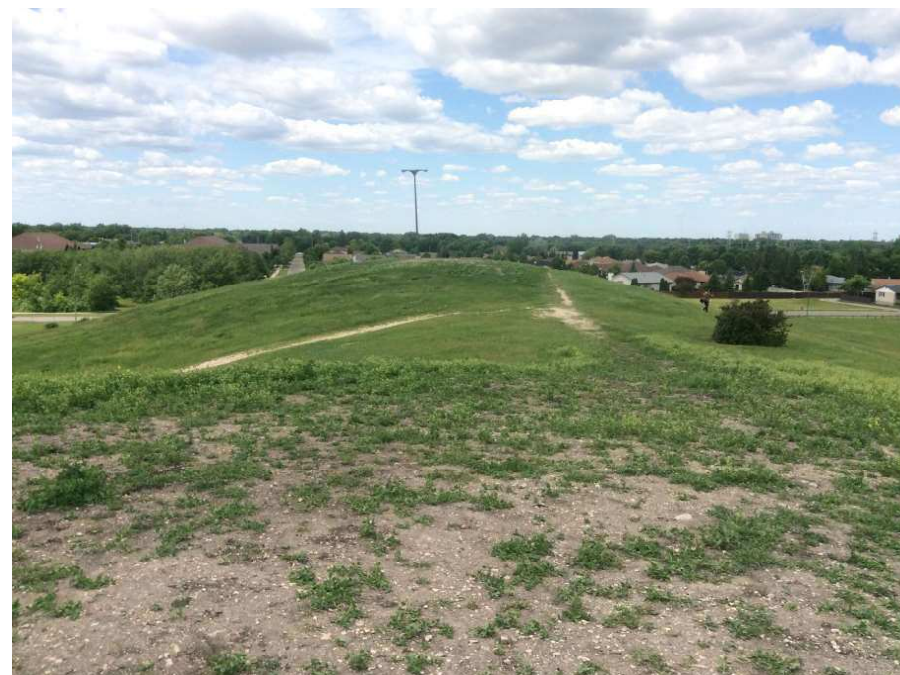
**Photo G2**

The Site was mainly grass covered and the grass was well maintained. Stressed vegetation was noted at the top of the waste mounds. No exposed waste was observed but the City staff noted that occasionally buried waste breaks the ground surface. No debris or dumping was noted. The Site was formerly used as a leaf and yard waste depot but signs have been installed advising people they are not to leave this type of waste at the Site anymore.

**Top of eastern waste mound facing west.  
Stressed vegetation visible in foreground**

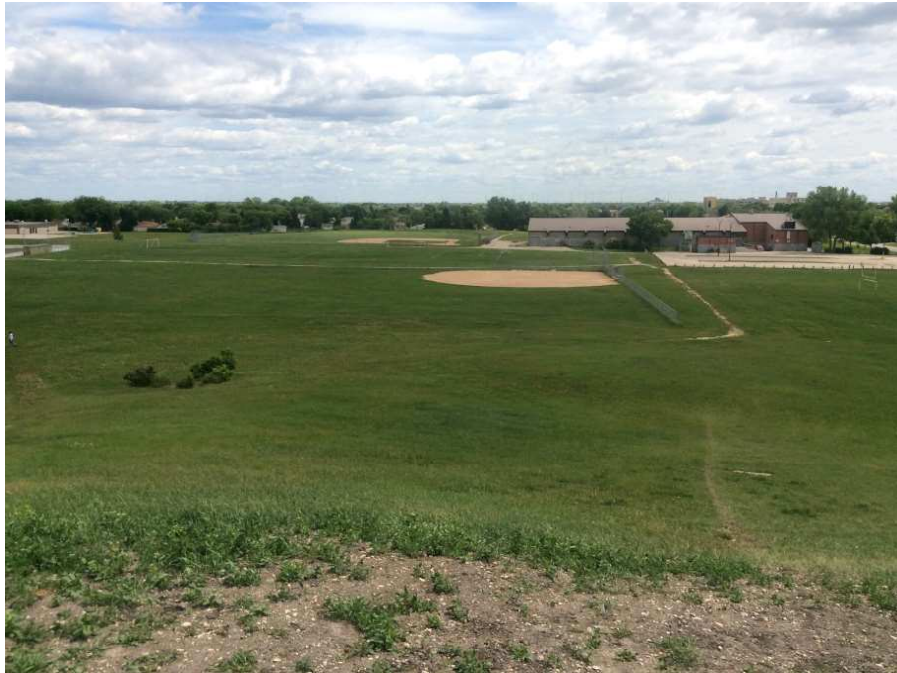
**Photo G3**  
**View of Site from waste mound facing east.**  
**Arena visible**

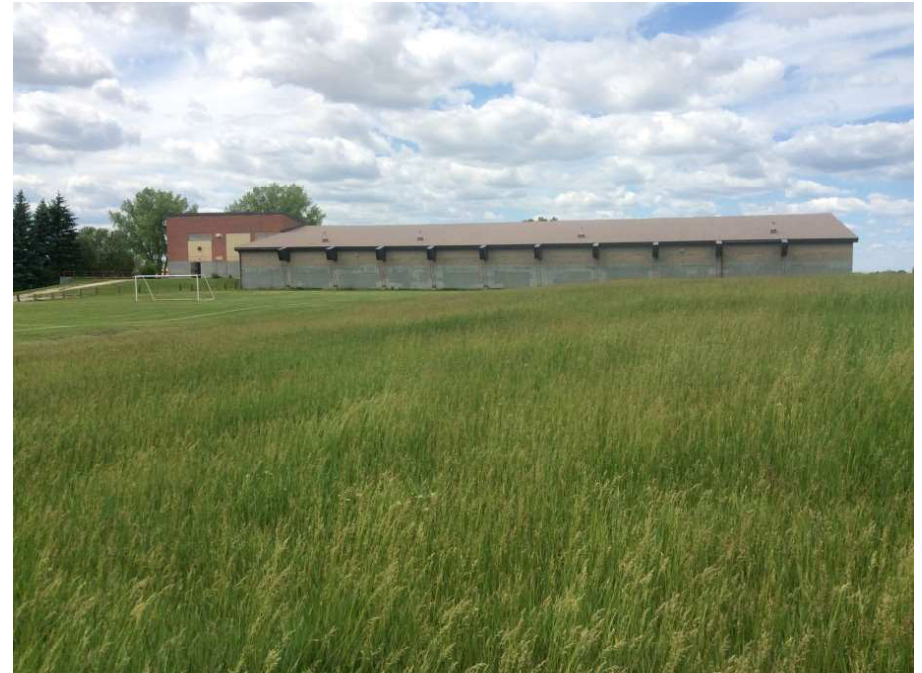
**Photo G4**  
**View from east end of the Site looking west**  
**towards arena**

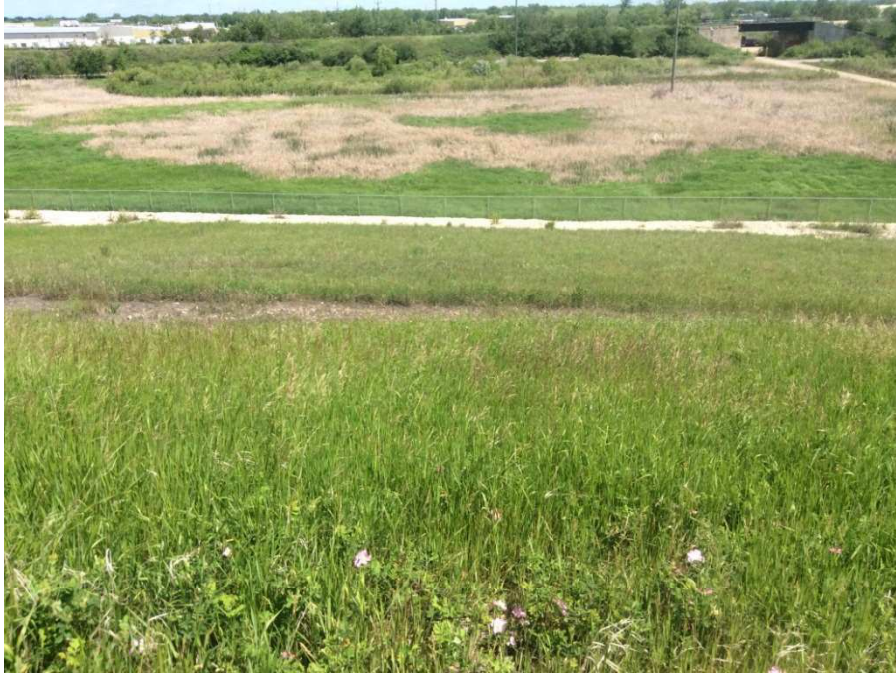
**Photo H1**  
**Neighbouring property to the north looking north**  
**from the top of the landfill**

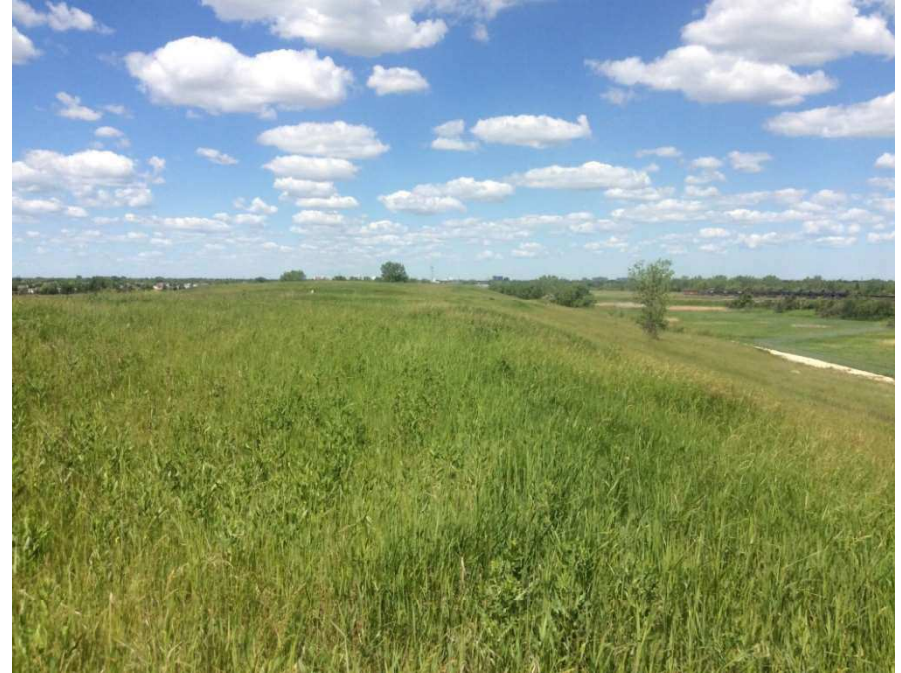
At the time of the Site visit, the Site contained slopes with settling evident at the top of the waste fill area. The slopes were not smooth and erosion was noted, specifically on the north and east sides. Generally no exposed debris was noted. A chair was noted. The Site has been fenced due to unauthorized recreational off-road use by the public. A hydrogen sulphide odour was noted near the leachate drain, which consists of vertical drains, installed to reduce mounding and installed at the southwest limit of the landfill. No buildings or landfill gas migration barriers were present on-Site. Stressed vegetation and bare areas were noted in the southern and eastern portions of the landfill. A ditch surrounds the landfill and a wetland area is present to the north.

**Photo H2**  
**Top of Cordite Road Landfill, looking west along**  
**the top of the waste fill area**

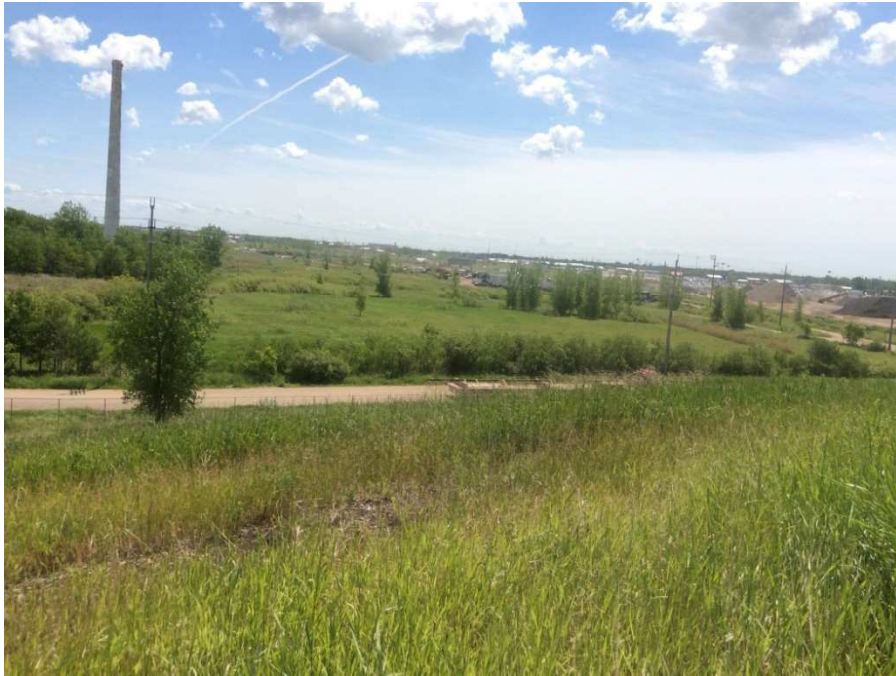
**Photo H3**

**View looking southeast from the east slope of the landfill Note: Chimney stack**

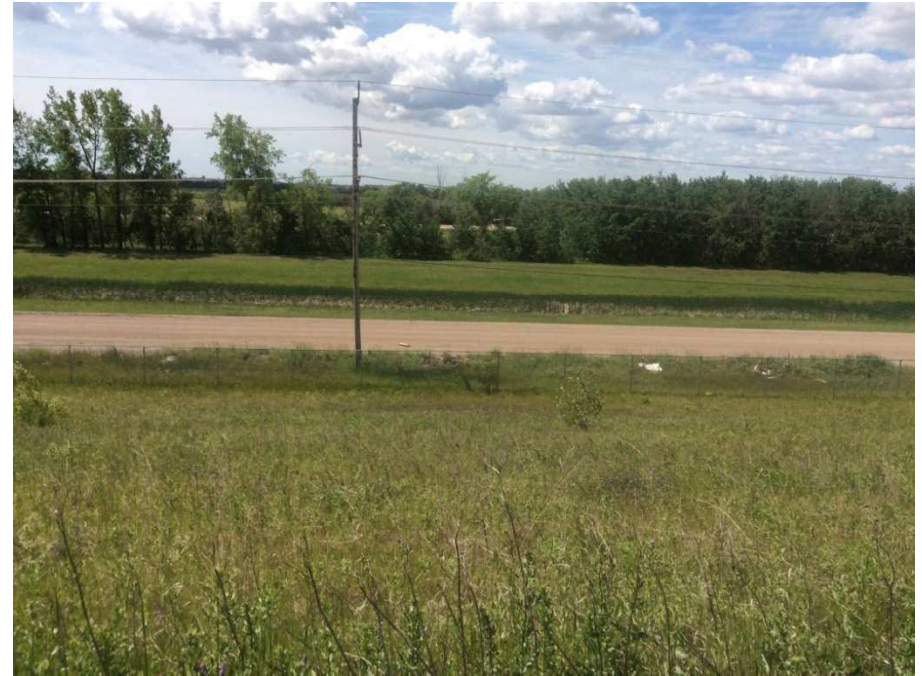
**Photo H4**

**View looking south from the south slope of the landfill**

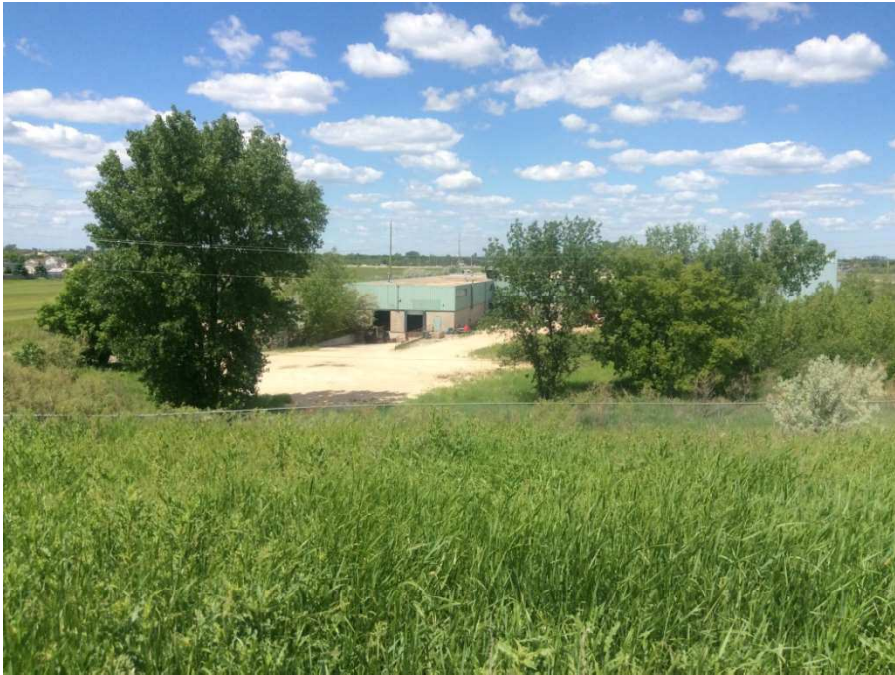
**View looking west from the west slope of the landfill**  
**Note: Industrial property (165 Cordite Road)**

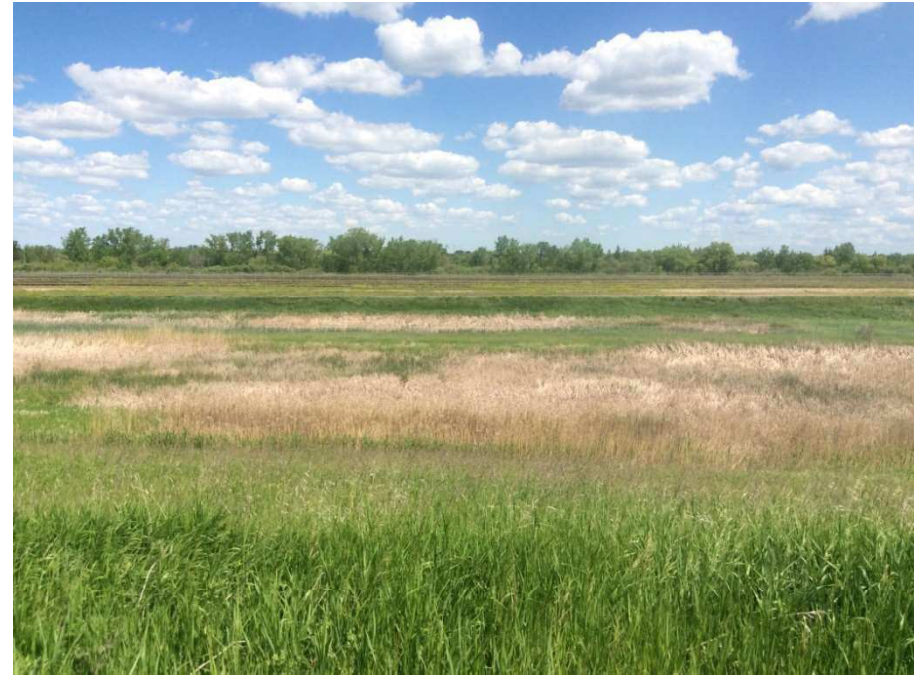
**View looking north from on top of landfill**  
**Note: Wetland with a rail line beyond**

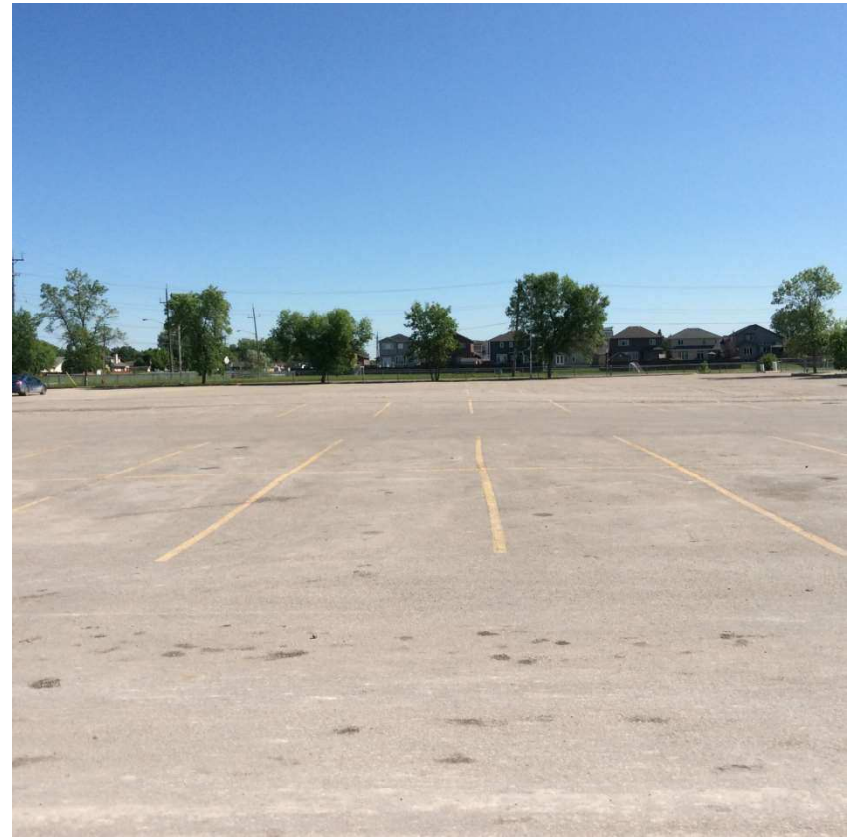
**Photo I2**

**Paved parking area to the west of the community centre building, looking north from west side of the outdoor rink**

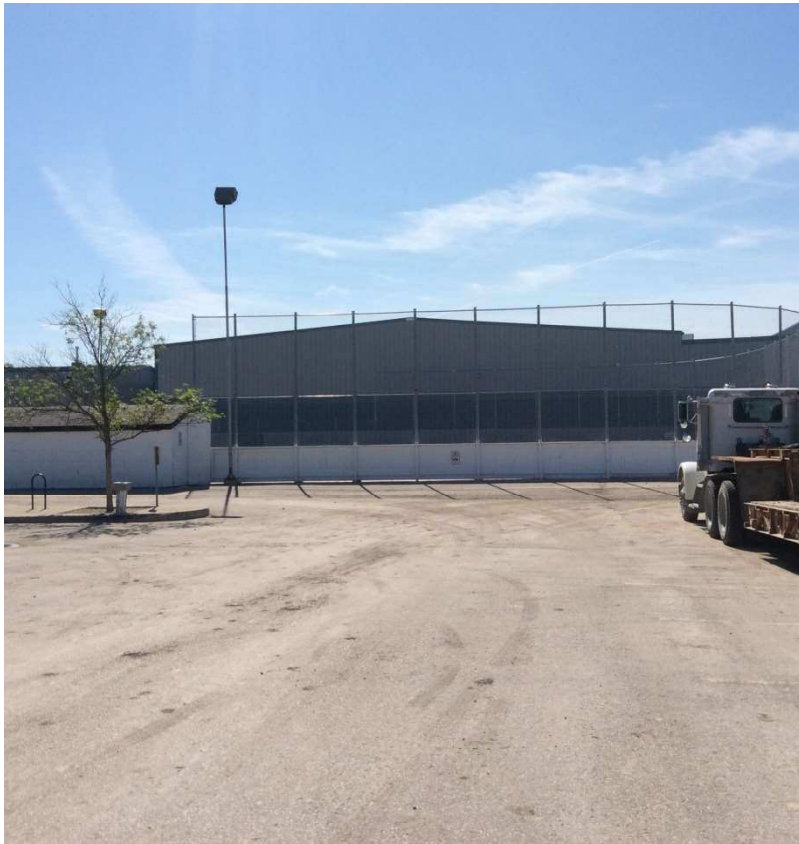
**Photo I3**

**Gateway Community Centre building looking east**  
**Note: outdoor rink in the foreground**

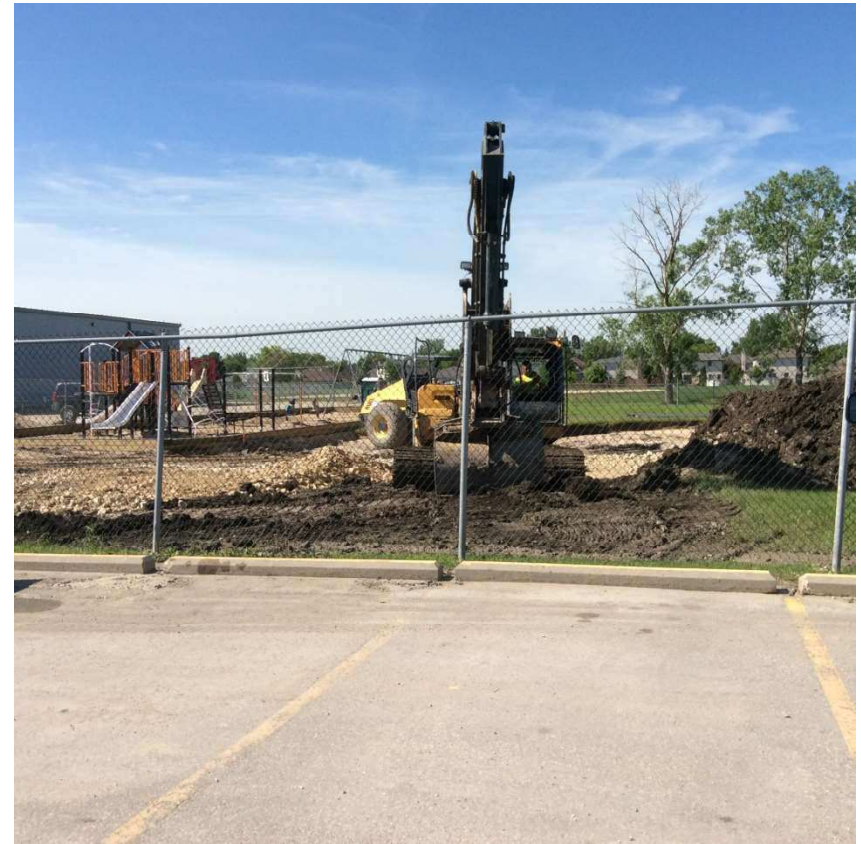
**Photo I4**

**Playground, looking south from the parking lot,**  
**west of the outdoor rink**

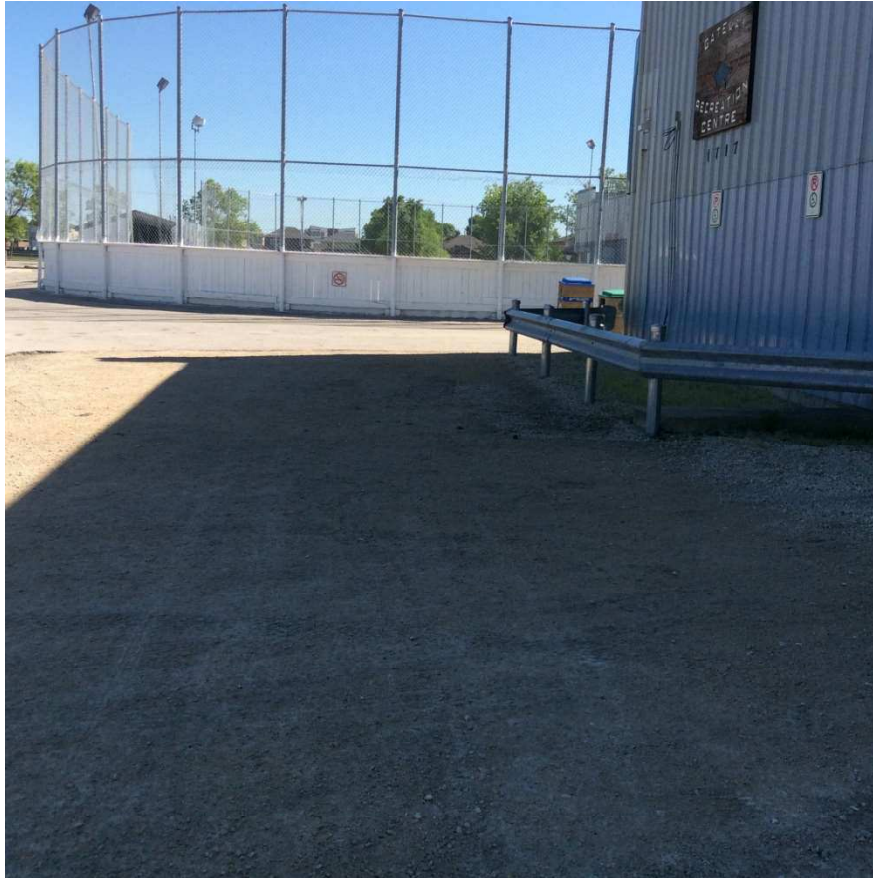
**Photo I5**  
**West side of community centre building,**  
**looking north**

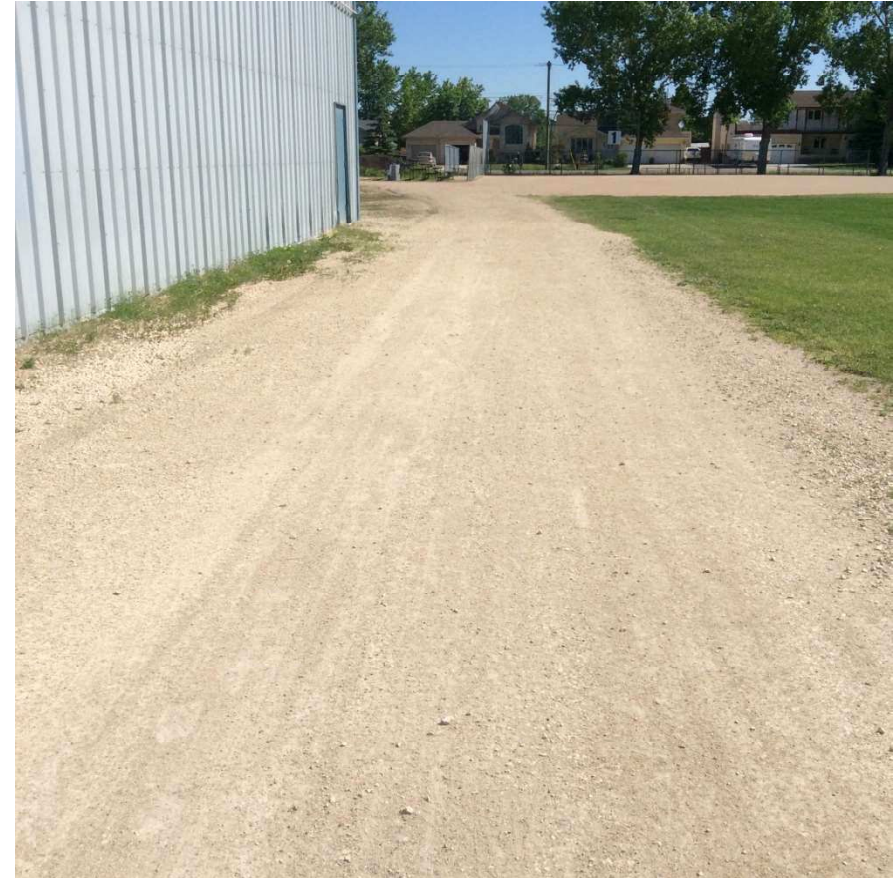
**Photo I6**  
**Northeast corner of community centre building,**  
**looking north**  
**Note: baseball diamond in the background**

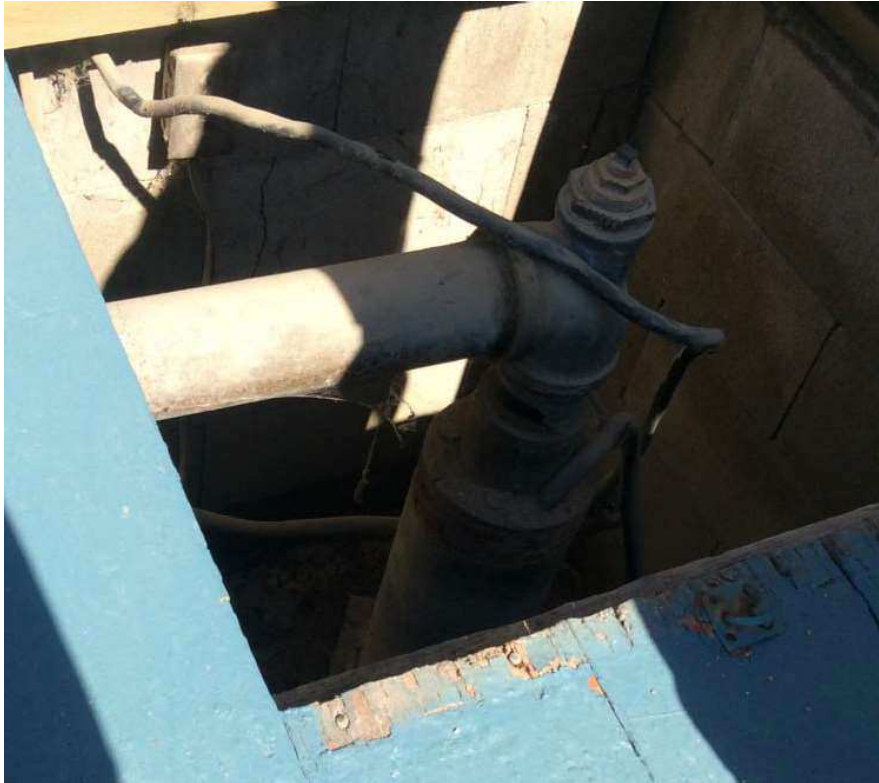
**Photo I7**  
**On-Site well used for outdoor rink**
