**September 2015**

# **Landfill Status Report for Closed Landfills Winnipeg, Manitoba**

**Submitted to:**  
City of Winnipeg

**Report Number: 1522283/1000**

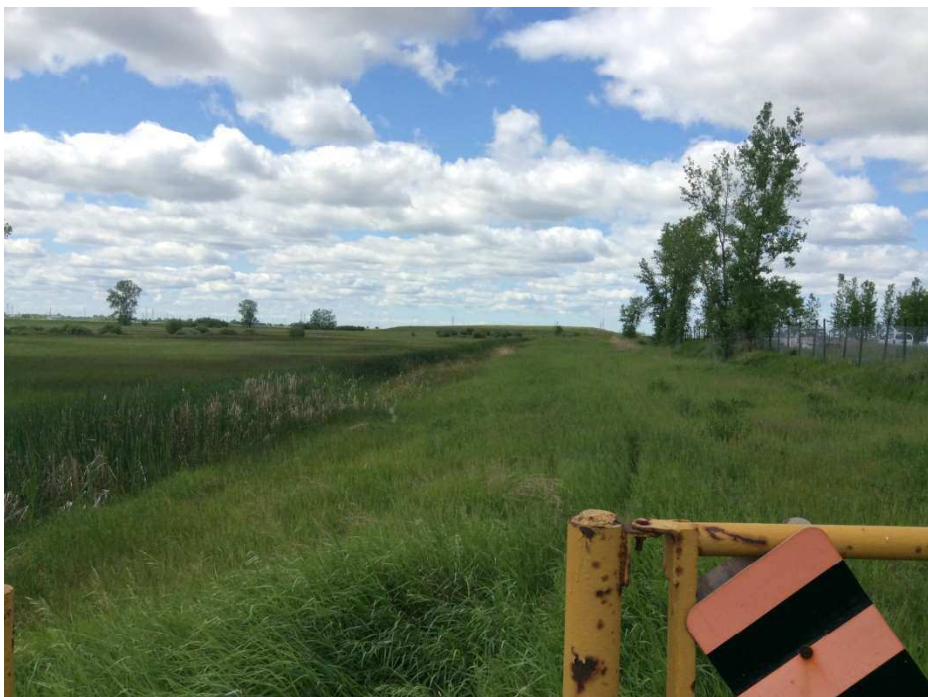
**Photo J1**

**View of Site looking west**

**Note: ditch in the foreground and a fence on the right side of the photograph**

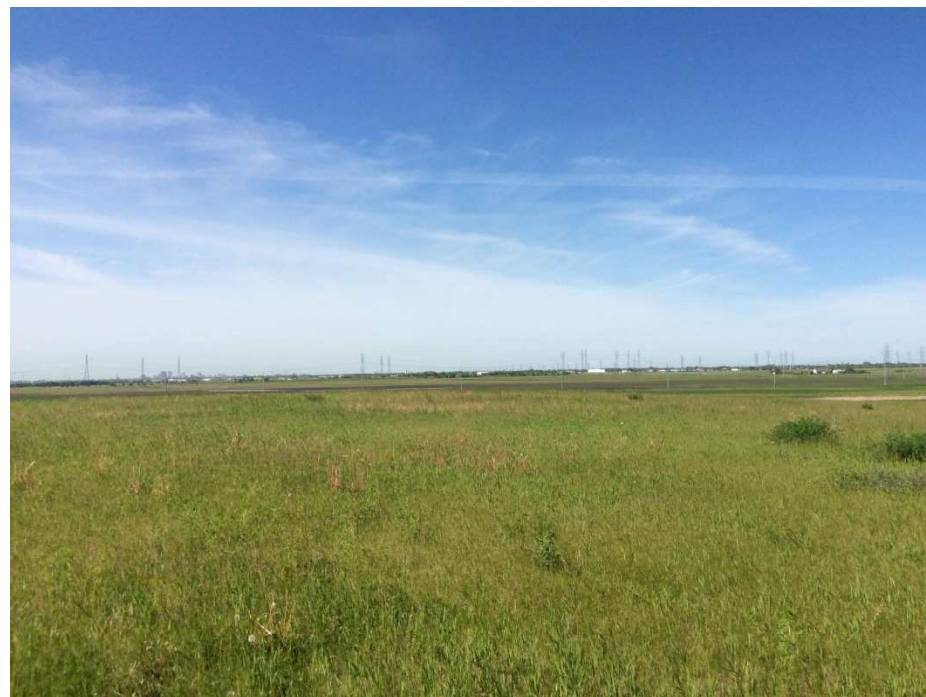
**Photo J2**

**View looking southeast from the Site**

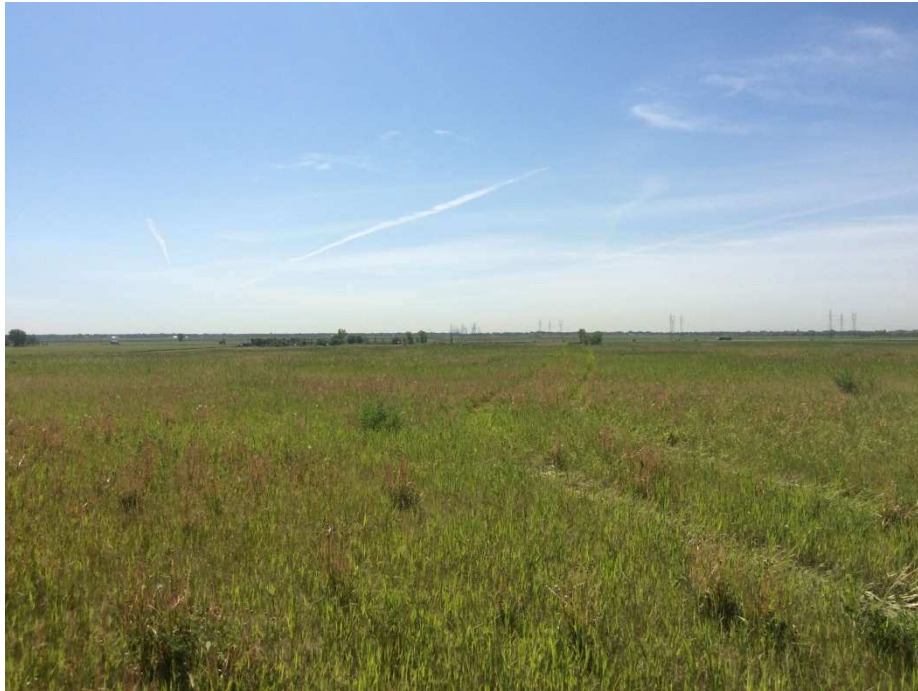
**Photo J3**  
View looking west from the Site

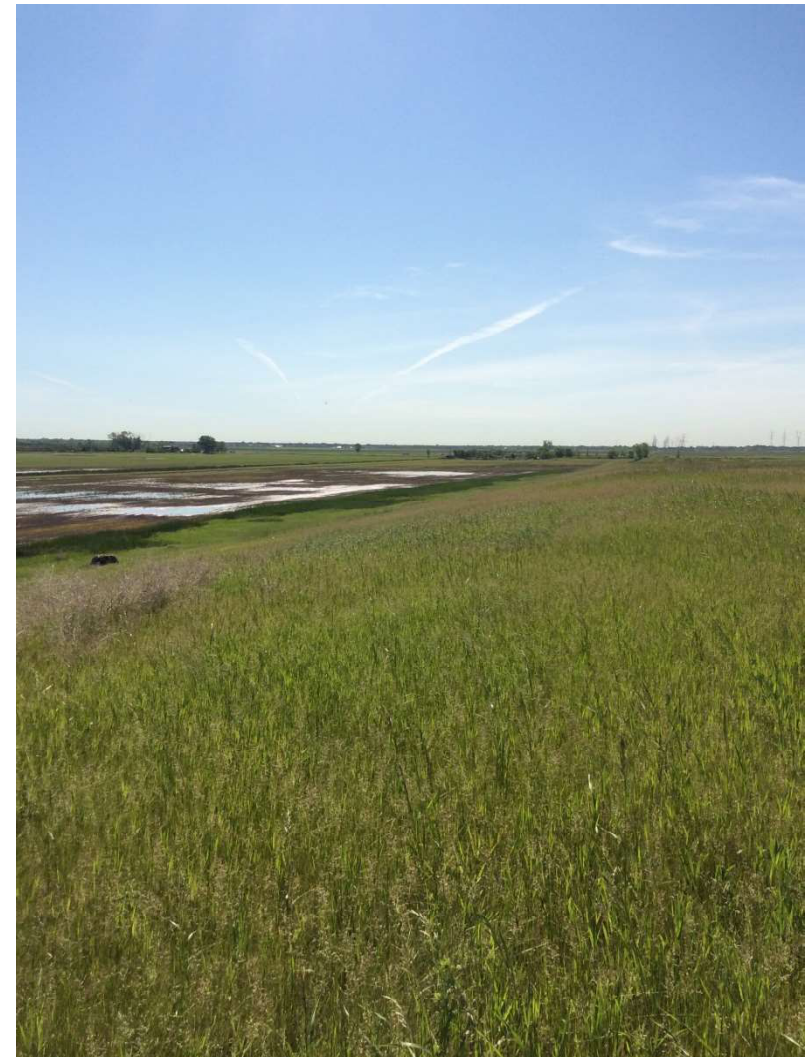
**Photo J4**  
View looking northeast from the  
west end of the Site

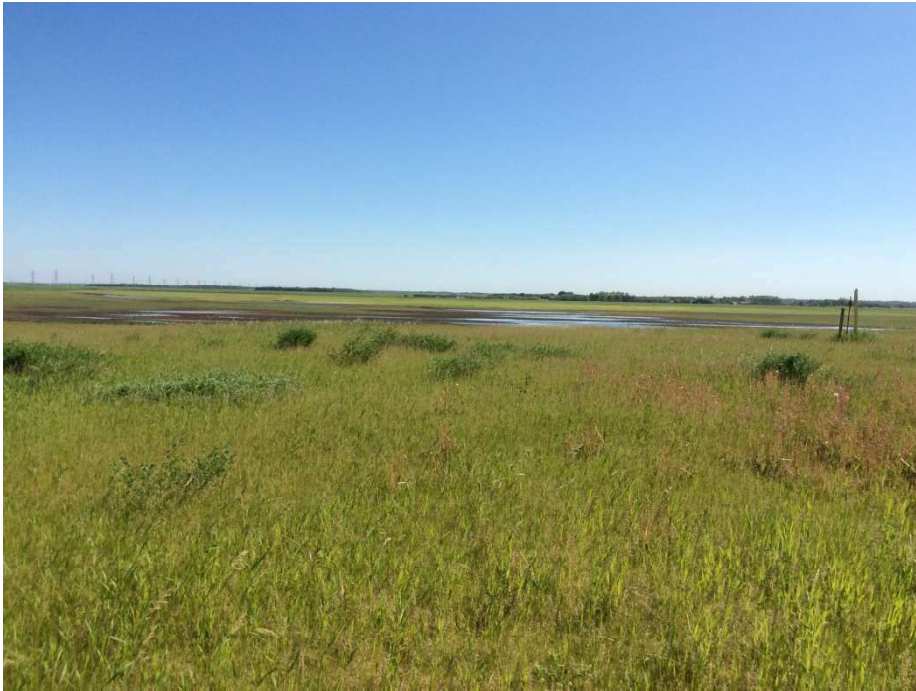
**Photo J5**  
**View looking north from the Site**

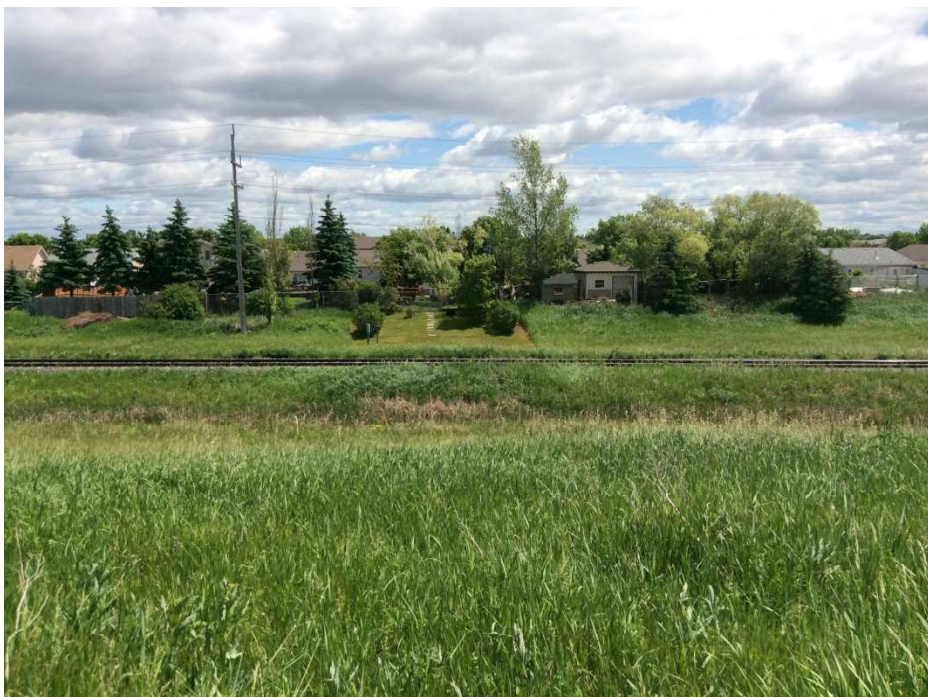
**Photo K1**

**Neighbouring property to the east looking east**  
**Note: rail line in the foreground, with residential properties beyond**

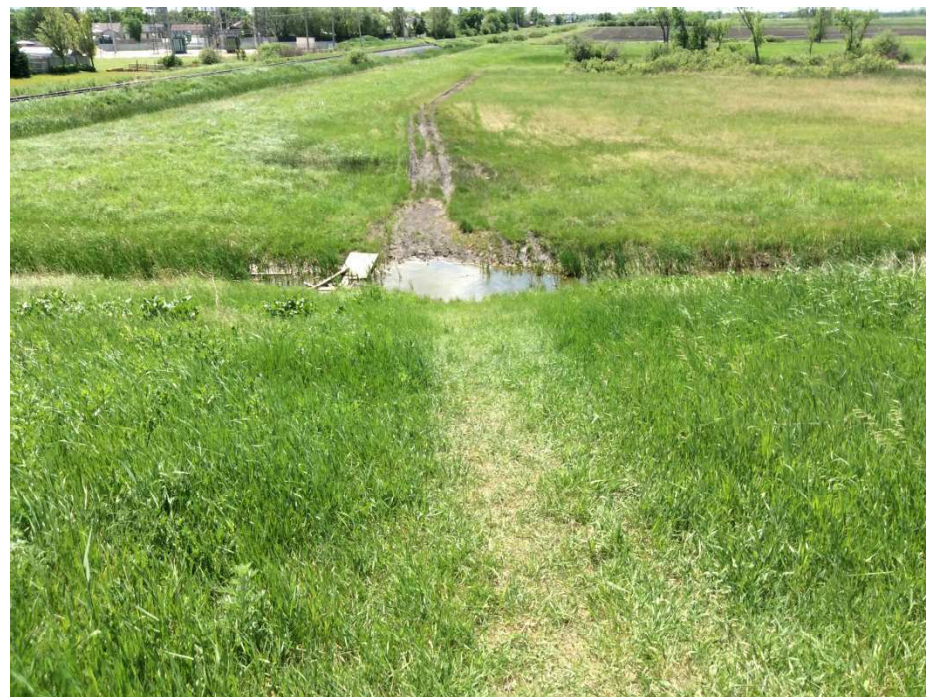
**Photo K2**

**Drainage ditch to the south of the landfill**  
**looking south**

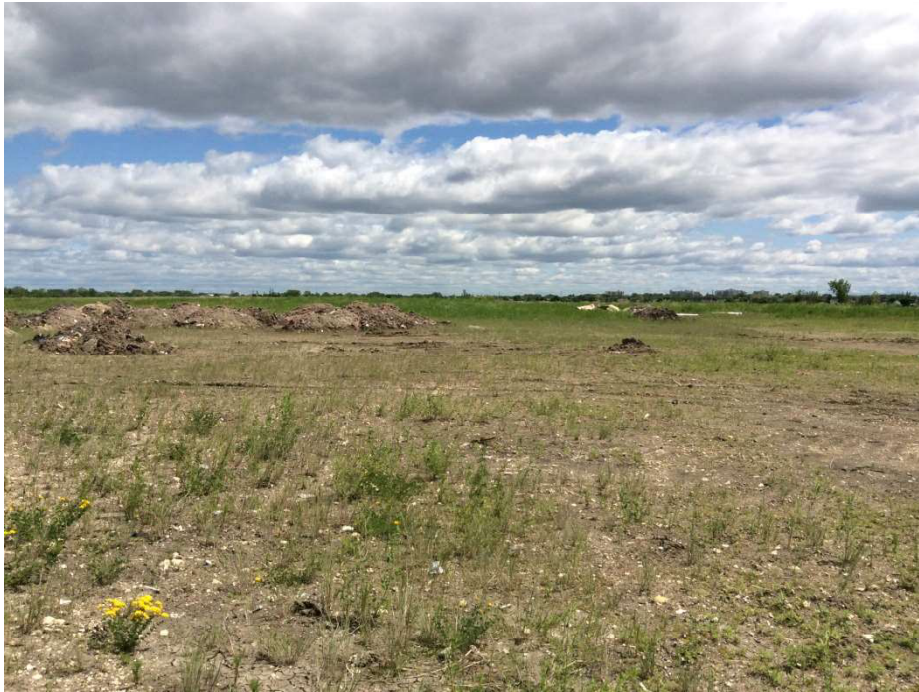
**Photo K3**

**View looking west at the west side of the landfill**  
**Note: fill dumping area**

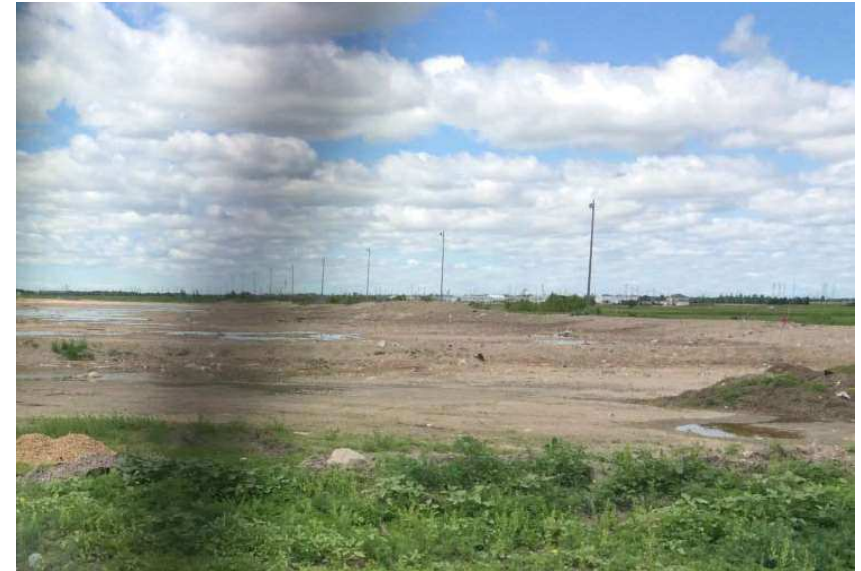
**Photo K4**

**View looking west at the snow dump from the west side of the landfill**

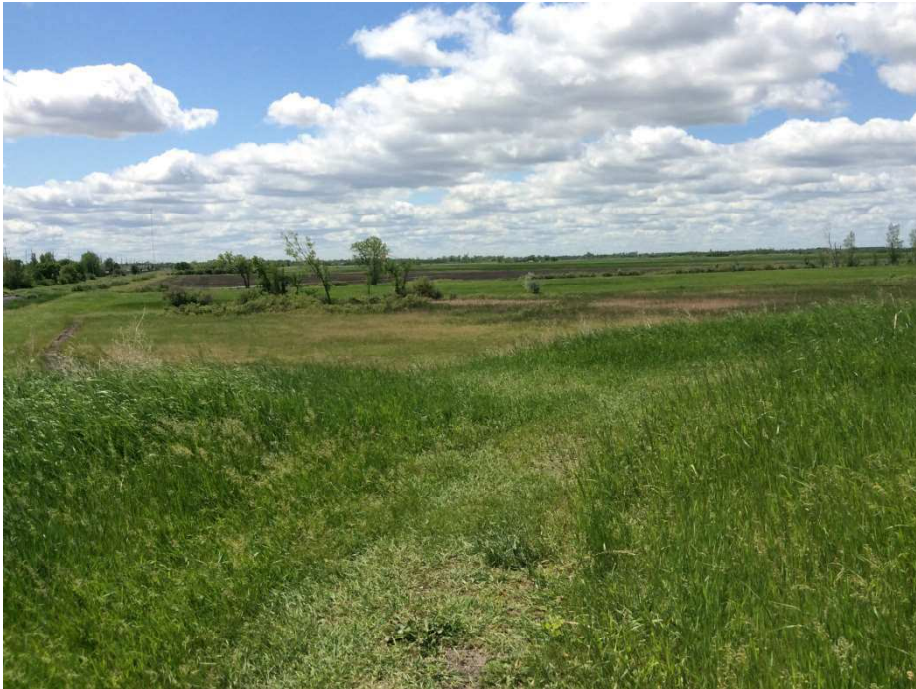
**Photo K5**  
**View looking south from the west side of the landfill**

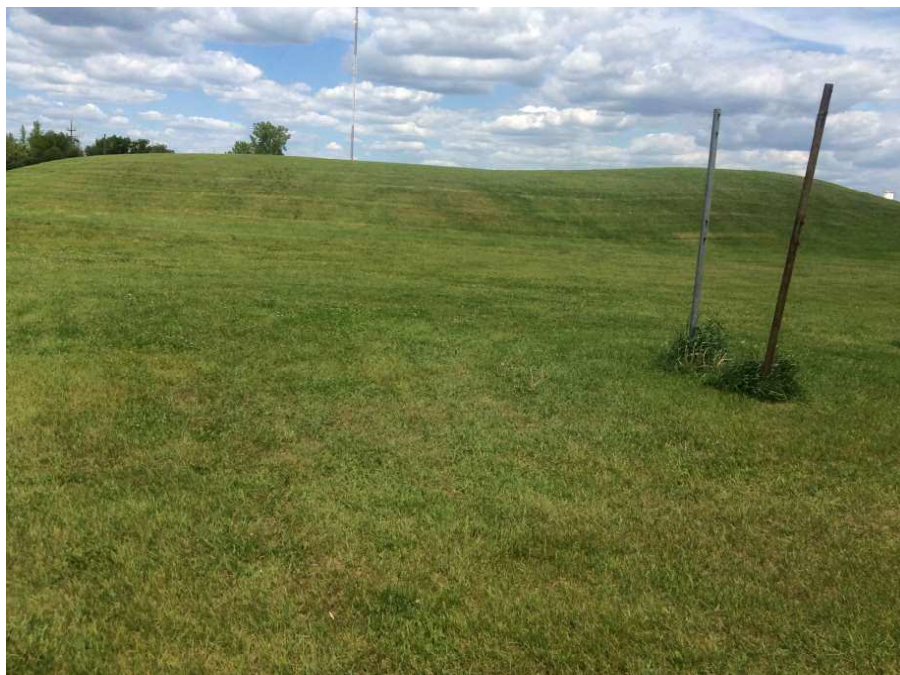
No depressions or settlement was noted during the Site visit although some bare patches of grass were noted on top of the mounded area. This bare grass may be associated with erosion.

**Photo L1**  
View looking north at the on-site mound  
from south parking lot

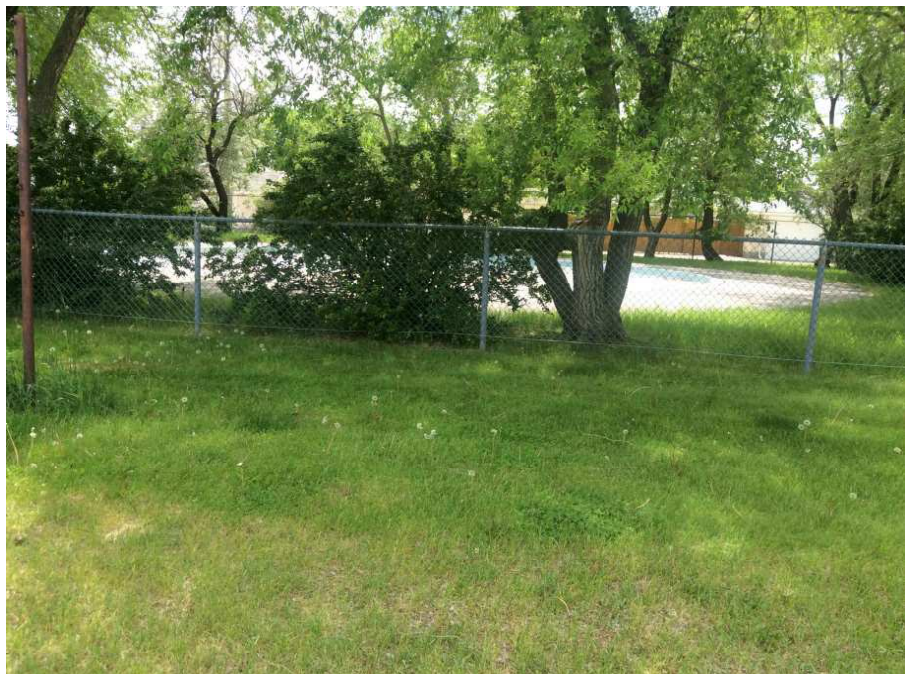
**Photo L3**  
**Wading pool in southern control zone**

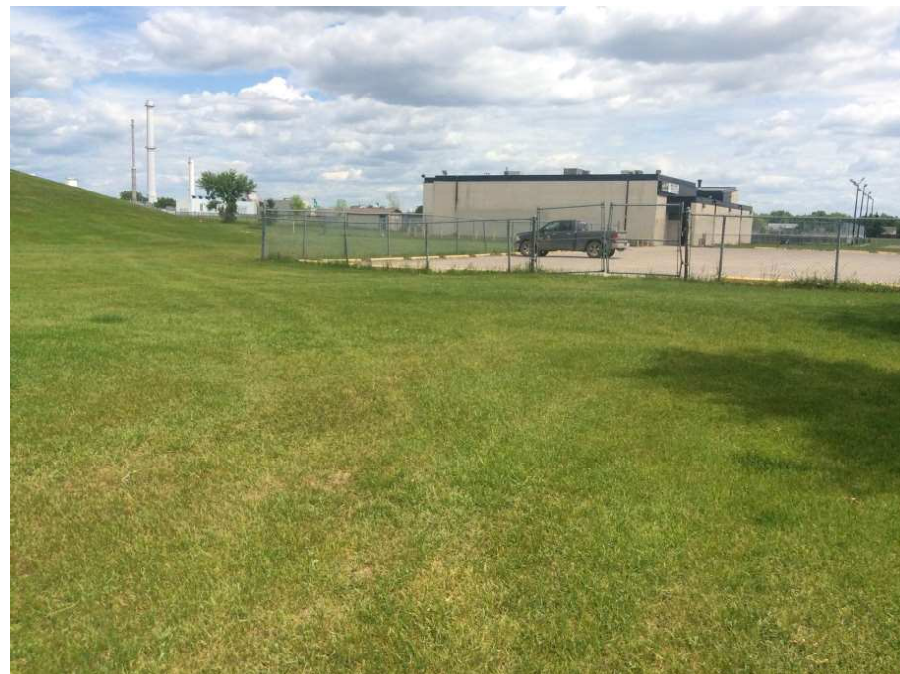
**Photo L4**  
**Southeast corner of the Site - parking lot  
 and the start of the mound (left)**

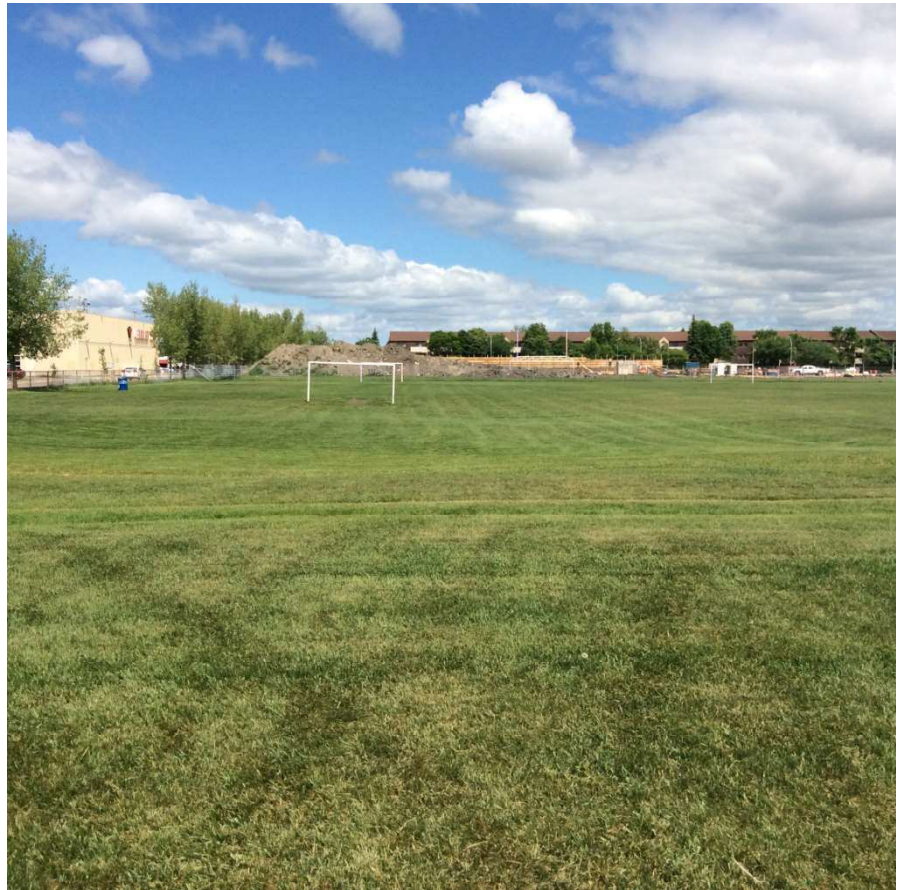
**Photo M2**  
View looking north of the landfill at the new indoor soccer fields construction

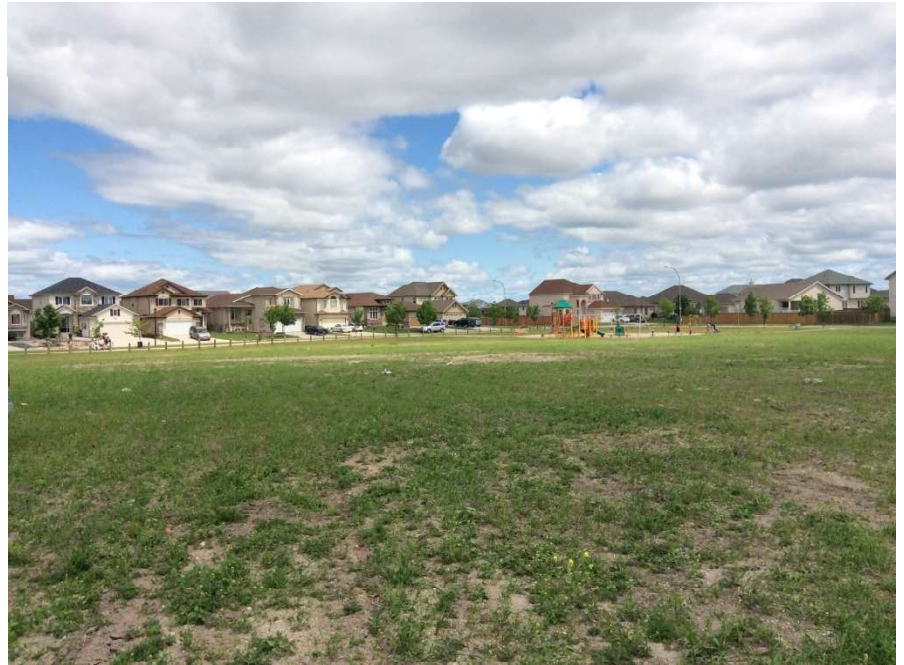
**Photo N2**  
View looking north from the landfill. Note: play structure

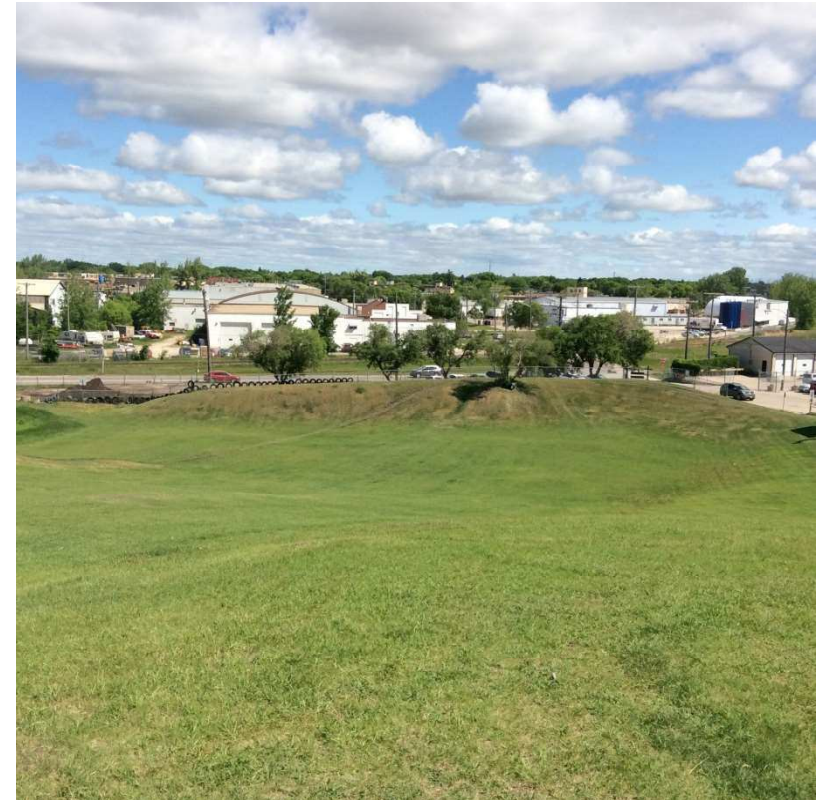
**Photo 02**  
North end of Site – used as a sliding area

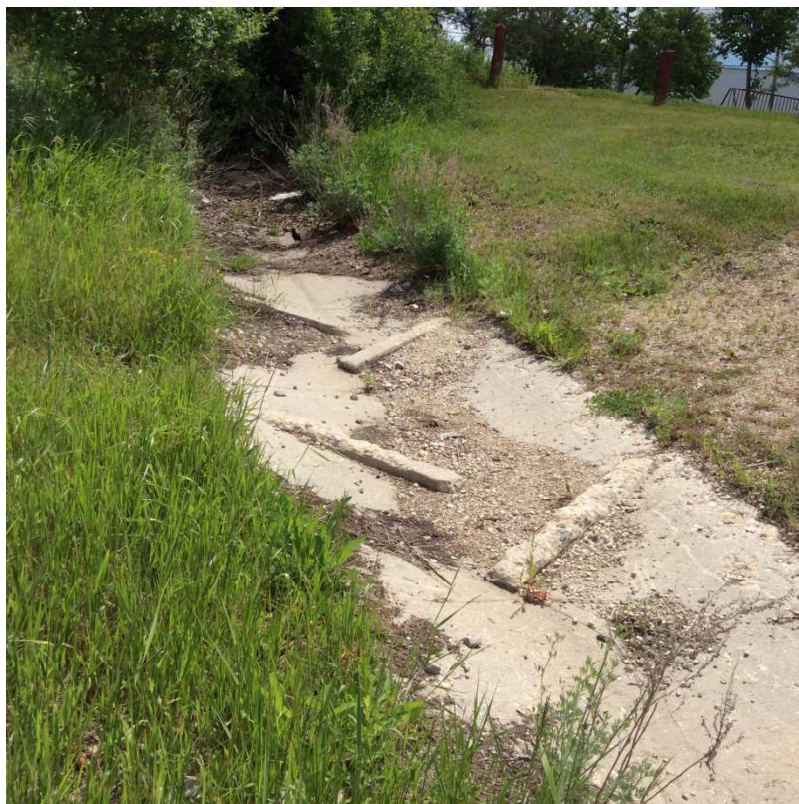
**Photo 03**  
Erosion control measures at southwest corner of the Site

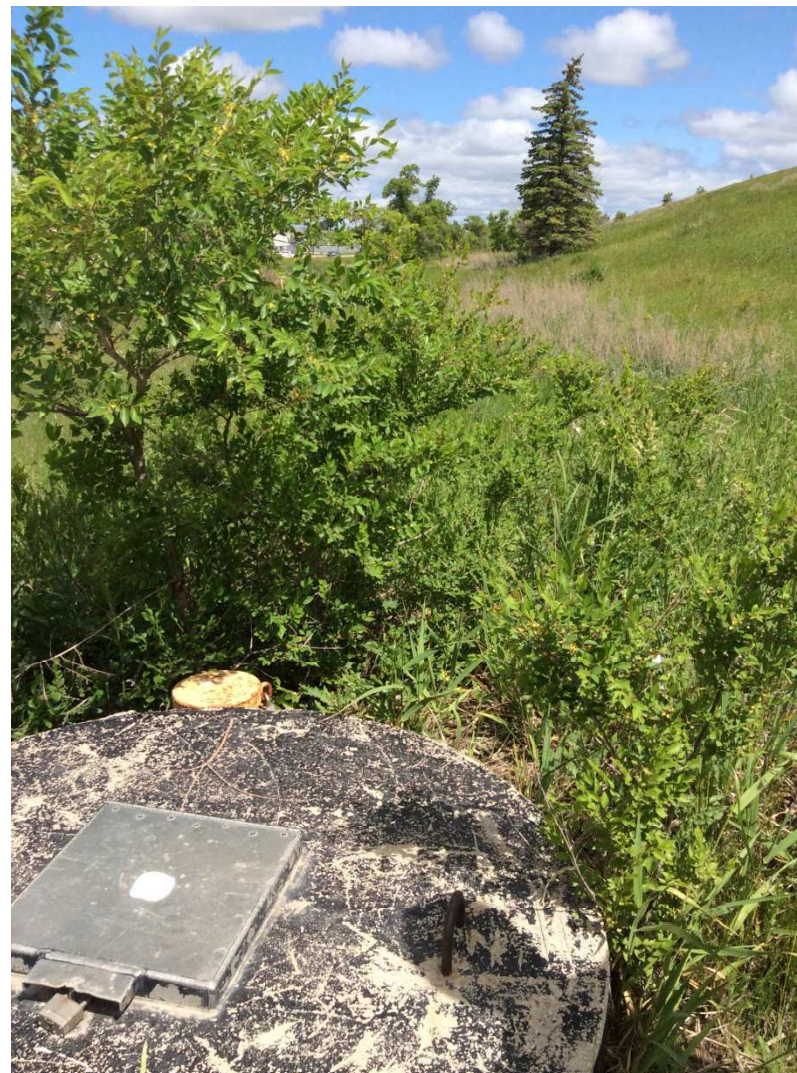
**Photo 04**  
Manhole, with west end Omand's Creek in the background

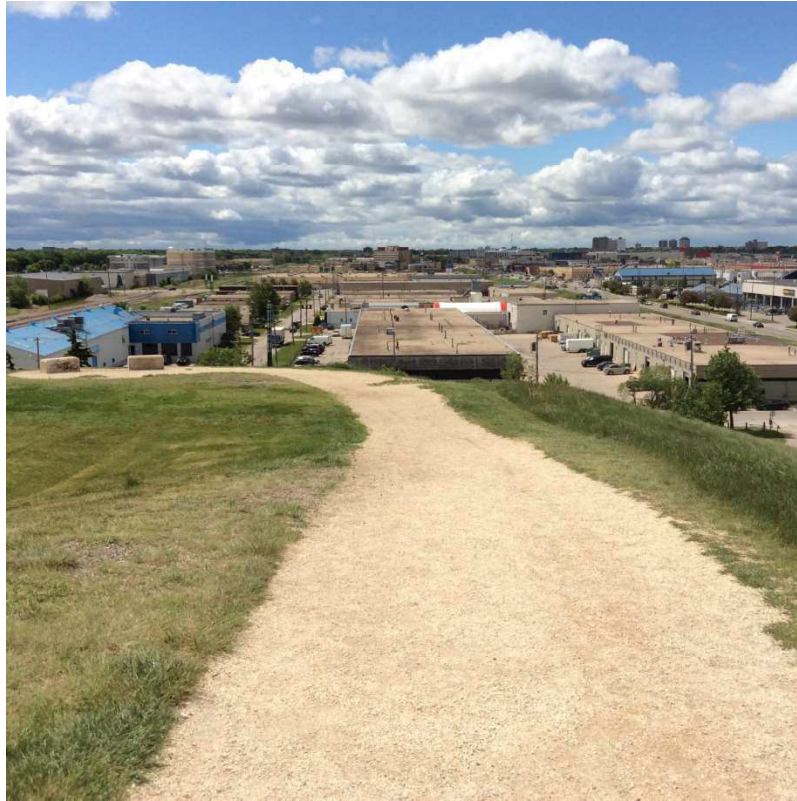
**Photo 05**  
Recreational path on top of Site,  
looking south

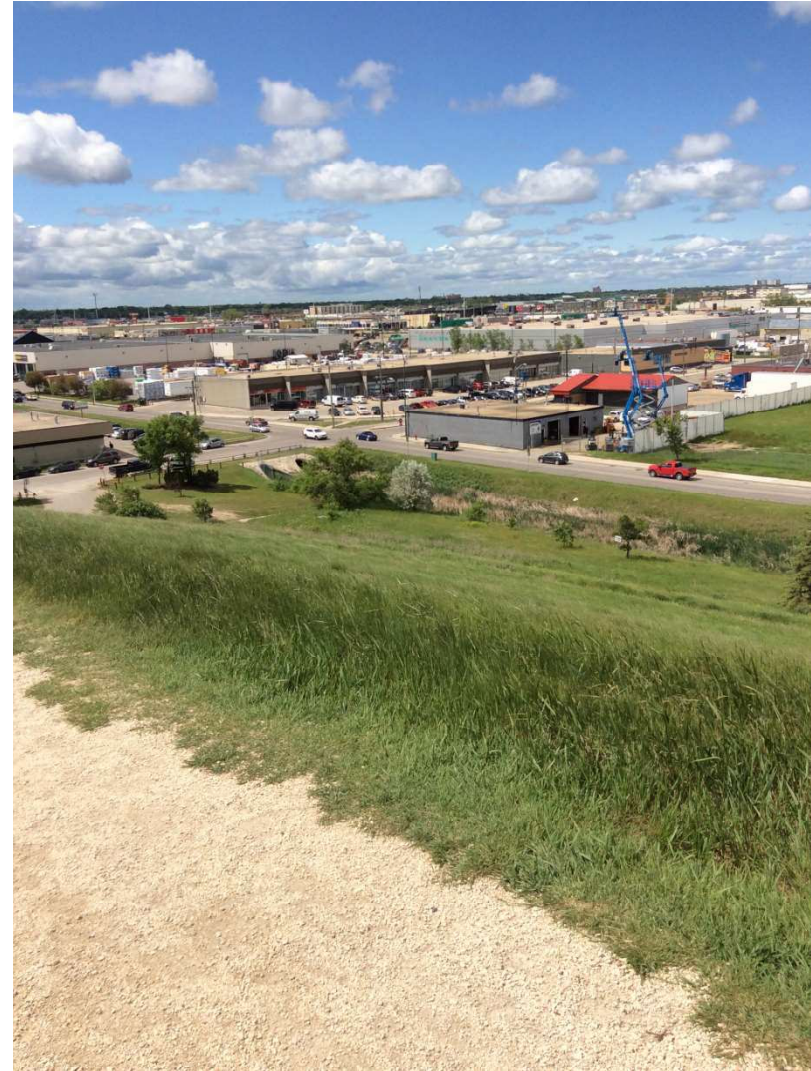
In the 1990s, leachate seeps were noted at the west end of the Site near Omand's Creek. Also, environmental impacts were noted between the Site and the adjacent drywall manufacturing company. It was unclear which Site was causing the impacts.

**Photo 06**  
Southwest corner of Site showing Omand's  
Creek along the west side

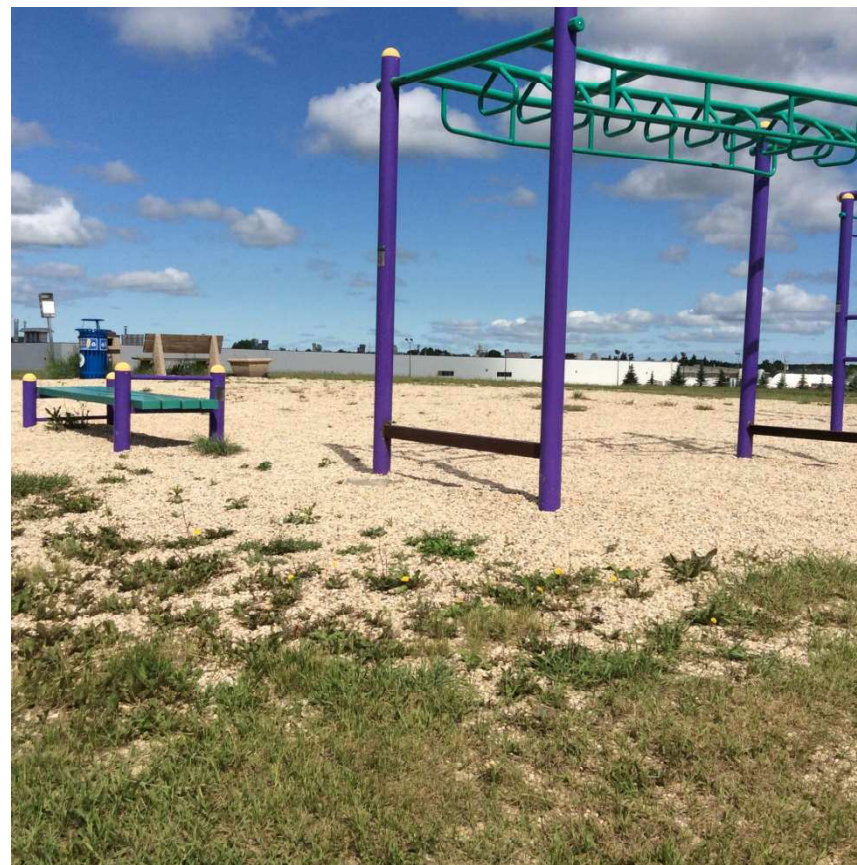
**Photo P2**  
Play structure at the top of the landfill Site

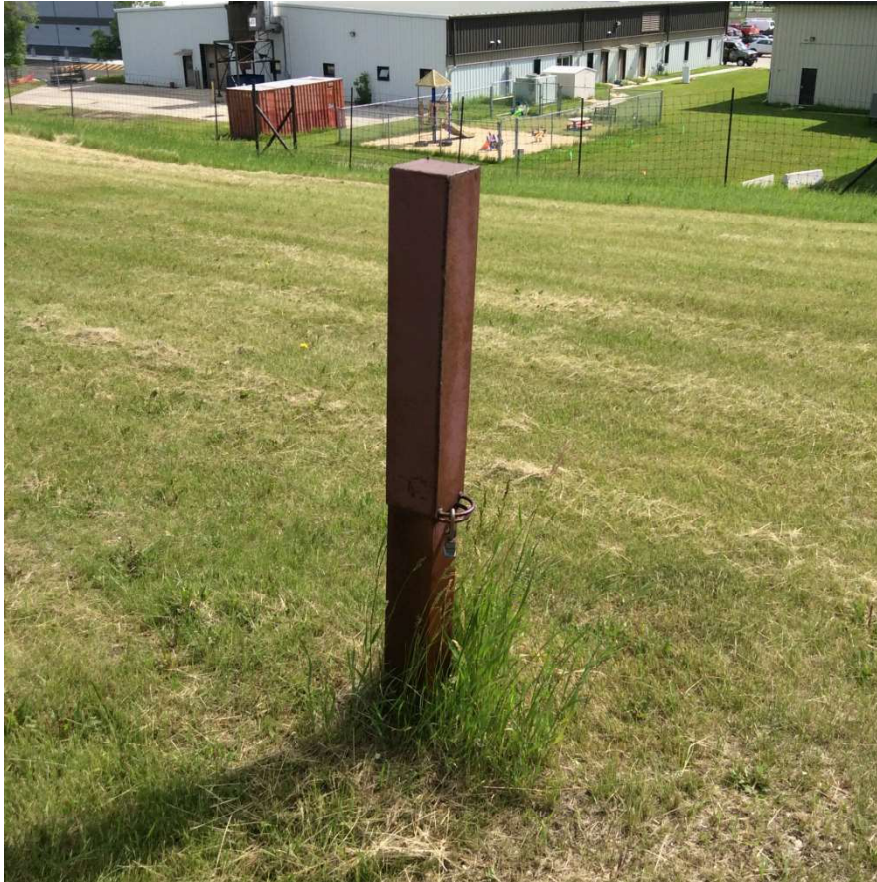
One probe was noted on-Site (P6L).

**Photo P3**  
**Monitoring well P6L**

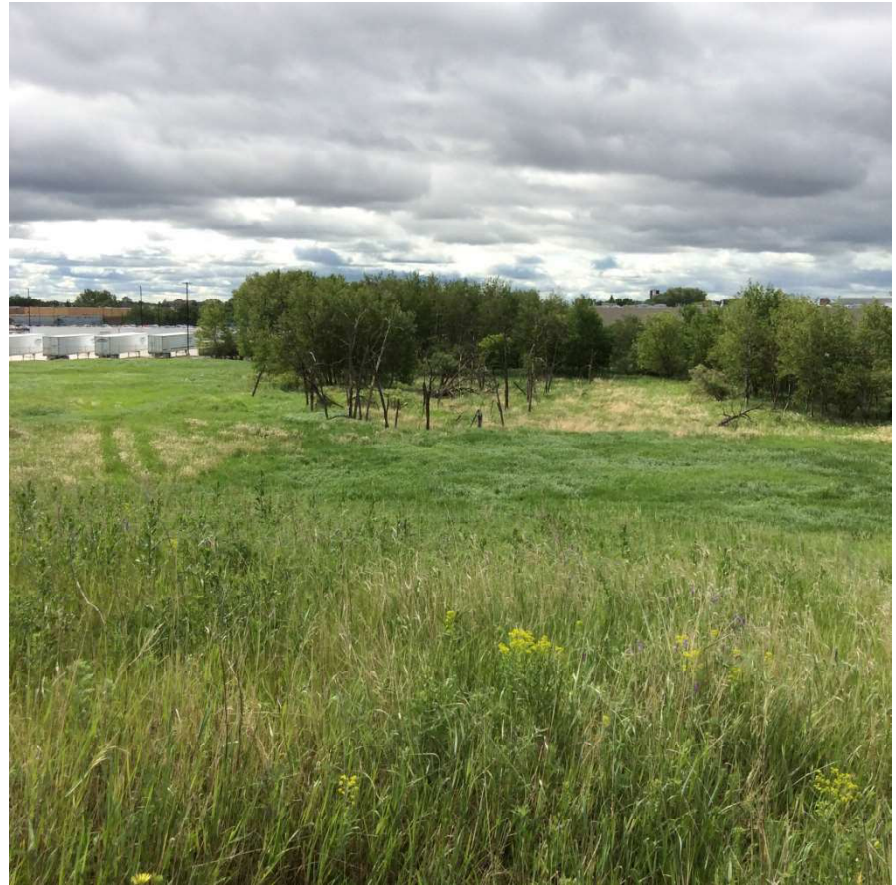
**Photo Q2**  
View looking southeast at dead trees  
Note: Boeing buildings beyond

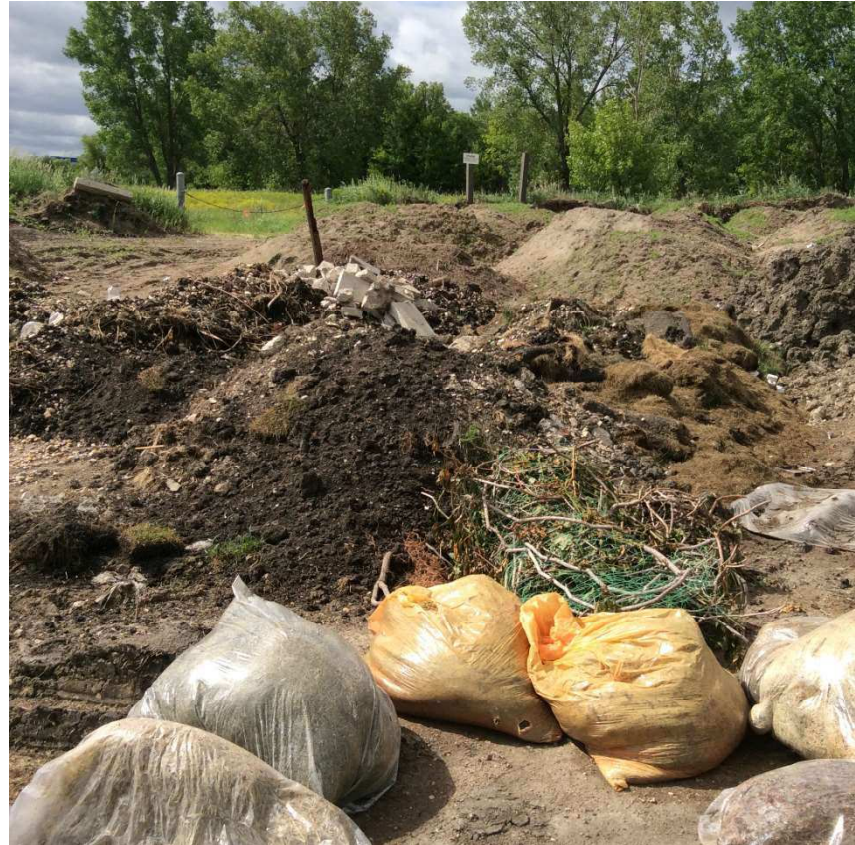
- Illegal dumping was noted just outside the landfill consisting mostly of fill. No other illegal dumping was noted and no drainage, leachate, erosion, or slope stability issues were identified during the Site visit. It was noted that the slopes were not evenly graded;
- No buildings were present on-Site;
- Large pieces of concrete and metal were noted throughout the landfill area; and,
- Thirteen wells were present on-Site.

Photo Q6  
Illegal dumping at north Site entrance

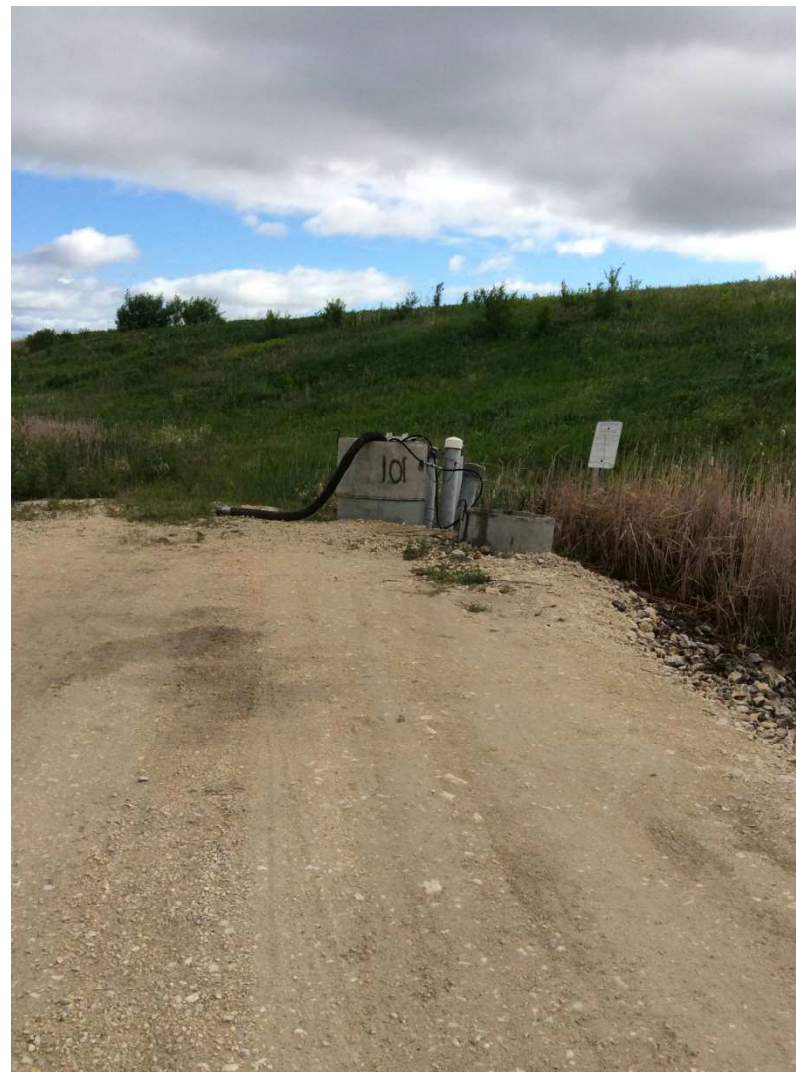
**Photo R2**  
Leachate manhole MH10 at southwest corner

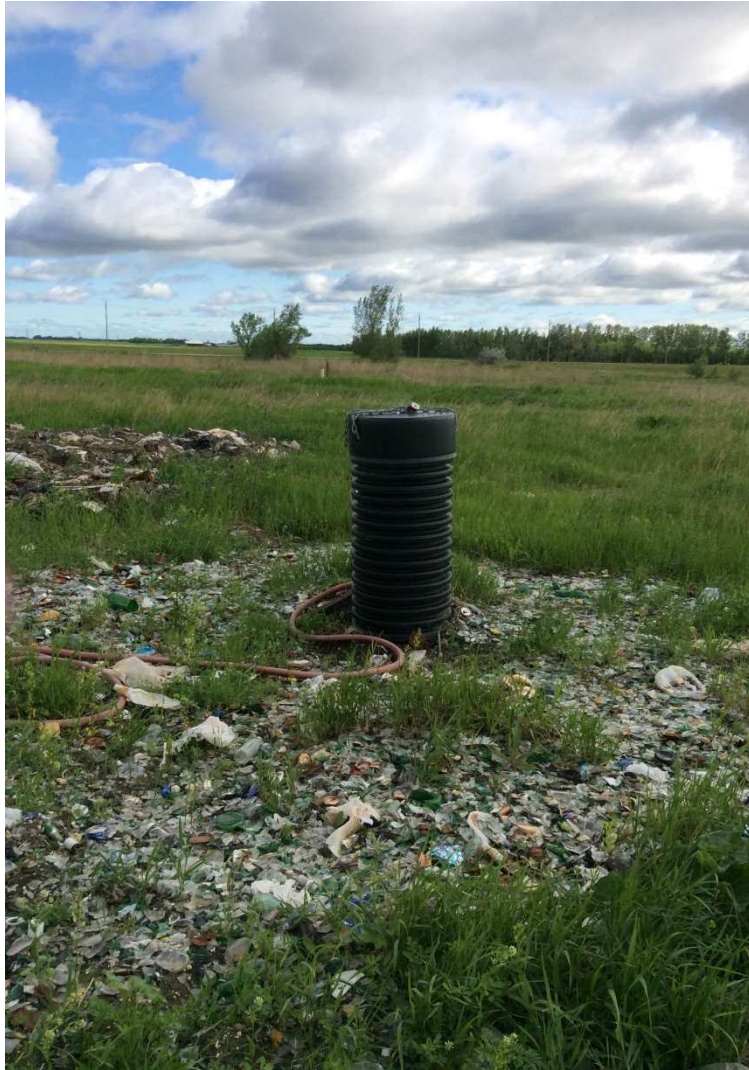
The waste boundary was well defined. No exposed waste was noted with the exception of some illegal dumping of material at the east end and a pile of crushed glass on the northwest corner of the landfill. The crushed glass, as noted on Figure R3, has been stockpiled to be used as filter material instead of crushed stone. The glass pile is located next to a large diameter leachate sump. The sump is being used as a trial system to reduce the leachate mound within the centre of the landfill.

**Photo R3**  
**Leachate sump trial at northeast corner of landfill**

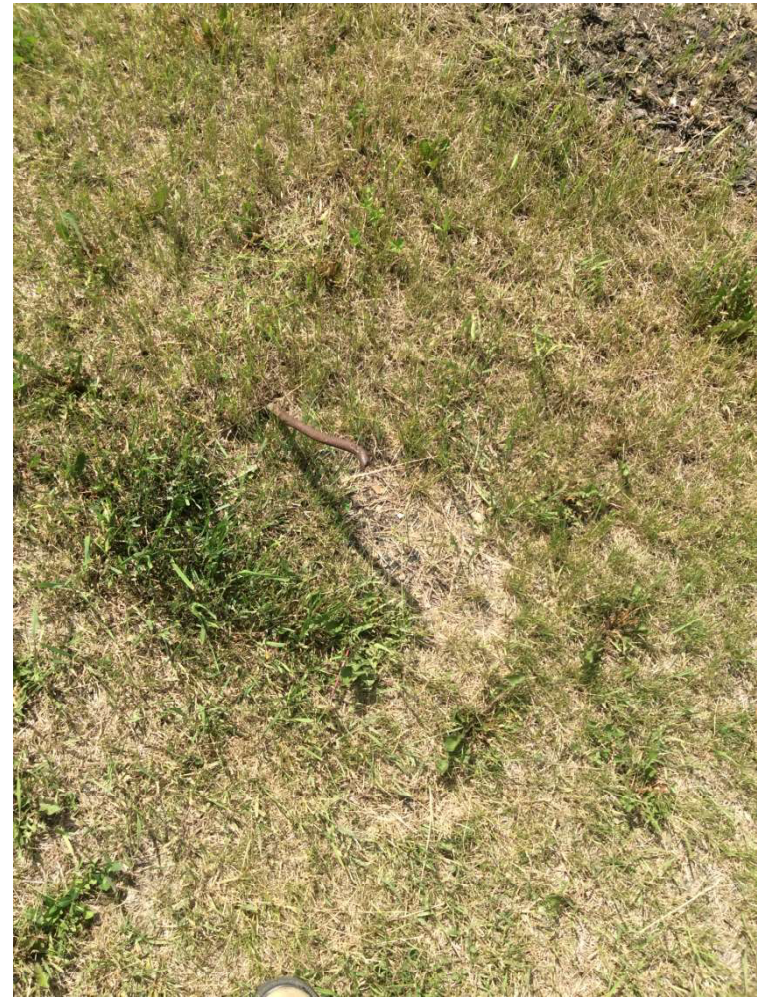
<b>Settlement/slopes</b>	None
<b>Erosion</b>	No
<b>Seeps</b>	No
<b>Other</b>	Some exposed waste noted

**Photo T8**  
Exposed metal coming from surface of  
landfill

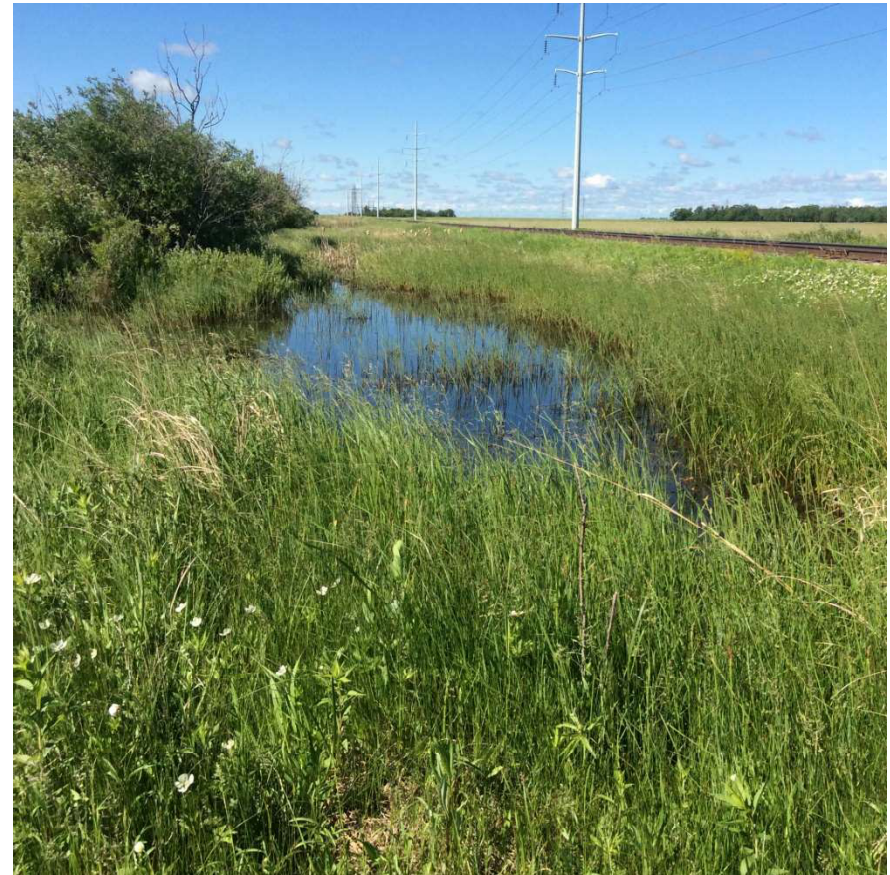
**Photo U2**  
View of swampy/wet area along the southeast side of  
the railway tracks, looking southwest

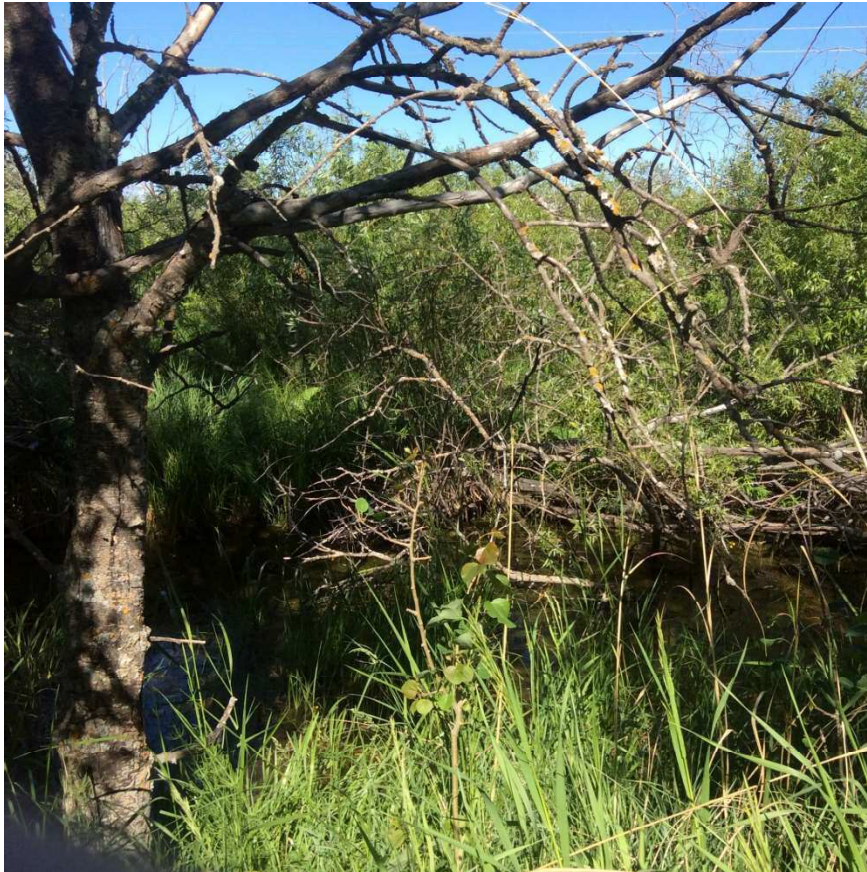
**Dead trees in wet area on east side of the Site**

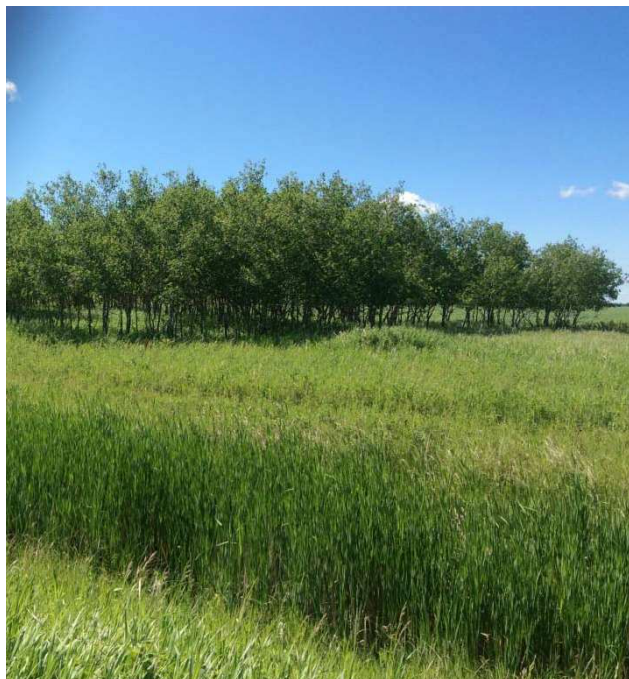
**Photo U7**  
View of drainage ditch looking southeast

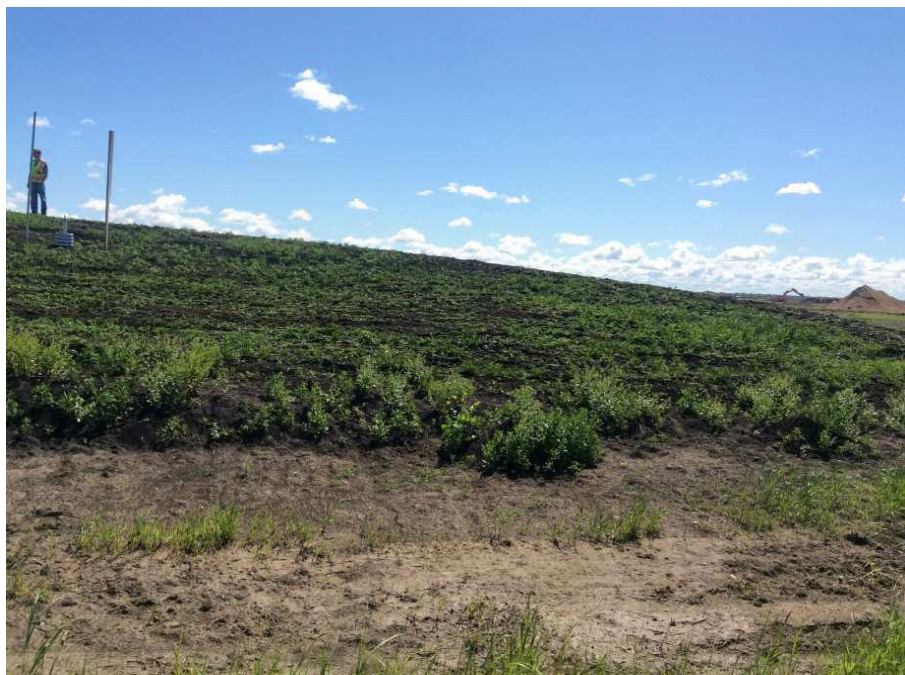
At the time of the Site visit, topsoil had been added and the Site had been reseeded. Vegetation was still in the process of growing. As such, the vegetation was sometimes sparse. Some areas appeared bare, indicative of potential effects of landfill gas. Slight areas of erosion from surface water runoff were noted at the northwest corner of the landfill. This was likely due to sparse vegetation.

**Photo W1**  
**Southwest corner of Site showing**  
**sparse vegetation**

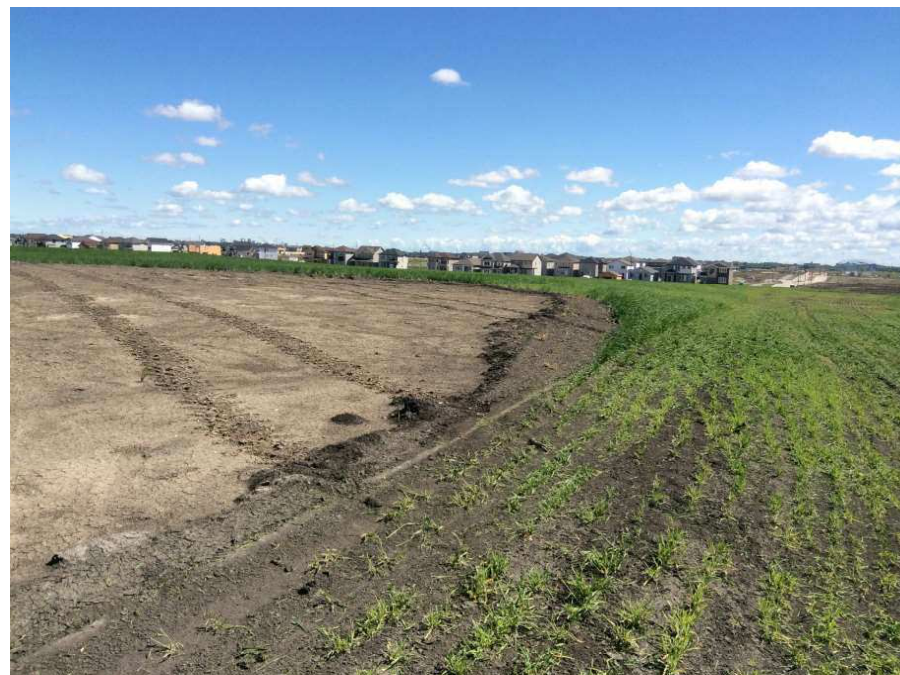
**Photo W2**  
**Area at the top of the landfill intended**  
**for a gravel pad**
