**September 2015**

# **Landfill Status Report for Closed Landfills Winnipeg, Manitoba**

**Submitted to:**  
City of Winnipeg

**Report Number: 1522283/1000**

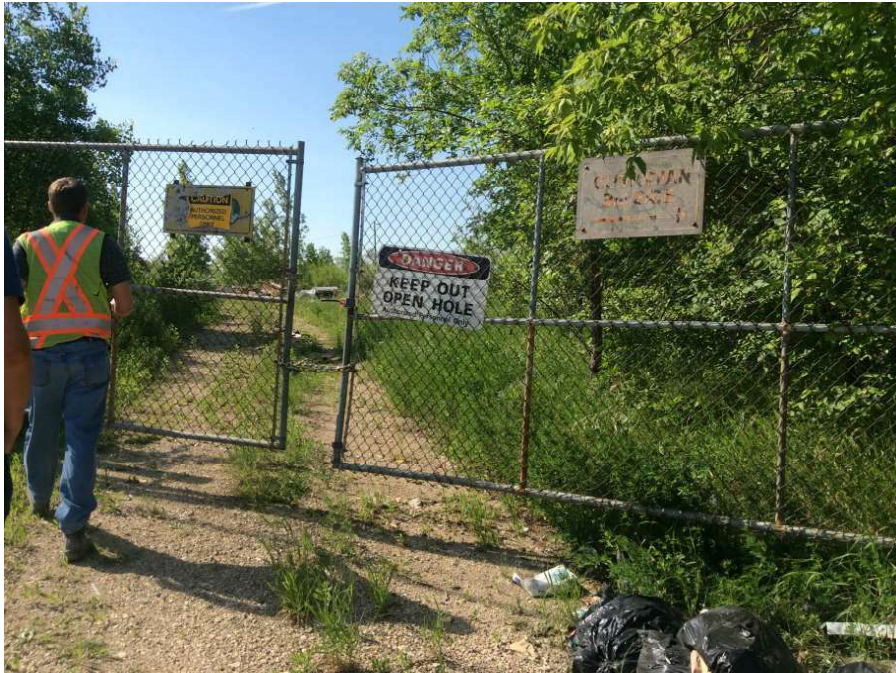
**Photo X5**  
**Elmwood Landfill – private property**  
**noting an open hole**

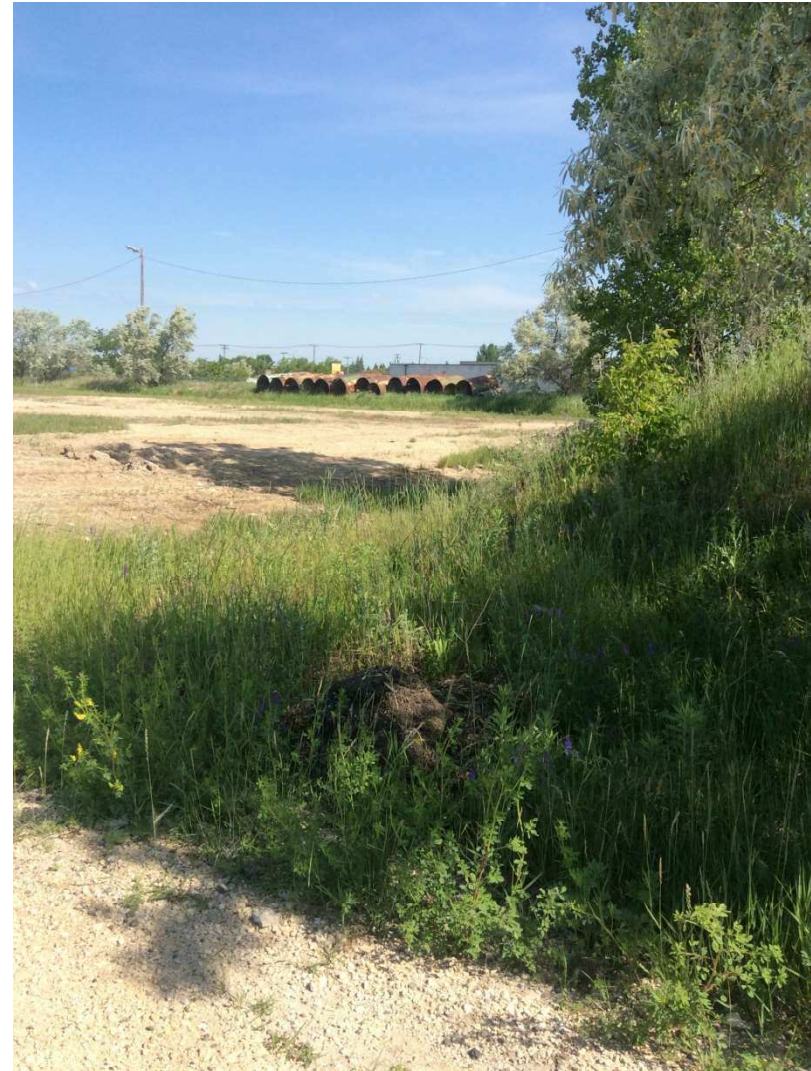
**Photo X8**  
**Elmwood Landfill – Tanks stored at north  
 edge of snow dump**

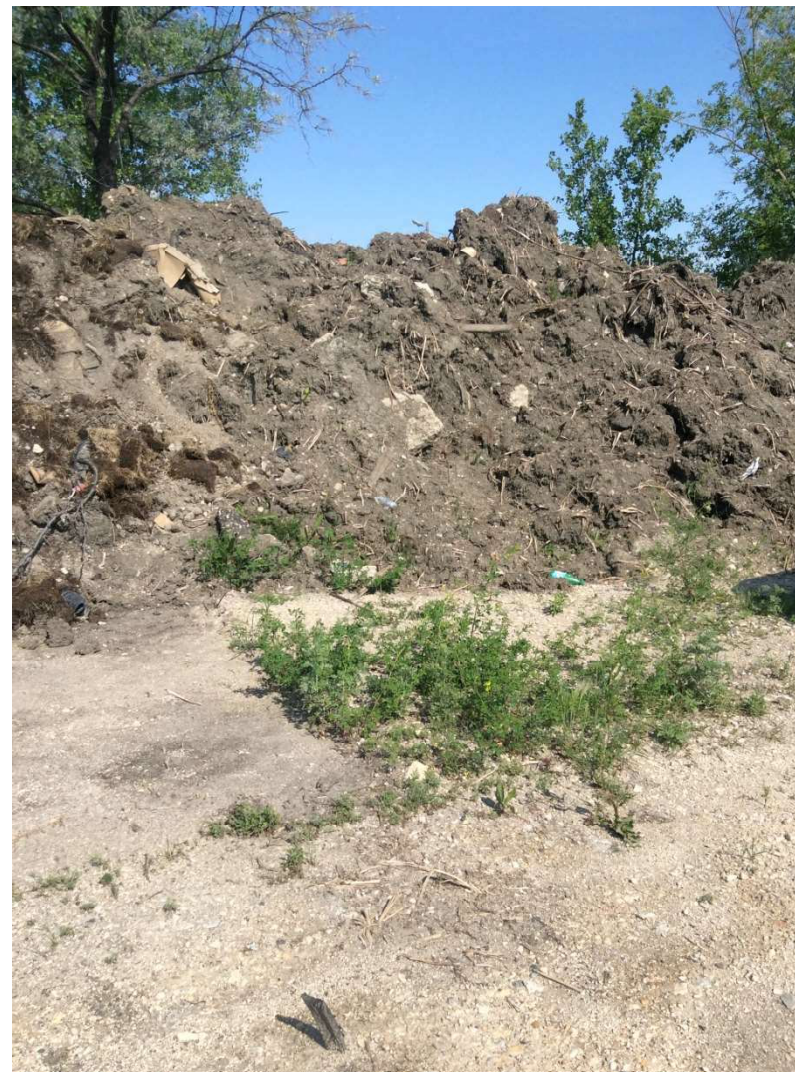
**Photo X10**

**Fill on the border of Nairn Avenue and Elmwood Landfills at the entrance to snow dump**

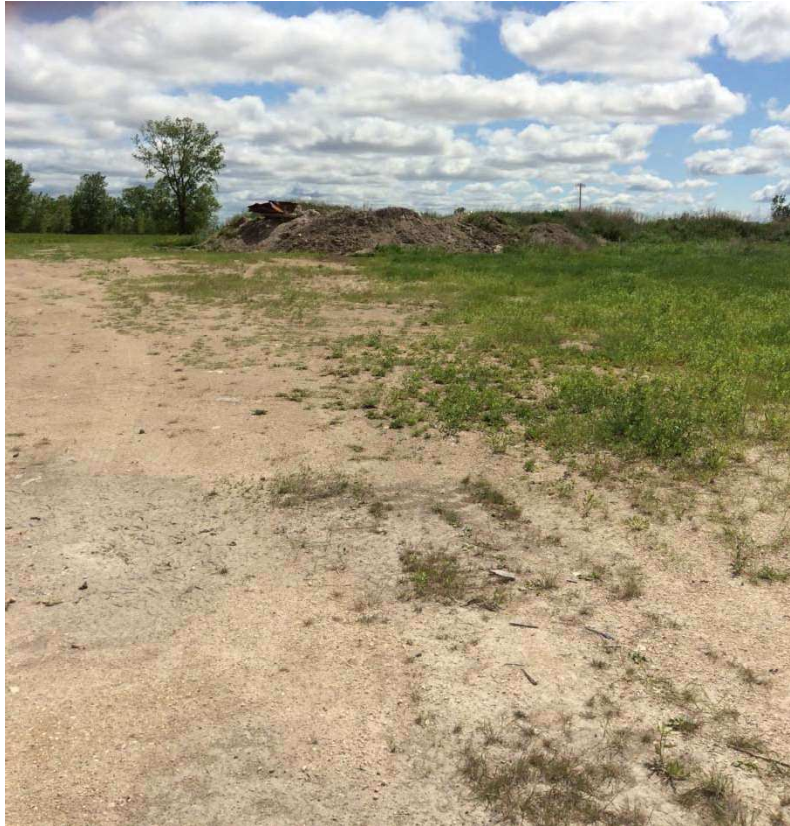
**Photo Y1**  
**Fill piles located in the central portion of the Site**

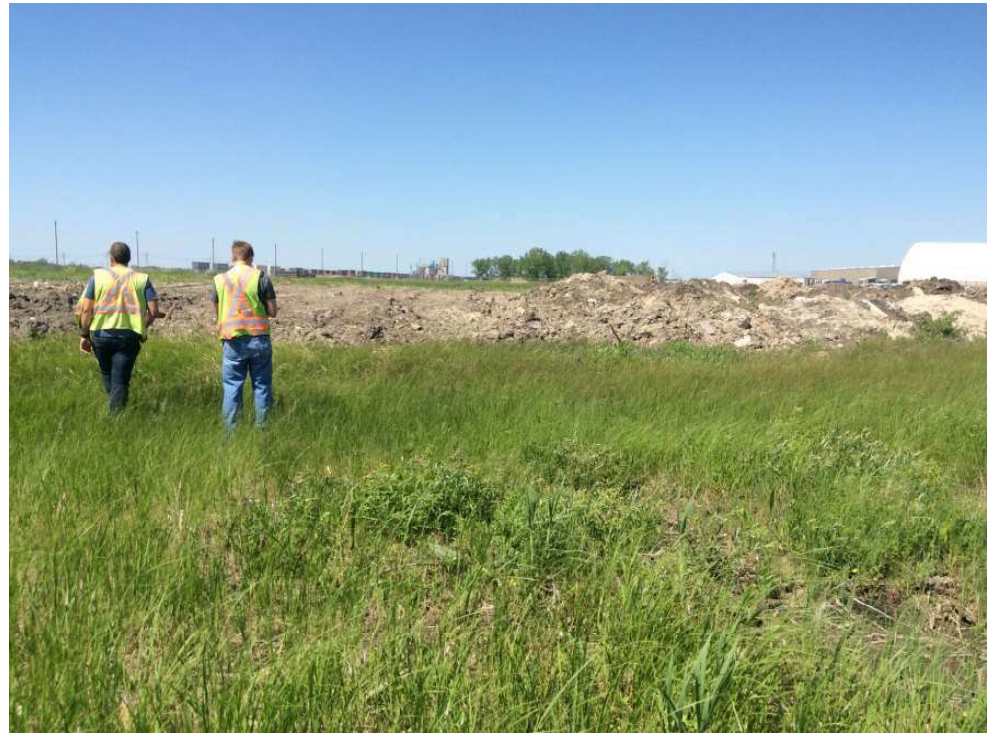
<b>Settlement/slopes</b>	generally flat, but is uneven because of the large amounts of fill brought to the Site.
<b>Erosion</b>	No
<b>Seeps</b>	No
<b>Other</b>	Exposed waste related to fill

**Photo Z2**  
**Fill piles**

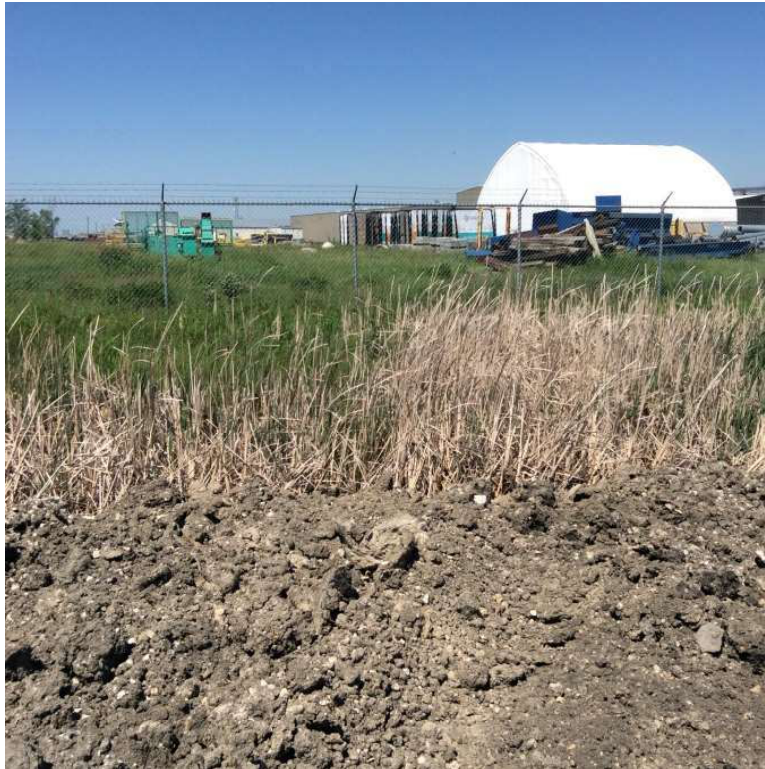
**Photo Z3**  
 Fill pushed up against low wet area with  
 western portion of landfill beyond the fence

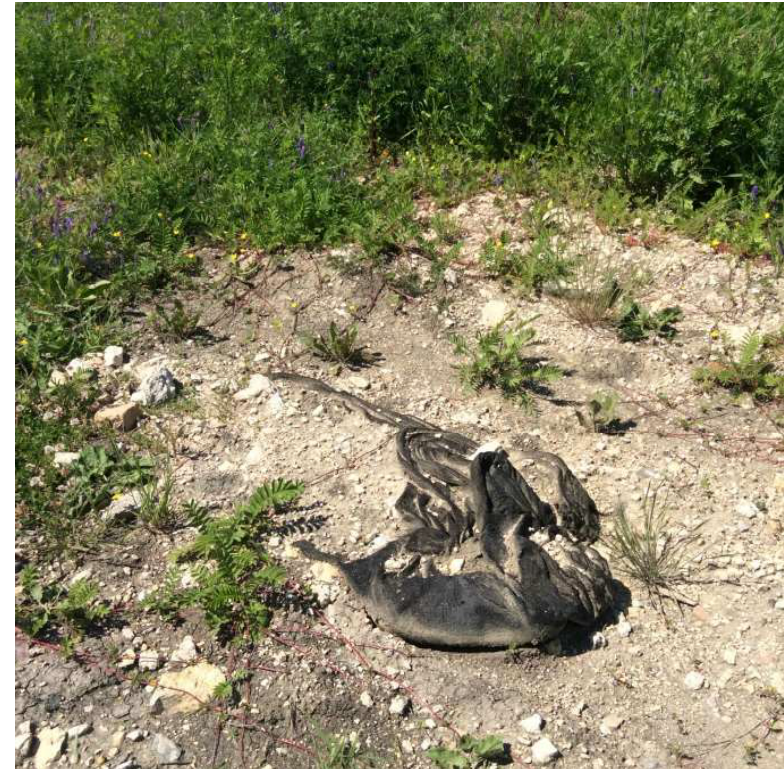
**Photo Z4**  
 Exposed waste in the fill

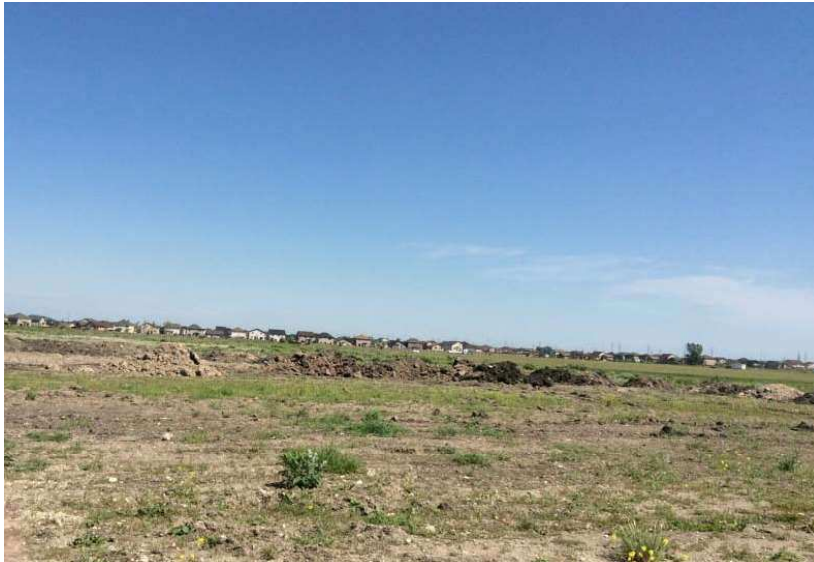
**Photo Z5**  
Looking north to fill piles. Lack of vegetation likely due to placement of fill.

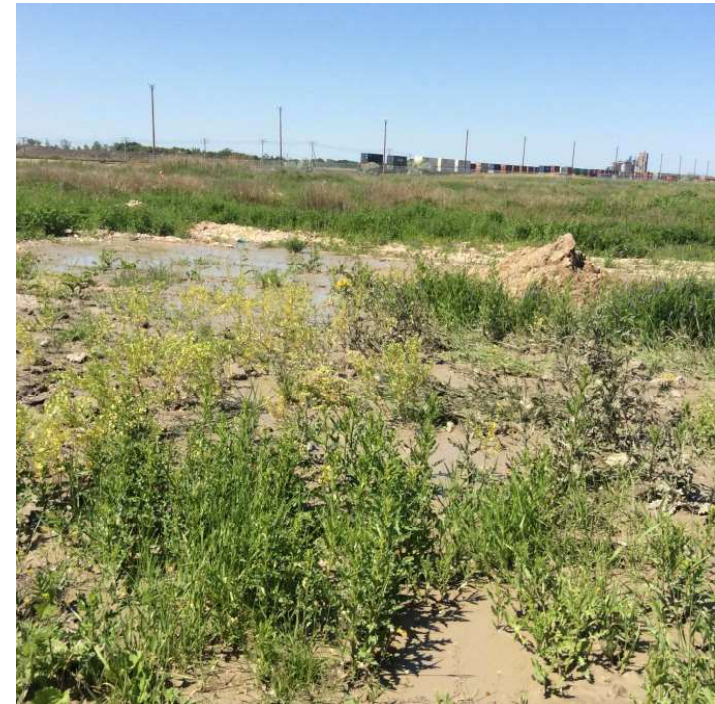
**Photo Z6**  
Looking southwest. Poor vegetation growth due to placement of fill.  
Low lying area.

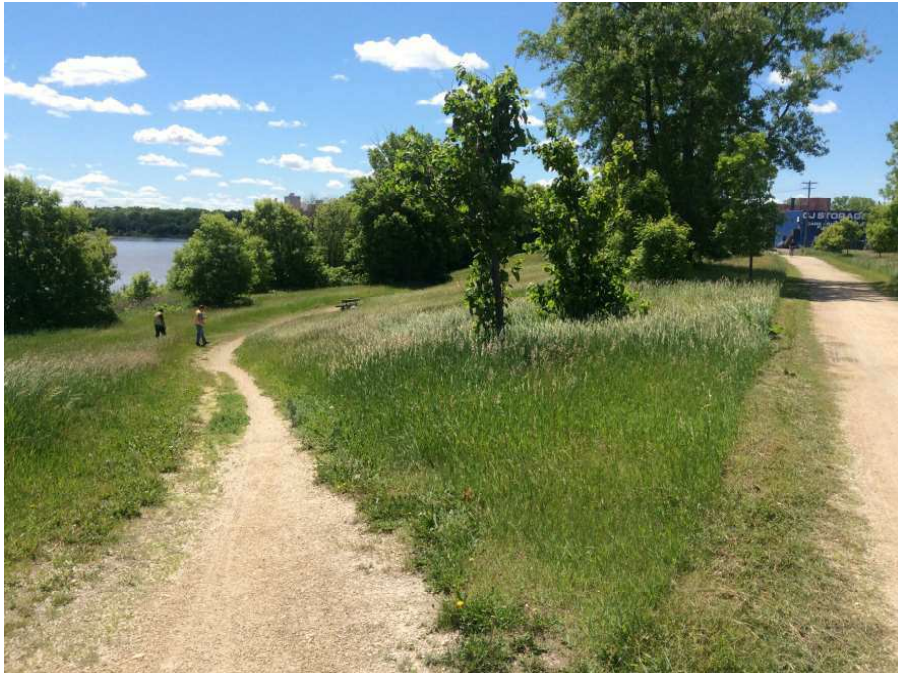
**Photo AA1**

**Area evaluated during site visit – expected landfill site from the northwest with walking trails**

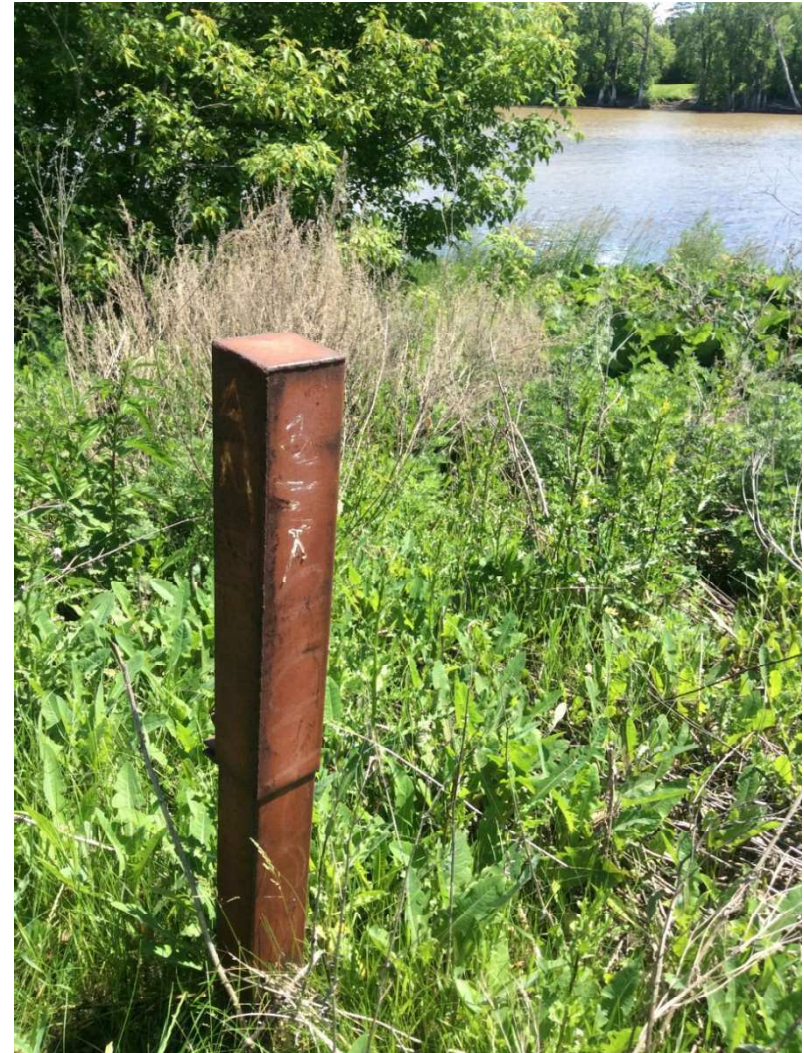
**Photo AA2**

There is no evidence of historical landfill gas monitoring at this Site, however two monitoring well casings were found at the Site during the Site visit.

**Monitoring probe at the banks of the Red River**

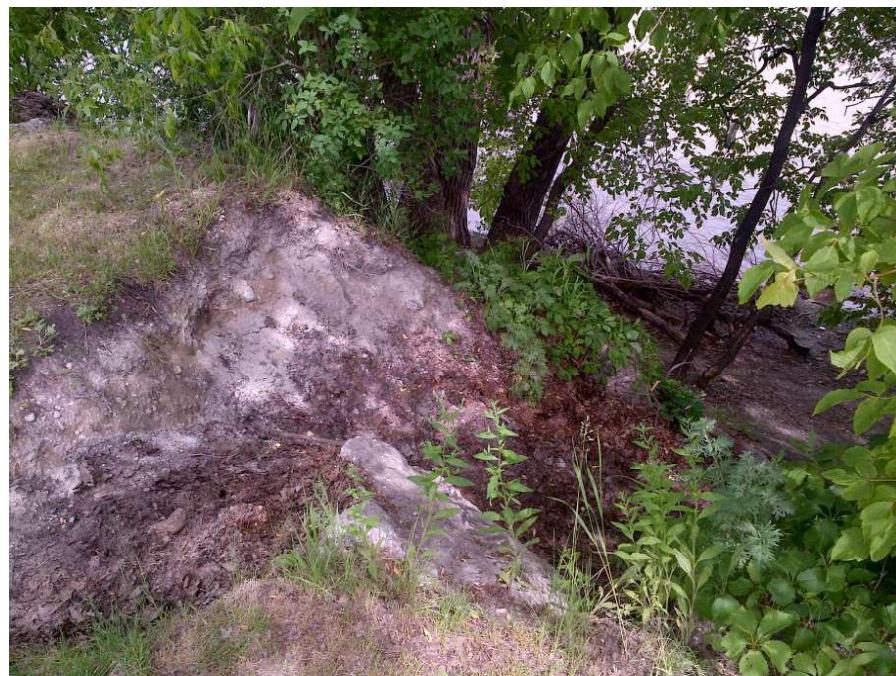
<b>Settlement/slopes</b>	Sloped towards the river
<b>Erosion</b>	Some areas along the banks of the river
<b>Seeps</b>	No
<b>Other</b>	--

**Photo BB4**  
**Evidence of erosion**

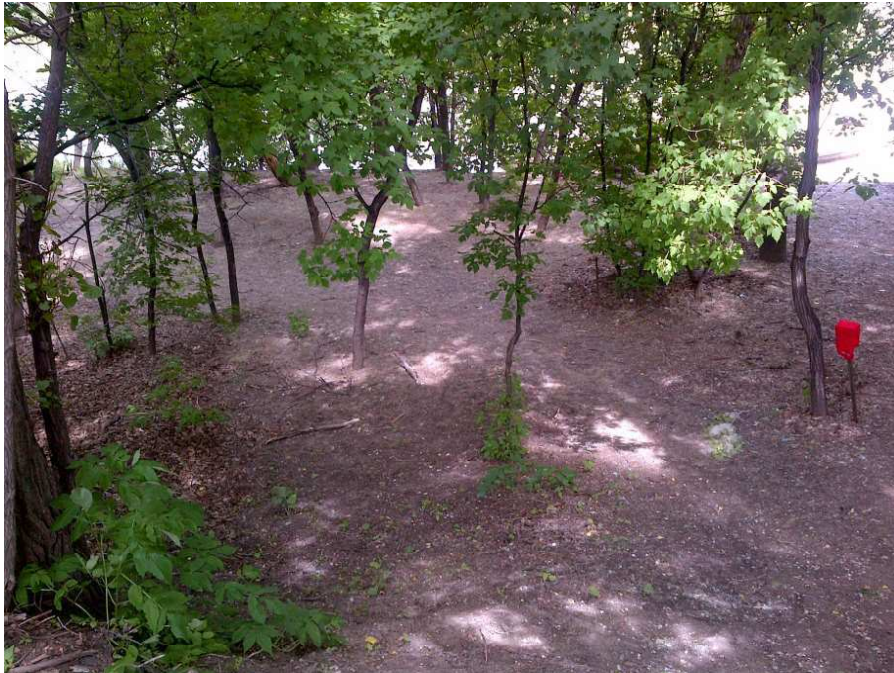
**Photo BB5**  
Lower treed area prone to flooding

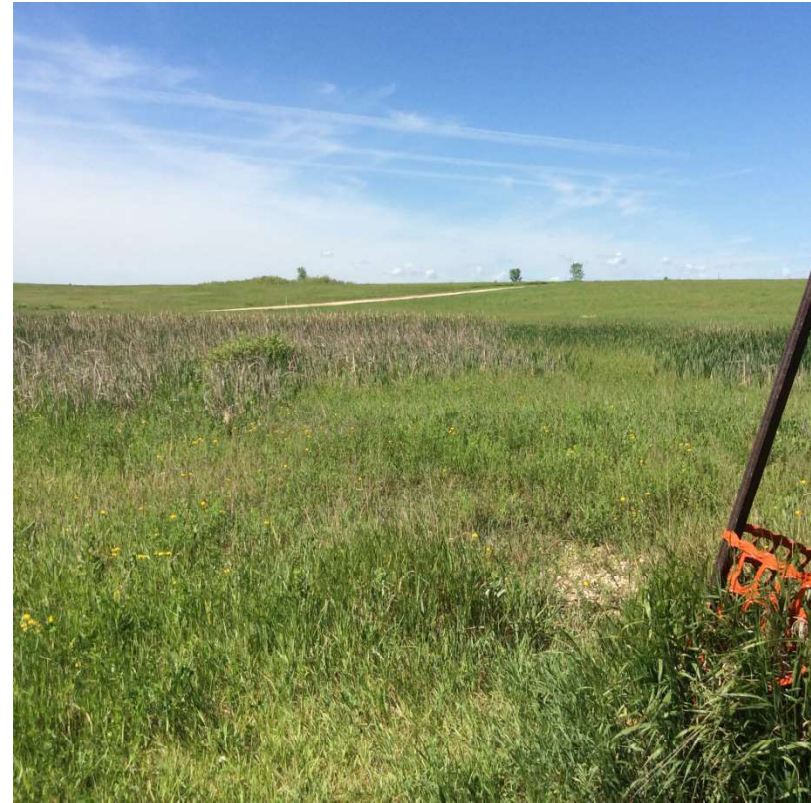
**Photo FF2**  
Looking southwest at the west mound. Low area with marsh type vegetation growing in foreground.

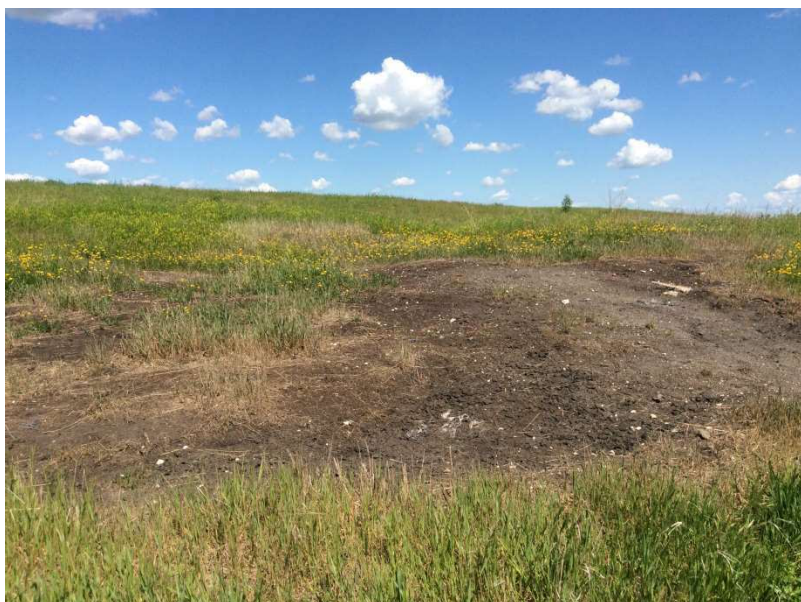
<b>Settlement/slopes</b>	Some areas of settlement with ponding
<b>Erosion</b>	No
<b>Seeps</b>	No
<b>Other</b>	Stressed vegetation noted

**Photo FF5**  
**Area of stressed vegetation**
